16001  
Pit, Below-Grade Tank, or  
Proposed Alternative Method Permit or Closure Plan Application

1.  
Operator: Burlington Resources Oil & Gas Company, LP OGRID #: 14538  
Address: PO BOX 4289, Farmington, NM 87499  
Facility or well name: SAN JUAN 28-6 UNIT 127N  
API Number: 30-039-30774 OCD Permit Number: \_\_\_\_\_  
U/L or Qtr/Qtr J Section 20 Township 28N Range 6w County: Rio Arriba  
Center of Proposed Design: Latitude 36.64395 °N Longitude -107.48693 °W NAD: ☐ 1927 ☒ 1983  
Surface Owner: ☒ Federal ☐ State ☐ Private ☐ Tribal Trust or Indian Allotment

<b>Historical hydrocarbon impacted soil was found during the BGT closure for the subject well. The excavation was 71' x 84' x 2-4.5' in depth and 620 c/yds of soil was transported to IEI land farm. Analytical results were below the regulatory standards, except for one well (130ppm TPH). OCD approved COPC request to backfill. No further action required. The closure report and laboratory analysis are attached for review.</b>

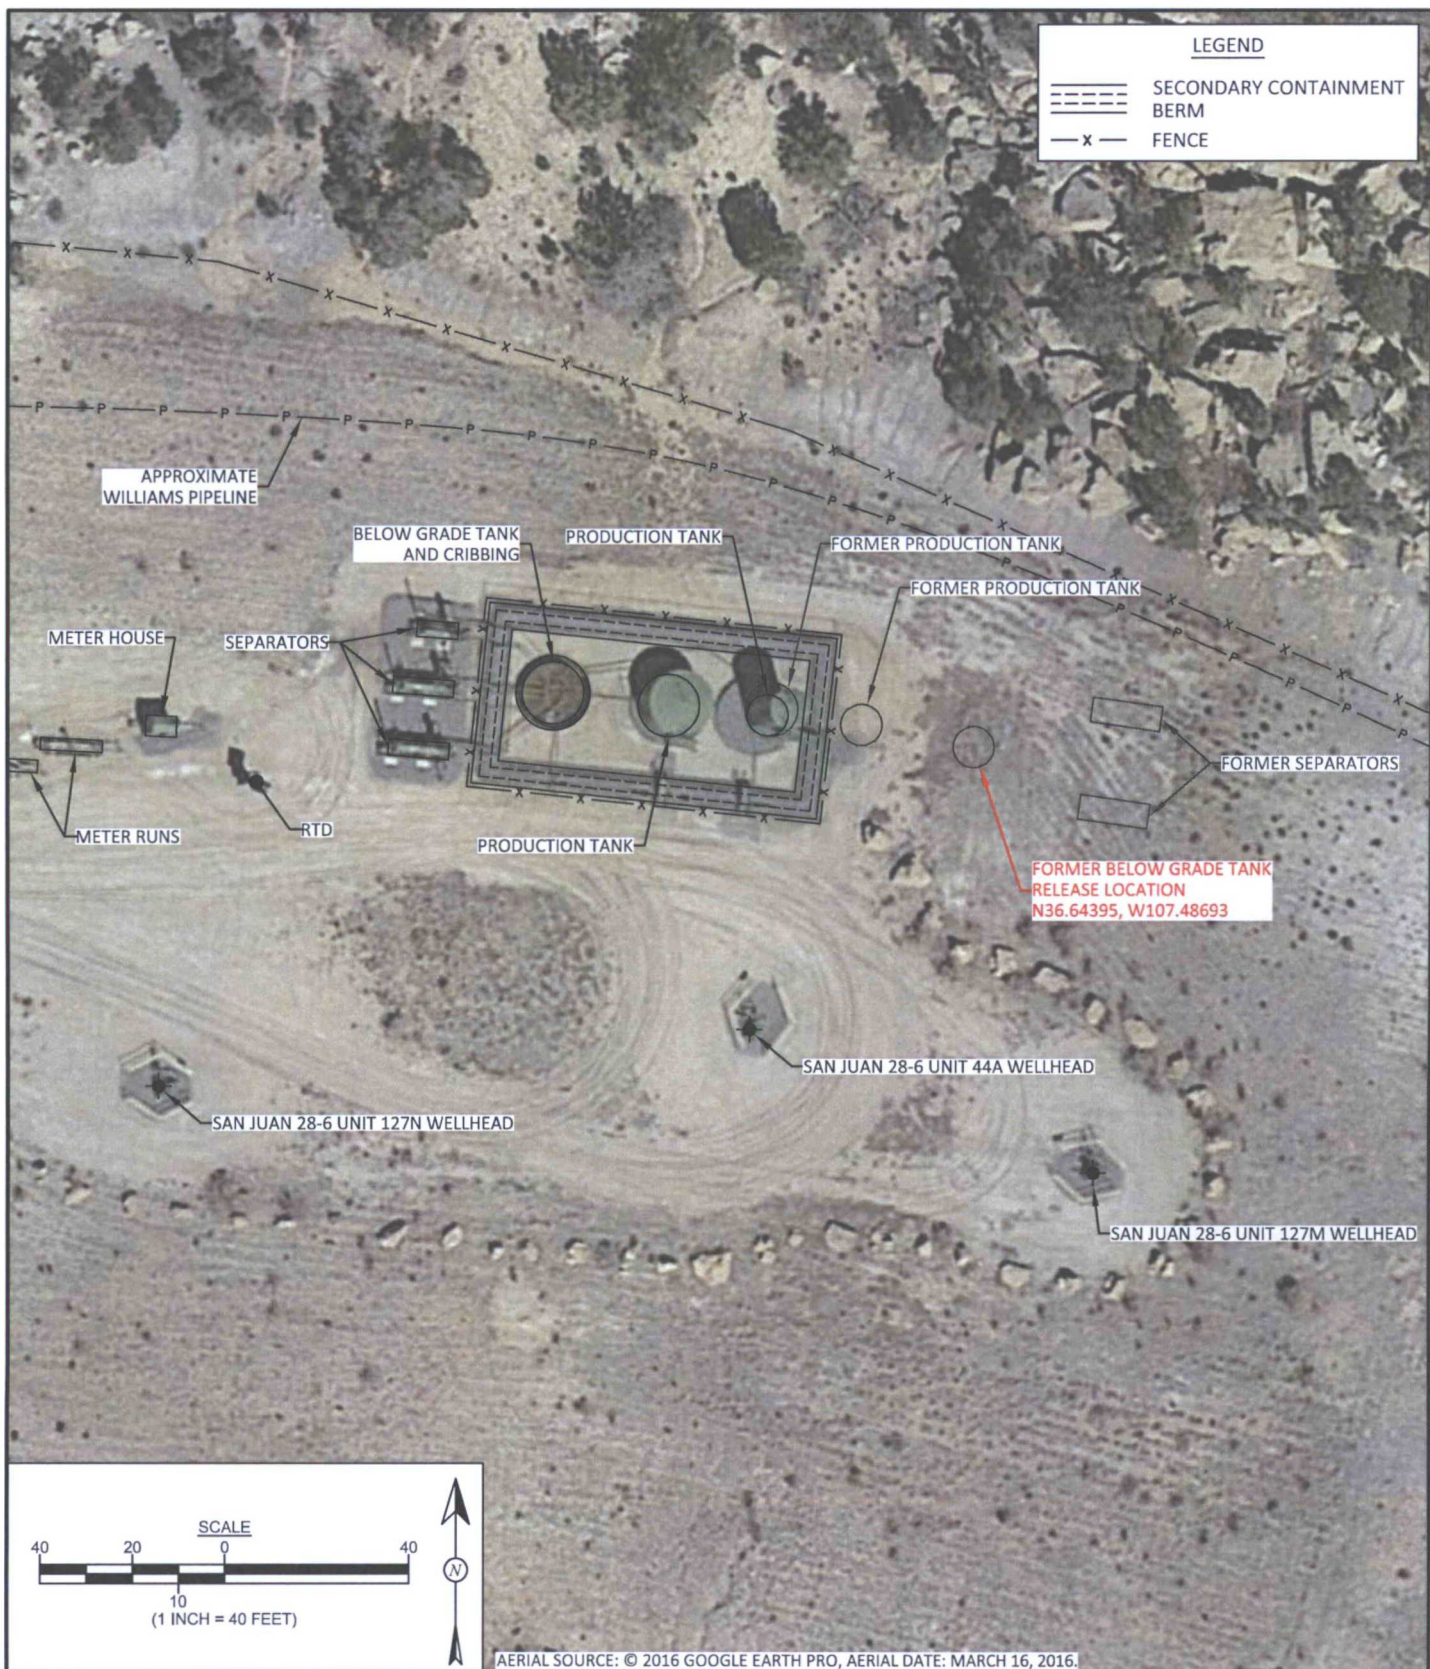
## FIGURE 2

### AERIAL SITE MAP 2016 AND 2017
