Pit, Below-Grade Tank, or  
Proposed Alternative Method Permit or Closure Plan Application

BELOW-GRADE TANK CLOSURE PLAN

GCU 155

API No. 3004507269

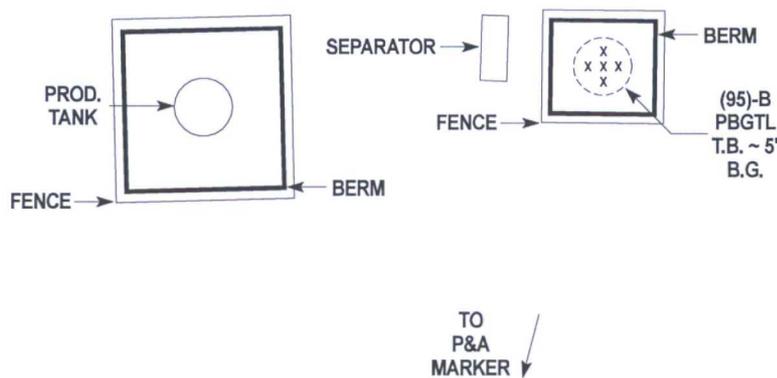
**SITE SKETCH** BGT Located: off  on site PLOT PLAN circle:  attached

OVM CALIB. READ. = **100.0** ppm RF=1.00  
OVM CALIB. GAS = **100** ppm  
TIME: **9:00** am/pm DATE: **10/25/17**
