Release Notification and Corrective Action

Name of Company Hilcorp Energy Company	Contact Jennifer Deal
Address 9a CR 5793	Telephone No. (505) 324-5128
Facility Name Sarah M. Hedges #1	Facility Type Gas Well
Surface Owner Private	Mineral Owner
API No. 30-045-60040

**RE: Remediation Report and Request for Closure
Hilcorp Energy Company
Sarah M. Hedges #1
San Juan County, New Mexico
NESE Section 23, Township 31N Range 12W**

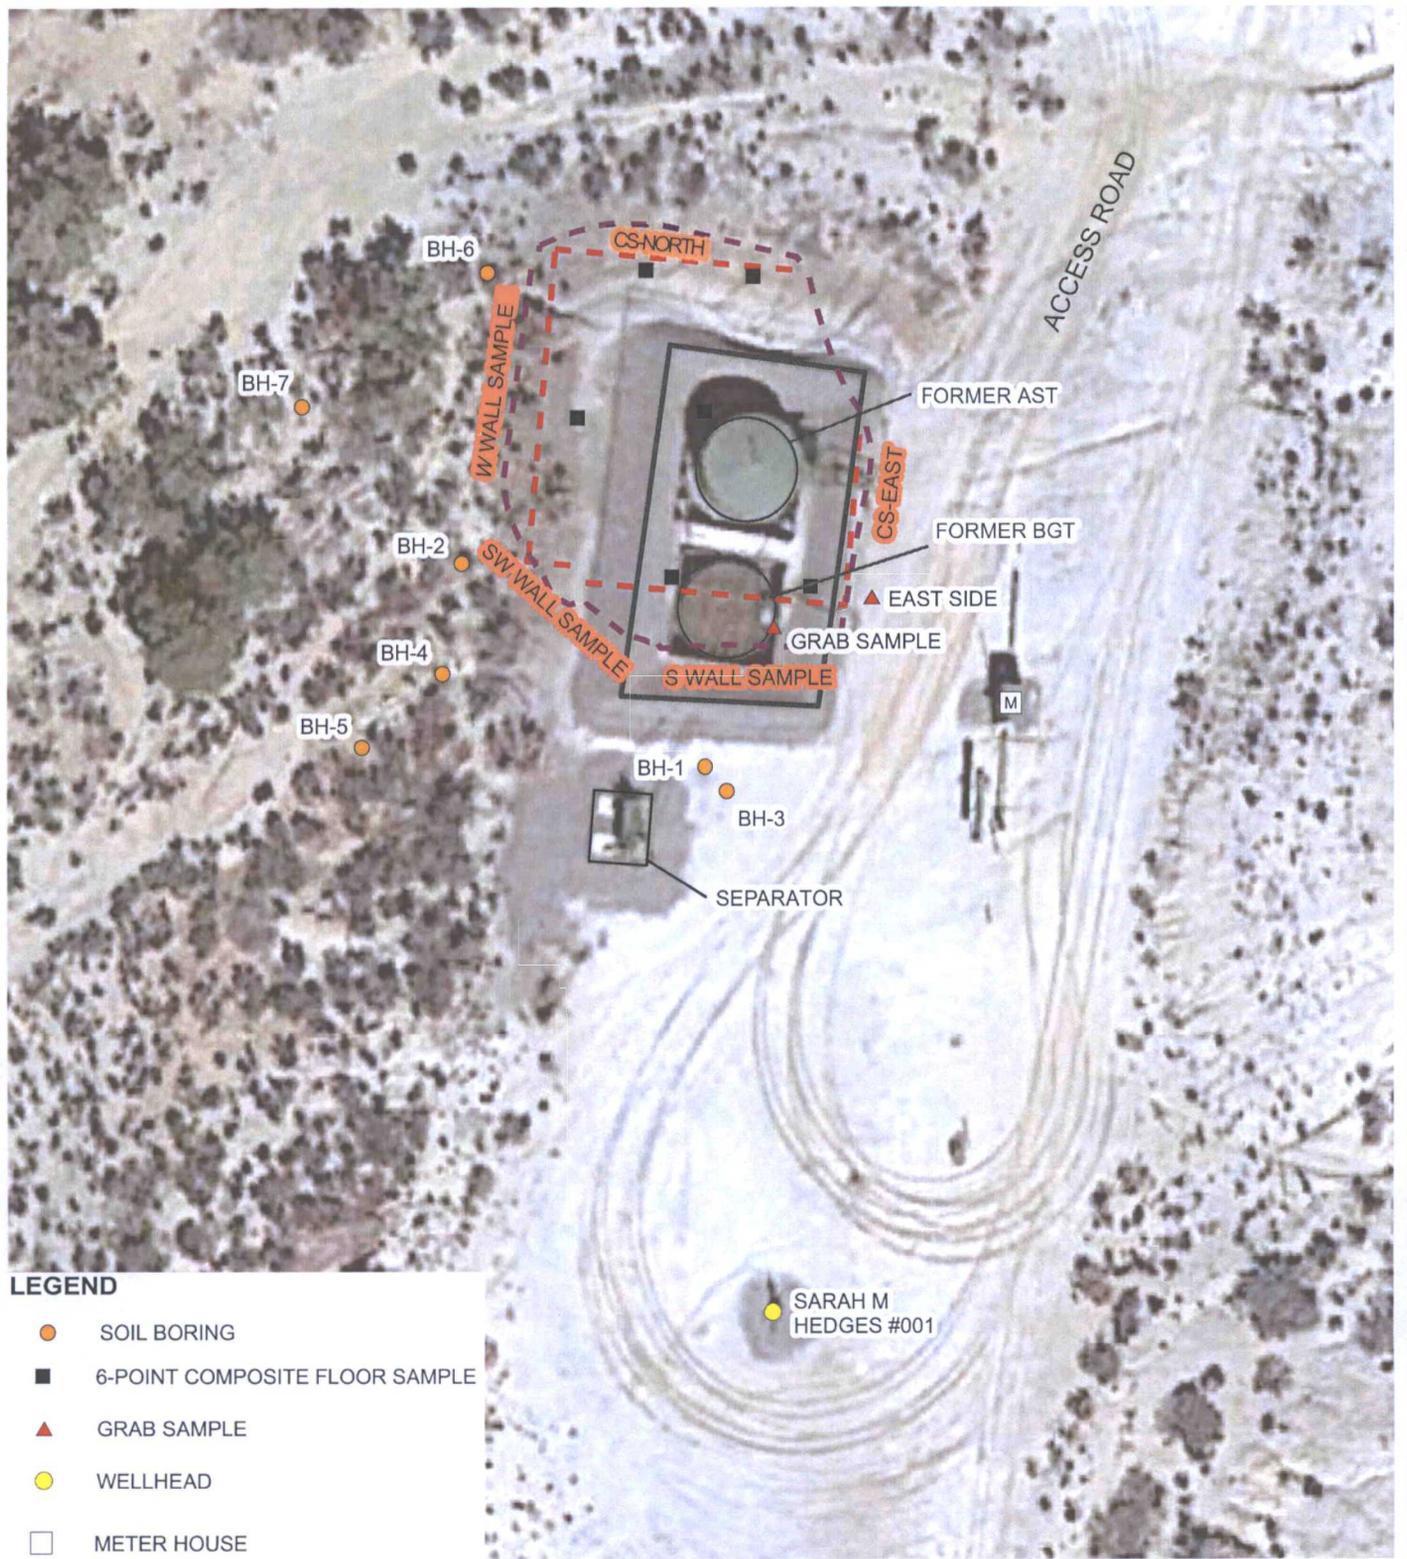
FIGURE 2
SITE MAP
 SARAH M HEDGES #1
 NESE SEC 23-T31N-R12W
 SAN JUAN COUNTY, NEW MEXICO
 HILCORP ENERGY COMPANY

On August 30 and 31, 2017, LTE advanced soil borings BH-1 through BH-7 to the south and west of the release location. A site map with soil boring and soil sample locations are depicted on Figure 2. Soil boring BH-1 was advanced with a hand auger and refusal was encountered at 16 feet below ground surface (bgs). Soil borings BH-2 through BH-7 were advanced using a hollow-stem auger. Soil borings ranged in depth from 16 feet to 35 feet bgs. Lithology at the Site was generally a silty sand from 0 feet to 15 feet bgs and a sandy silt from 15 feet to 35 feet bgs. The soil boring logs are included as Attachment 2.

Based on field and laboratory results from the initial excavation sampling and site investigation, Hilcorp increased the excavation extent to the south and west, and advanced the depth of the excavation to approximately 23 feet bgs (Figure 2). On September 26, 2017, LTE collected three 5-point composite soil samples from the new excavation sidewalls (S Wall Sample, SW Wall Sample, and W Wall Sample), one 6-point composite soil sample from the floor of the excavation (Floor Sample), and, as requested by on-site NMOCD personnel, a discrete soil sample (Grab Sample) from a small area of staining on the floor near the south wall. On October 4, 2017, Hilcorp advanced a pothole immediately east of the excavation to 13 feet bgs where refusal was encountered. Pothole sample East Side was collected from 12 feet to 13 feet bgs. The excavation samples were submitted under the same preparation guidelines and laboratory analyses listed above.

Laboratory analytical results indicate soil samples collected from the north and east walls of the excavation on August 18, 2017 and samples collected from the floor, south wall, southwest wall, and west wall on September 26, 2017 were compliant with the NMOCD site-specific standards for benzene, total BTEX, and TPH. The discrete Grab Sample analytical results indicated a TPH concentration of 290 mg/kg. Laboratory analytical results for the soil sample collected from the pothole east of the excavation indicated no concentrations of benzene, total BTEX, or TPH exceeded the NMOCD site-specific standard.

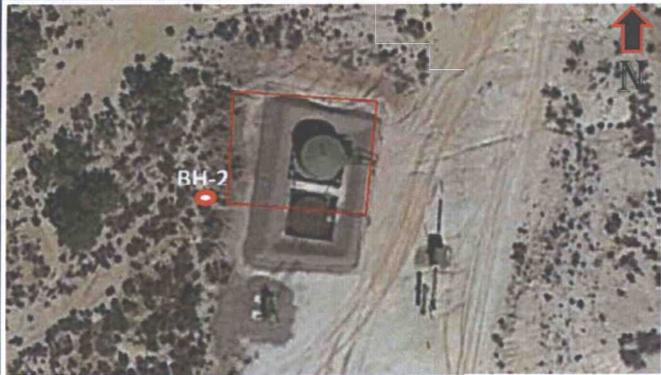
Penetration Resistance	Moisture Content	Vapor (ppm)	Staining	Sample #	Depth (ft. bgs.)	Sample Run	Recovery	Soil/Rock Type	Lithology/Remarks	Well Completion
					0				<u>Silty Sand</u> , loose, lt. brown, 30% f.-med. grained sand	
					2					
	Dry	0.7			4					
					6					
					8					
	Dry	0.3			10				- Loose-med. Dense, increase in silt content	
					12					
					14					
	Dry	0.0			16					
					18					
	Dry	0.0			20				- Brown, caliche	
					22					
	Dry	981.3		BH-2 @25' 1630	24					
					26				<u>Silt w/ Sand</u> , gray staining, soft-med. stiff	
					28					
	Dry	372.5		BH-2 @30' 1635	30

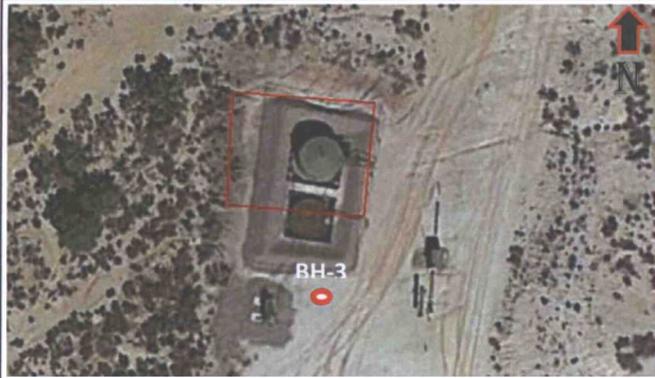
Penetration Resistance	Moisture Content	Vapor (ppm)	Staining	Sample #	Depth (ft. bgs.)	Sample Run	Recovery	Soil/Rock Type	Lithology/Remarks	Well Completion
					0				<u>Light brown, 10% fine</u>	
	Dry	0.0	None	1	2	0-5				
					4					
					6					
	M	0.0	None	2	8	5-10			orange brown, a lot of FeO Staining	
					10					
					12					
	M	0.1	None	3	14				Light Brown with Caliche 20% fine	
					16					
					18	15- 20			dark brown, more silt	
					20					
					22				dark brown fat clay	
									band of black fine grained shale	20.5' to 21'
	M	5.4	Grey		24				grey sand with 25% fines	
					26					
					28				SAA	
					30					
	TD

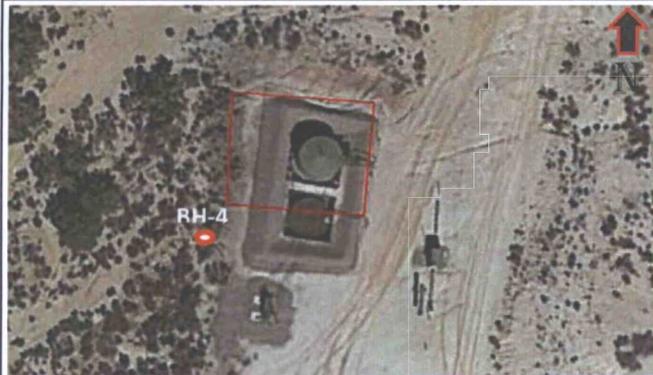
Penetration Resistance	Moisture Content	Vapor (ppm)	Staining	Sample #	Depth (ft. bgs.)	Sample Run	Recovery	Soil/Rock Type	Lithology/Remarks	Well Completion
	Dry	0.0	No		0				<u>Light brown sand with silt unconsolidated (20%)</u>	
					2					
					4					
					6					
					8					
	M		NO		10				Orange-brown silty sand	
					12					
					14				Brown sand W/ Silt (30%)	
		5.4			16				Dark brown silt w/sand (40%)	
					18					
					20					
					22				V. hard, silt w/sand (60% silt) redish brown	
					24					
				BH-4 @ 25' 1610	26				Gray-black staining	
		1337			28					
				BH-4 @ 30' 1615	30				wet-dry (shoe wet, soil dry)	
		38.3

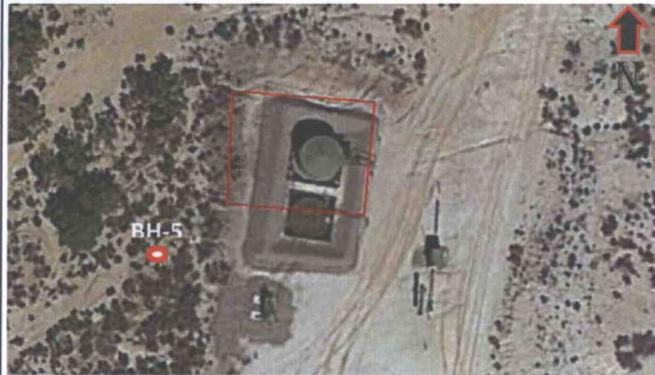
Penetration Resistance	Moisture Content	Vapor (ppm)	Staining	Sample #	Depth (ft. bgs.)	Sample Run	Recovery	Soil/Rock Type	Lithology/Remarks	Well Completion
	Dry	0.4			0				Sand w/ Silt , light brown, 30% sand Fine-med grained	
					2					
					4					
	Dry	0.3			6					
					8					
					10					
					12					
	Dry	0.3			14				Silty Sand , 75% silt	
					16					
					18					
	Dry	2.4			20				- gray, redish brown, caliche	
					22					
	Dry	457.3		BH-5 @ 25' 1620	24				- gray staining	
					26					
				BH-5 @ 30' 1625	28					
	Dry	47.3			30				- gray, light brown

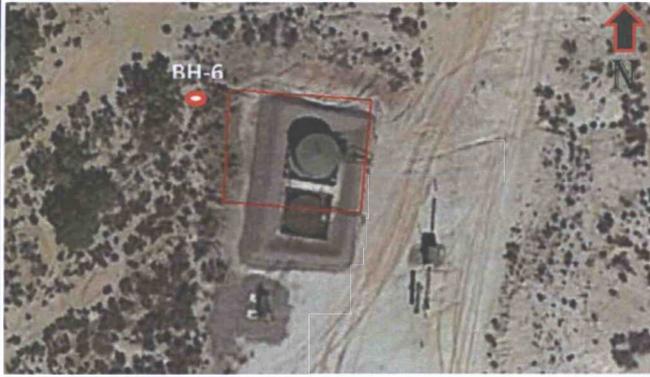
Penetration Resistance	Moisture Content	Vapor (ppm)	Staining	Sample #	Depth (ft. bgs.)	Sample Run	Recovery	Soil/Rock Type	Lithology/Remarks	Well Completion
					0					
					2					
	Dry	0.3			4				Sand w/ Silt , 35% Fine-medium grained sand, Light brown	
					6					
					8					
	Dry	1.1			10					
					12					
	Dry	0.7			14					
					16					
					18					
	Dry	0.9			20			- increase in silt content, gray-reddish		
					22					
	Dry	20.3			24			- gray staining, slight odor		
					26					
					28					
	Dry	856.3		BH-6 @ 30' 1640	30			- gray staining

Penetration Resistance	Moisture Content	Vapor (ppm)	Staining	Sample #	Depth (ft. bgs.)	Sample Run	Recovery	Soil/Rock Type	Lithology/Remarks	Well Completion
					30					
					32					
	Dry	70.7		BH-6 @ 35' 1645	34					
					36				TD @ 35'	
					38					
					40					
					42					
					44					
					46					
					48					
					50					
					52					
					54					
					56					
					58					
					60					
					62					
					64					
					66					
					68					
					70					
					72					
					74
