**Release Notification and Corrective Action**

| Facility Name Horton #3 | Facility Type gas well | |

**RE: SOIL SAMPLING AT THE HORTON #3 WELL SITE LOCATED AT SECTION 13, TOWNSHIP 32 NORTH, RANGE 12 WEST, SAN JUAN COUNTY, NEW MEXICO**

**SITE PHOTOGRAPHY  
POTASSIUM PERMANGANATE APPLICATION  
HALLADOR ENERGY  
HORTON #3 WELL SITE  
PROJECT NUMBER 18010-0001  
APRIL 2018**

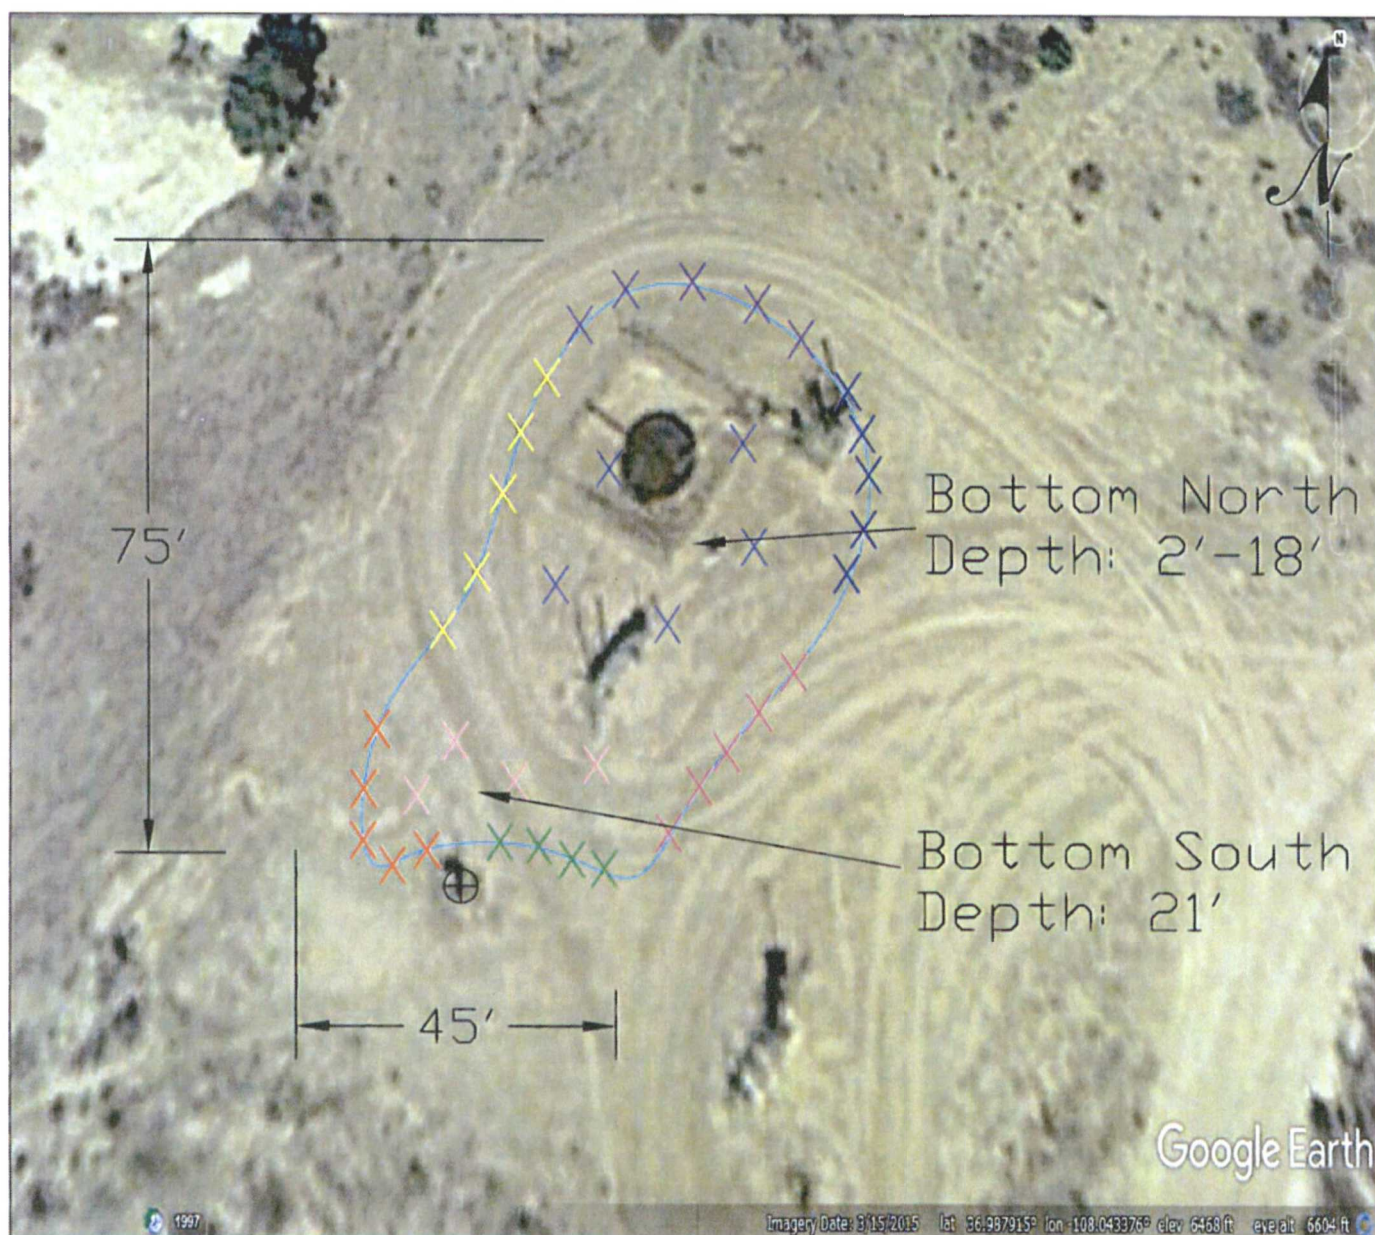
| SCALE: NTS | | | FIGURE NO. 2 | | REV |

| SITE MAP | | | | | |

Prior to Envirotech's arrival, the area around and beneath the former location of the BGT was excavated to the extents of approximately seventy-five (75) feet long by forty-five (45) feet wide with a depth ranging from two (2) feet to twenty-one (21) feet below ground surface (bgs). Five (5)-point composite samples were collected from the excavation with NMOCD representative, Mr. Cory Smith as a witness; see enclosed *Field Notes*. The samples were identified as *South Wall*, *South Cup*, *Bottom South*, *West Wall*, *Bottom North*, *North Wall*, *Northeast Wall*, and *East Wall*; see enclosed *Site Map*.

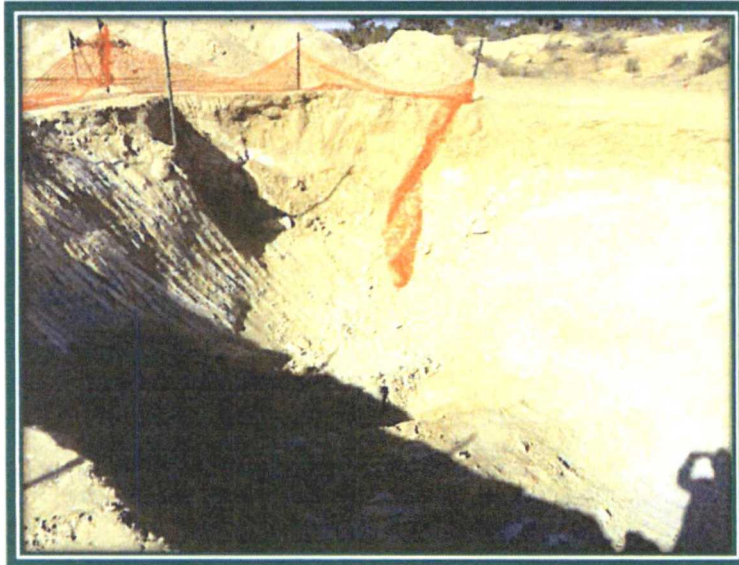
We have excavated and hauled to the disposal facility in excess of 700 cubic yards of contaminated soil. The southwest portion of the excavation is at bedrock. As a practical matter the indurated nature of the bedrock prevents any deeper excavation into the bedrock.

Picture 1: View of Excavation Prior to Potassium Permanganate Application  
(View to Southwest)

On April 3, 2018 Envirotech personnel returned to the site to perform potassium permanganate application activities. Three-hundred (300) gallons of potassium permanganate solution was applied to the excavated area; see enclosed *Site Photography*.

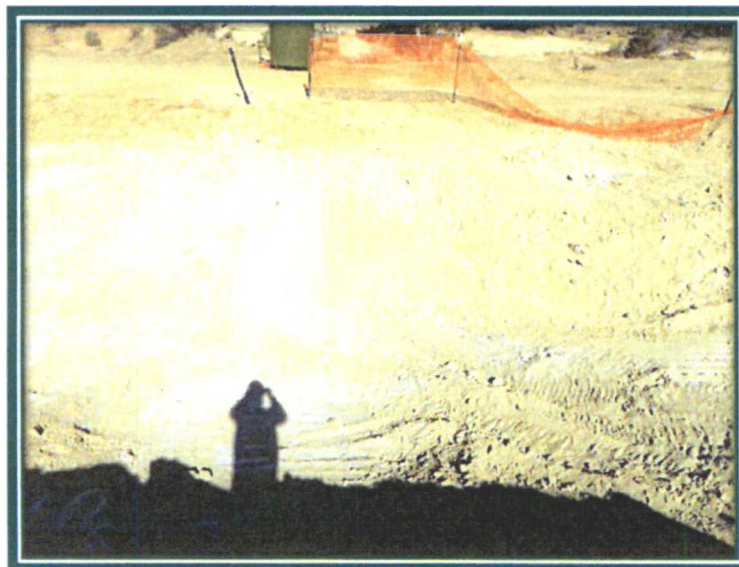
Picture 2: View of Excavation Prior to Potassium Permanganate Application  
(View to West)

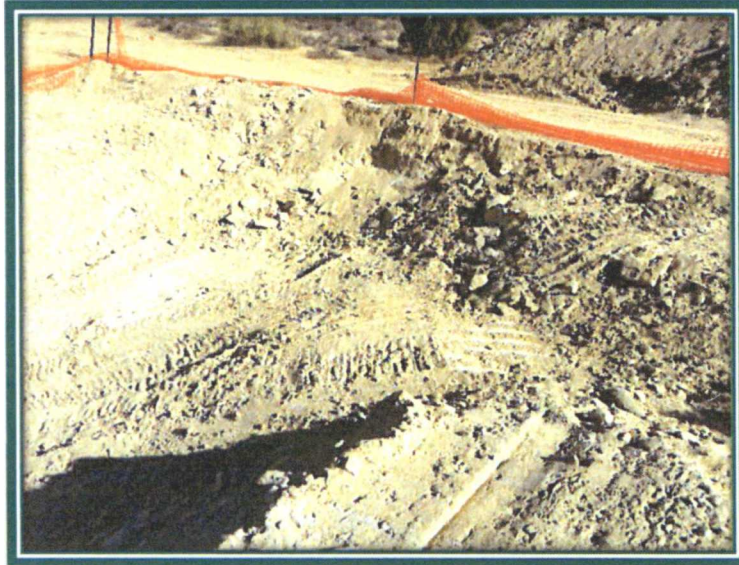
Picture 3: View of Excavation Prior to Potassium Permanganate Application  
(View to North)

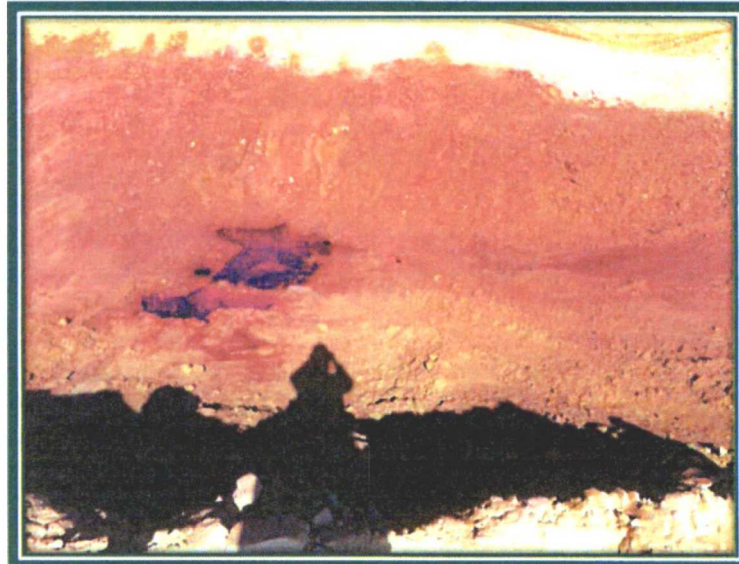
The samples collected from the *South Wall*, *Bottom South*, and *Bottom North* were screened in the field for TPH using USEPA Method 418.1 and organic vapors (OV) using a photoionization detector (PID). The *South Wall* returned a result of 15.8 mg/kg OV and 180 ppm of TPH, the *Bottom South* returned a result of 756.0 mg/kg OV and 392 ppm TPH, and the *Bottom North* returned a result of 386.0 mg/kg OV and 468 ppm TPH; see enclosed *Field Notes*. The eight (8) samples were placed into laboratory provided four (4)-ounce glass jars, capped headspace free, and transported on ice, under chain of custody, to Envirotech's Analytical Laboratory to be analyzed for TPH using USEPA Method 8015D (GRO, DRO, and ORO), and benzene and total BTEX using USEPA Method 8021B. All samples returned results below the regulatory standards with the exception of the *West Wall* and the *Bottom North*, which returned results of 224.6 mg/kg of TPH and 235.1 mg/kg of TPH, respectively.

Picture 4: View of *West Wall* and *Bottom North* Subsequent of  
Potassium Permanganate Application

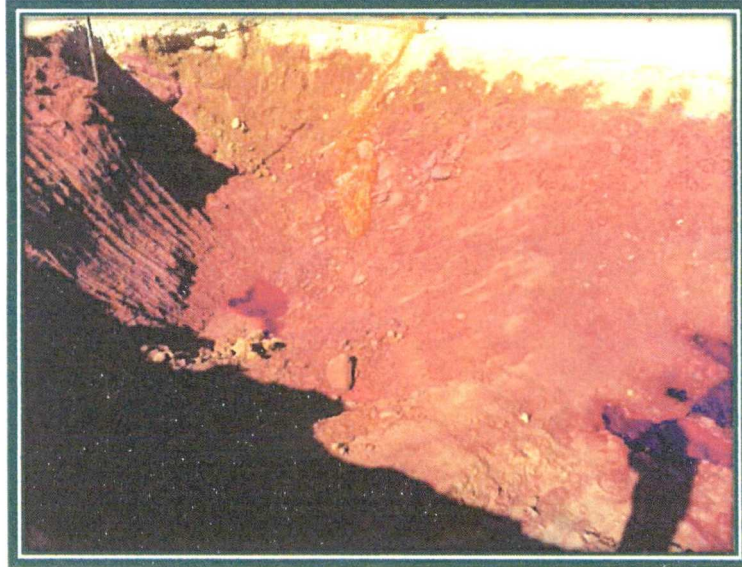
Picture 5: View of Excavation Subsequent to Potassium Permanganate Application (View to Southwest)

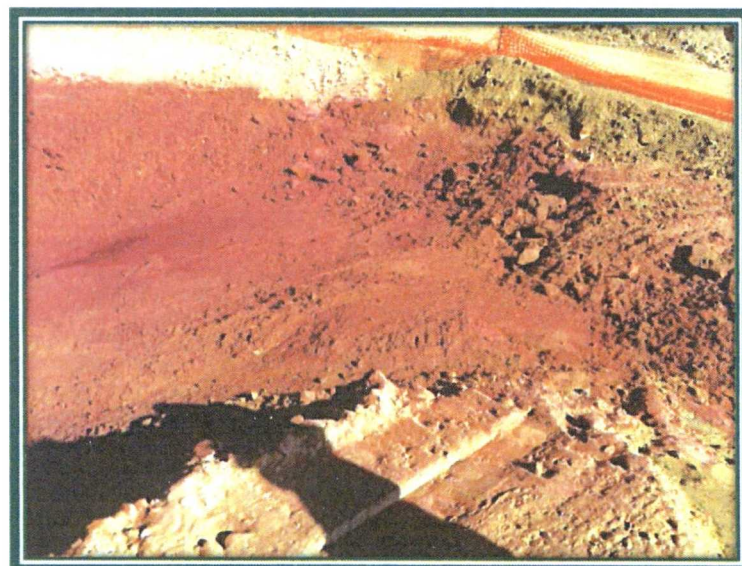
Picture 6: View of Excavation Subsequent of Potassium Permanganate Application (View to East)
