Pit, Below-Grade Tank, or  
Proposed Alternative Method Permit or Closure Plan Application

BELOW-GRADE TANK CLOSURE PLAN

**WD HEATH B 004**

**API No. 3004520969**

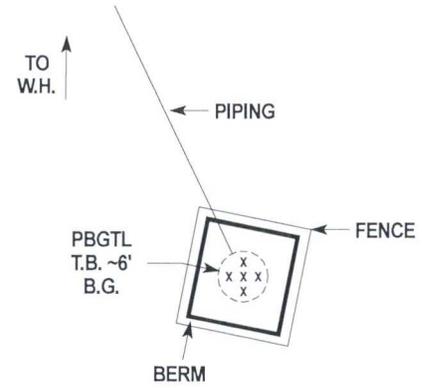
SITE SKETCH	BGT Located: off <input checked="" type="checkbox"/> on <input type="checkbox"/> site	PLOT PLAN circle: <input checked="" type="checkbox"/> attached	OVM CALIB. READ. = <b>NA</b> ppm RF=1.00
			OVM CALIB. GAS = <b>NA</b> ppm
			TIME: <b>NA</b> am/pm DATE: <b>NA</b>

SITE OBSERVATIONS:	LOST INTEGRITY OF EQUIPMENT: YES <input checked="" type="checkbox"/> NO <input type="checkbox"/> EXPLANATION -
APPARENT EVIDENCE OF A RELEASE OBSERVED AND/OR OCCURRED: YES <input checked="" type="checkbox"/> NO <input type="checkbox"/> EXPLANATION -	
EQUIPMENT SET OVER RECLAIMED AREA: YES <input checked="" type="checkbox"/> NO <input type="checkbox"/> EXPLANATION -	
OTHER: <b>NMOC D OR BLM REPS. NOT PRESENT TO WITNESS CONFIRMATION SAMPLING.</b>

DEPTH TO GROUNDWATER: **>100'** NEAREST WATER SOURCE: **>1,000'** NEAREST SURFACE WATER: **<1,000'** NMOC D TPH CLOSURE STD: **1,000** ppm
