Pit, Below-Grade Tank, or
Proposed Alternative Method Permit or Closure Plan Application

BELOW-GRADE TANK CLOSURE PLAN

GCU 271

API No. 3004522237

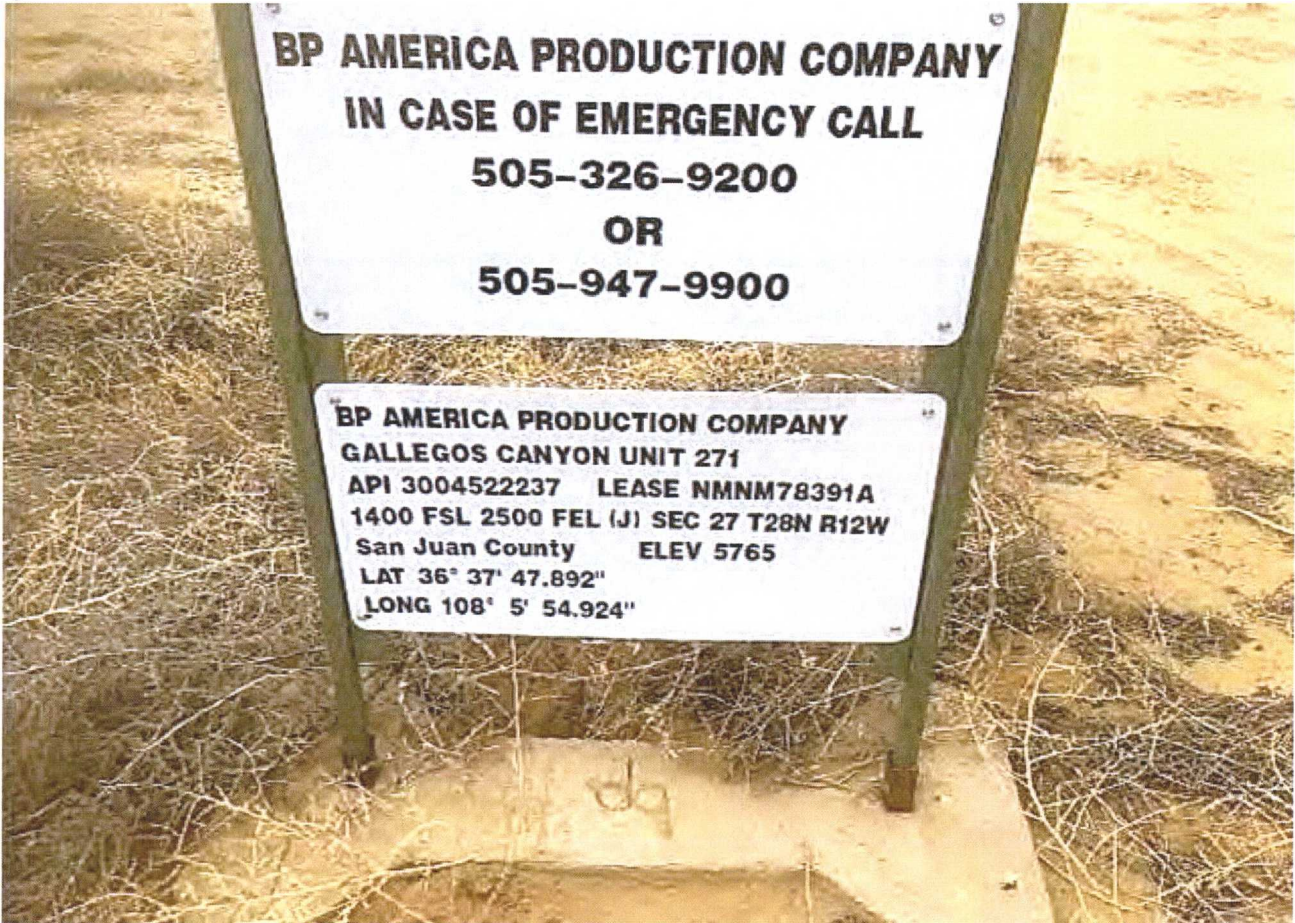
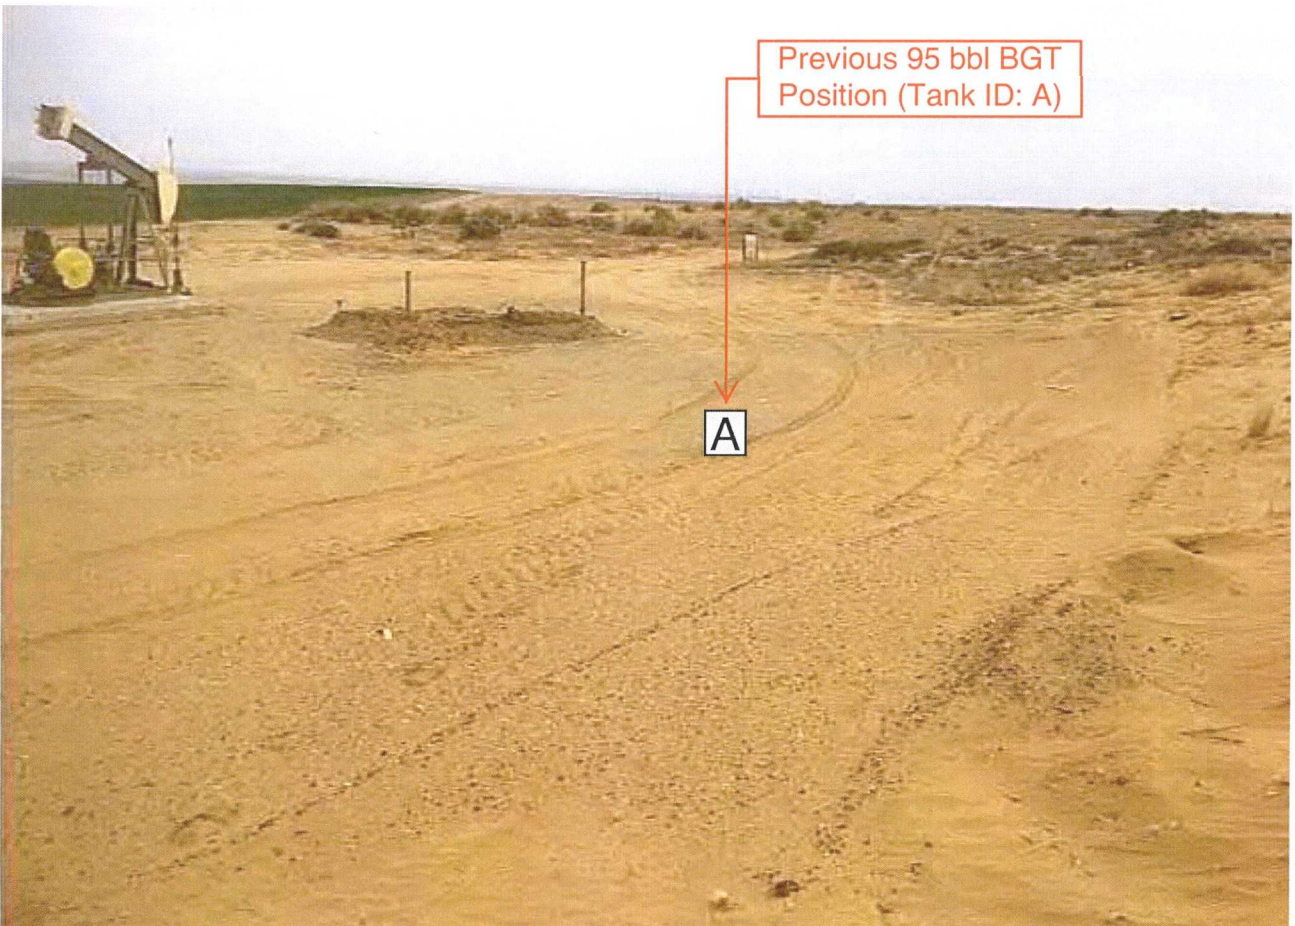
The area has been backfilled and BGT location's surface condition is clear, but within the site's operational area. The location will be reclaimed once the well is plugged and abandoned.

Closure report on C-144 form is included including photos of reclamation completion.
