## Release Notification

Site Name	MARTIN WHITTAKER #035	Site Type	Oil
Date Release Discovered	August 23, 2018	API# (if applicable)	30-039-23285

**RE: Below Grade Tank Release and Final Excavation Report  
Martin Whittaker #35  
API #30-039-23285  
Incident No. NCS 1825433658  
Rio Arriba County, New Mexico**

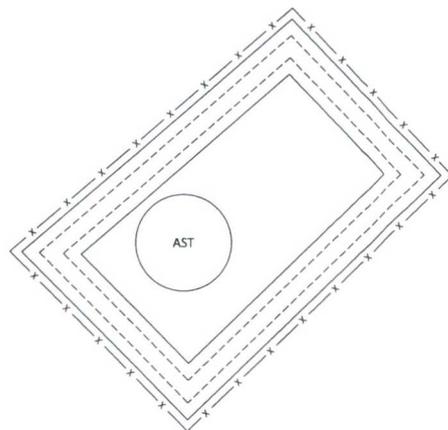
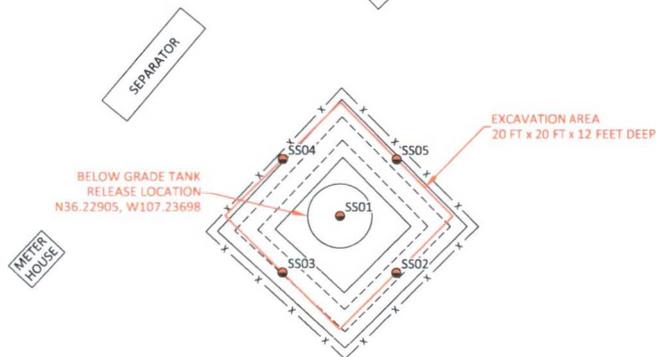
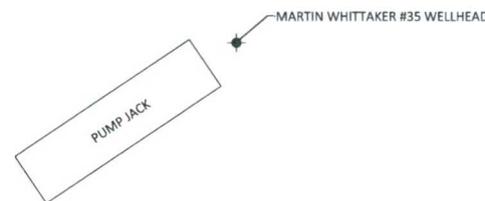
**FIGURE 3**

Laboratory analytical results are summarized in Table 1 and on Figure 3. The laboratory analytical report is attached.

**FINAL EXCAVATION SAMPLE LOCATIONS AND RESULTS SEPTEMBER 2018**  
 DJR OPERATING  
 MARTIN WHITTAKER #35  
 API:30-039-23285  
 INCIDENT NO. NCS 1825433658  
 NE¼, NE¼, SECTION 15, T23N, R4W  
 RIO ARRIBA COUNTY, NEW MEXICO  
 N36.22905, W107.23672

Laboratory Analytical Results								
Sample ID	Date	Depth (ft)	Benzene (mg/kg)	Total BTEX (mg/kg)	TPH-GRO (mg/kg)	TPH-DRO (mg/kg)	TPH-MRO (mg/kg)	Chlorides (mg/kg)
<b>NMOC ACTION LEVEL</b>			<b>10</b>	<b>50</b>	<b>&lt;10.0</b>	<b>100</b>	<b>600</b>	
SS01	9/20/18	12	<0.050	<0.300	<10.0	201	16.5	246
SS02	9/20/18	2 to 10	<0.050	<0.300	<10.0	<10.0	<10.0	33.8
SS03	9/20/18	2 to 10	<0.050	<0.300	<10.0	<10.0	<10.0	85.3
SS04	9/20/18	2 to 10	<0.050	<0.300	<10.0	<10.0	<10.0	124
SS05	9/20/18	2 to 10	<0.050	<0.300	<10.0	<10.0	<10.0	34.1

On September 20, 2018, Cottonwood conducted clearance activities at the excavation area and BGT release area. Laboratory sampling results above the NMOCD action level of 100 mg/kg TPH (as GRO/DRO/MRO) were reported in SS01 (excavation base). The highest TPH concentration was reported in SS01, with a concentration of 218 mg/kg.

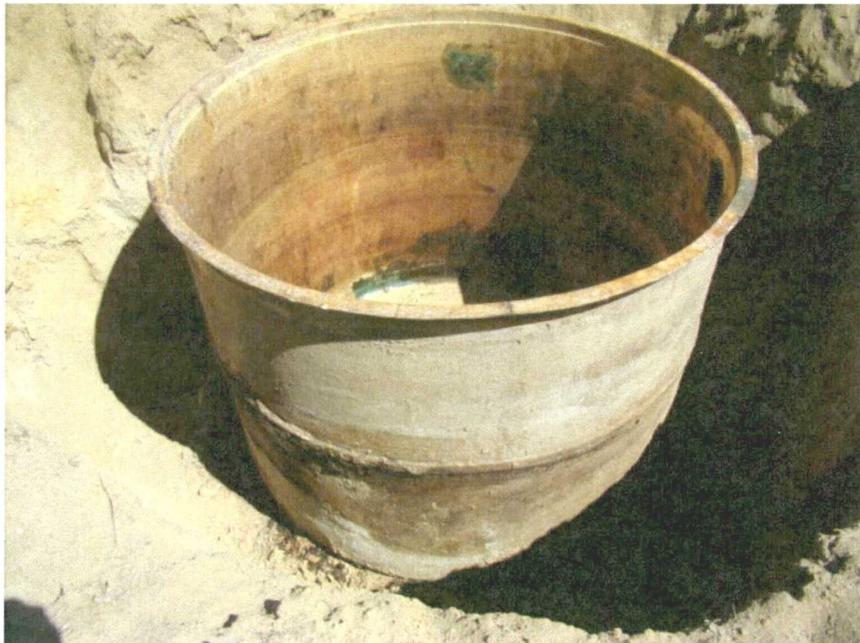
While removing soil around the BGT to provide visibility in preparation for eventual well plugging and abandonment, contaminated soil was observed near the base of the BGT. Cottonwood Consulting (Cottonwood) personnel traveled to the location on September 20, 2018, to collect confirmation soil samples of the excavation extents at the former BGT location. Soil sampling consisted of collection of five soil samples (SS01 through SS05) from the walls and base of the excavation.

Photo 2: Subject below grade tank with visibly stained soil at the base of the tank pit. Photo taken August 29, 2018.

The area of the final excavation measured approximately 20 feet by 20 feet by 12 feet deep. Approximately 61 yds<sup>3</sup> of visibly contaminated soil were removed during excavation activities and disposed of at Industrial Ecosystems Landfarm (NMOCD Permit #NM-01-0010B) in September and October 2018. Sample locations and final excavation extents are presented on Figure 3. A photograph log and copies of disposal documents (C-138) are attached.

Based on the final laboratory analytical results of the excavation of petroleum contaminated soils at the Martin Whittaker #35, benzene, total BTEX, TPH, and chloride concentrations were below the applicable NMOCD action levels for the final sidewalls of the excavation but were above the NMOCD TPH action level for the excavation base. However, JANOGA granted approval to treat the base of the excavation with an oxidizing agent, and on October 24, 2018, 300 gallons of potassium permanganate were applied.

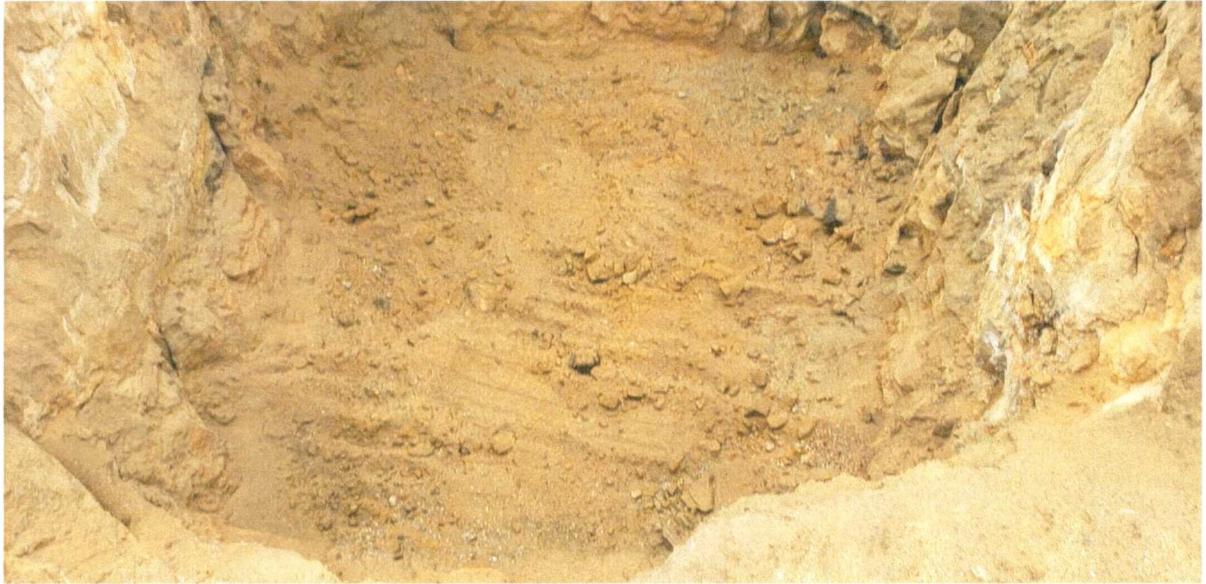
Photo 3: Excavation prior to application of potassium permanganate. Photo taken October 24, 2018.

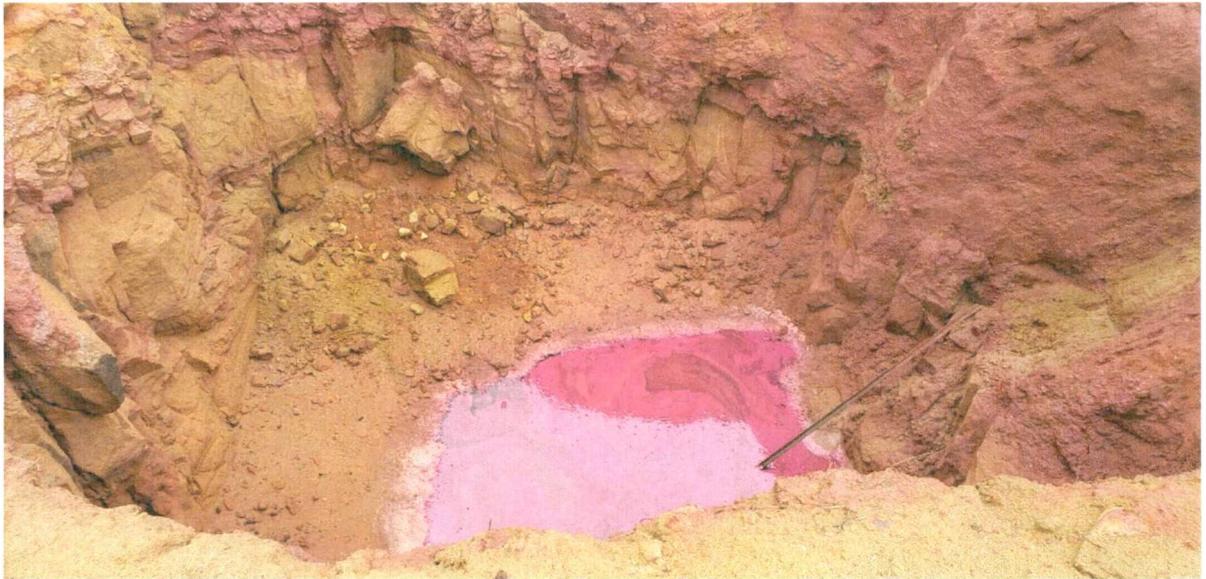
Photo 4: Excavation upon application of potassium permanganate. Photo taken October 24, 2018.
