## Release Notification

Site Name: Heaton LS 005	Site Type: Natural Gas Production Well Pad
Date Release Discovered: 2013	API#: 30-045-10251

# Heaton LS 005

SVE Operation and Performance Oct.2018  
API# 30-045-10251  
(M), S28, T31N, R11W  
SVE GPS:  
36.865510°, -108.001121°

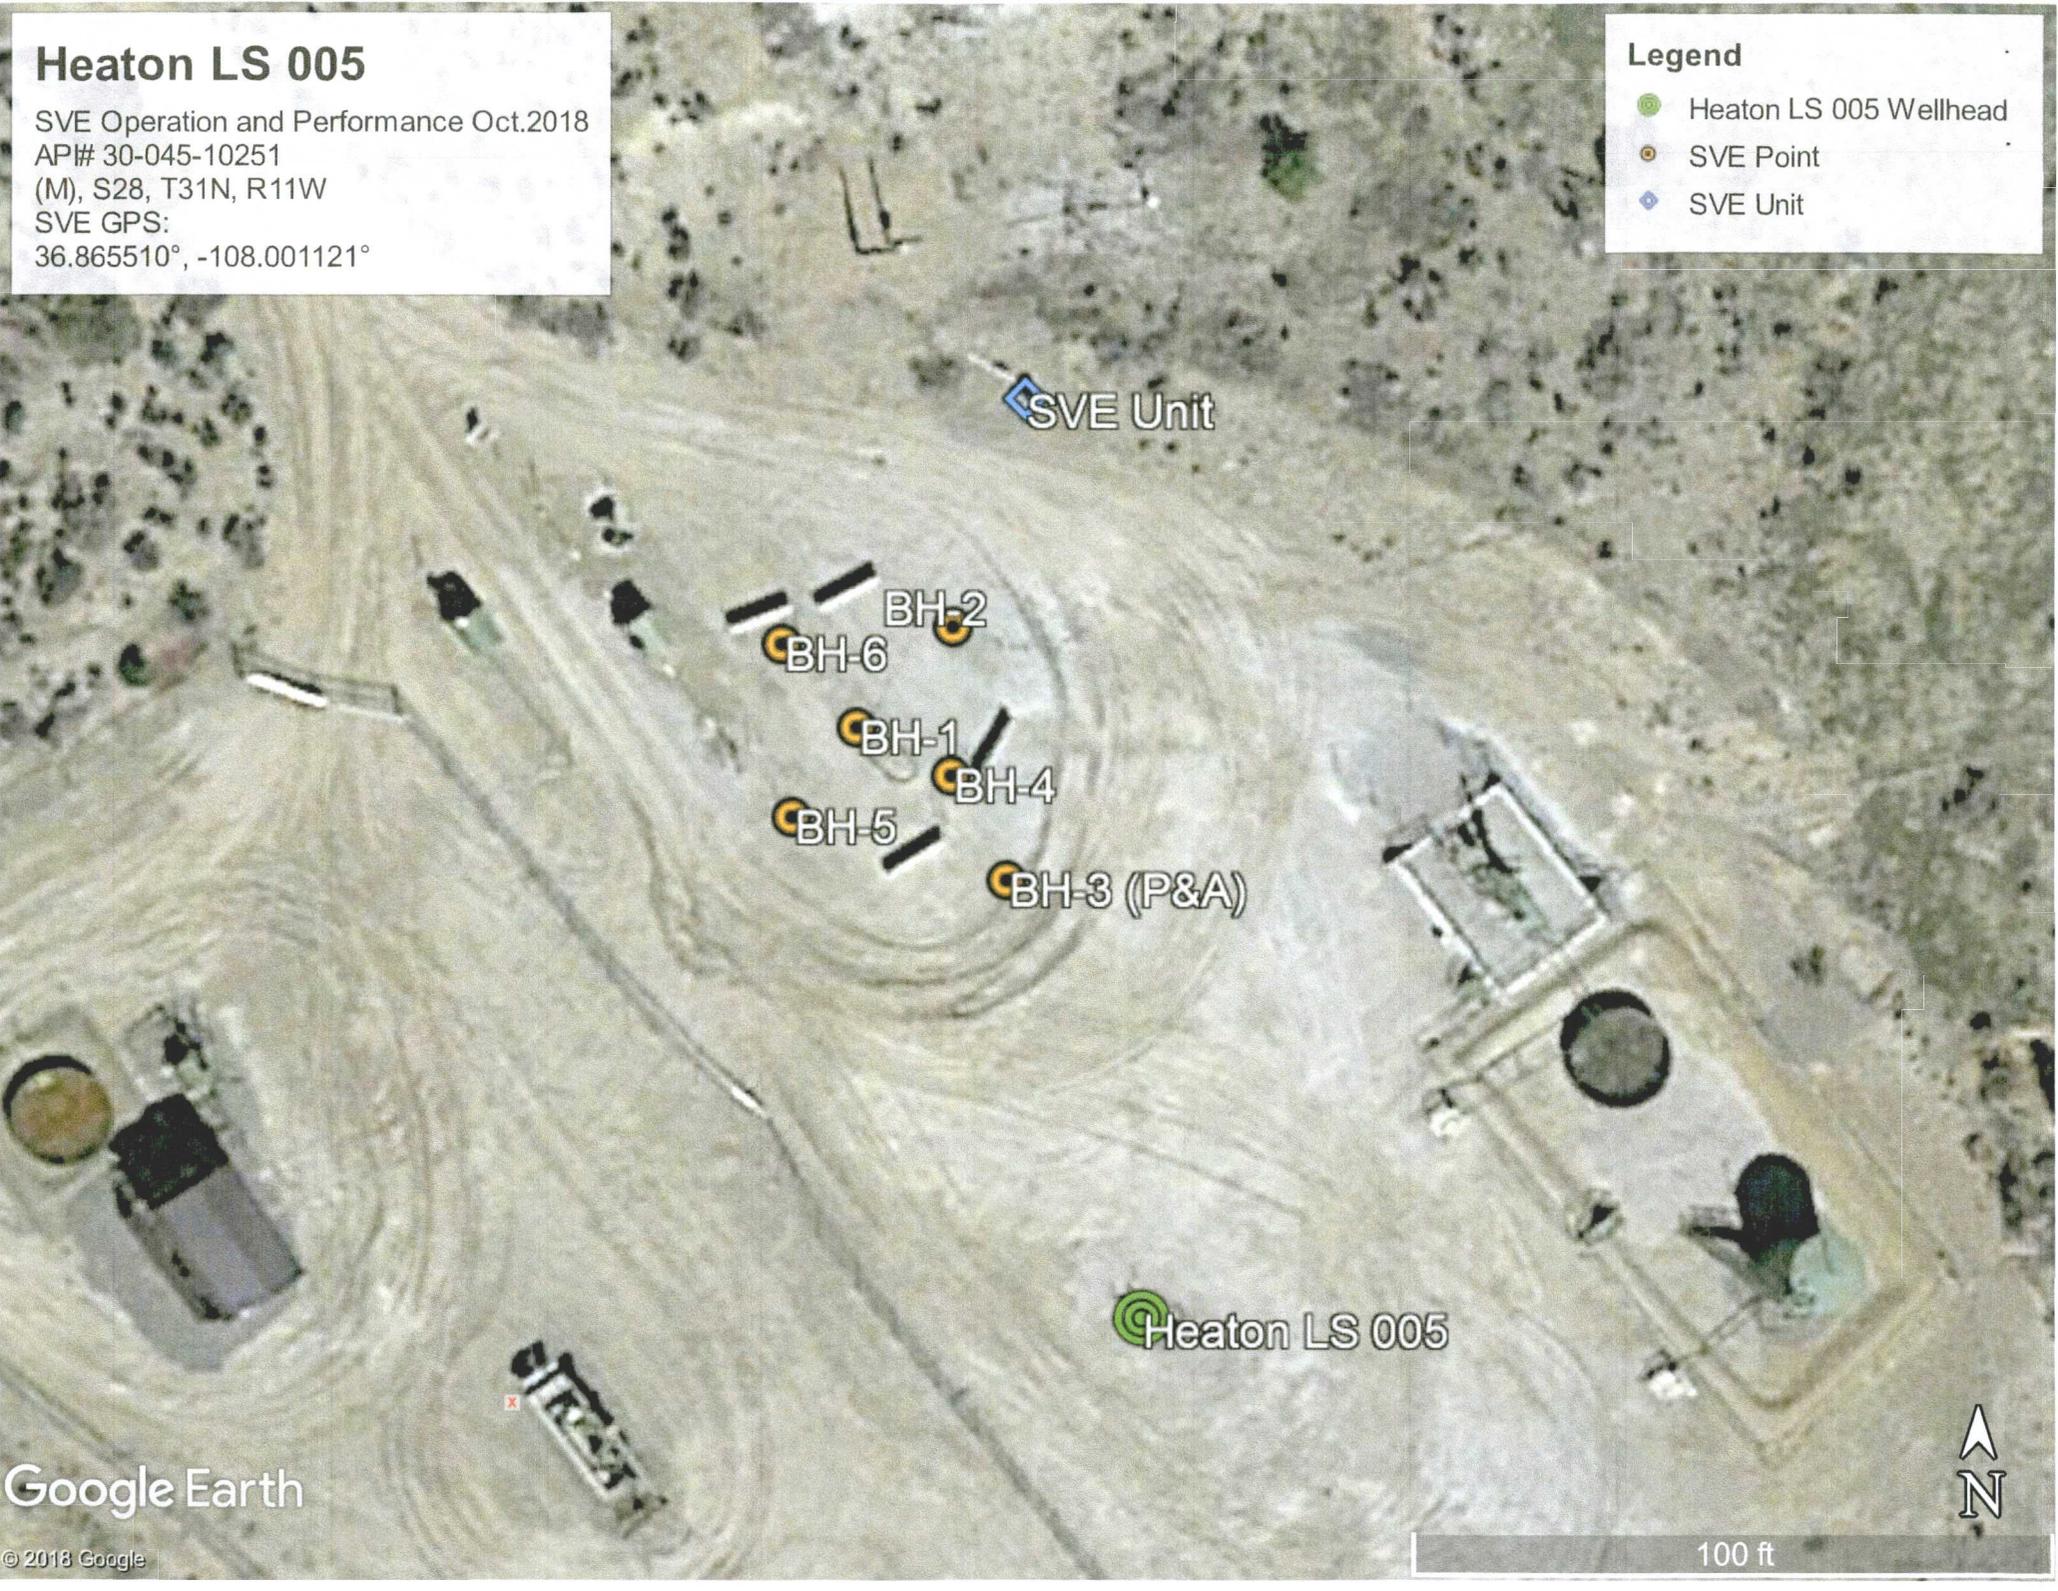
- Heaton LS 005 Wellhead
- SVE Point
- ◆ SVE Unit
