Pit, Closed-Loop System, Below-Grade Tank, or  
Proposed Alternative Method Permit or Closure Plan Application

BELOW-GRADE TANK CLOSURE PLAN

**Florance Y # 3 – Tank ID: B**

**API #: 3004527988**

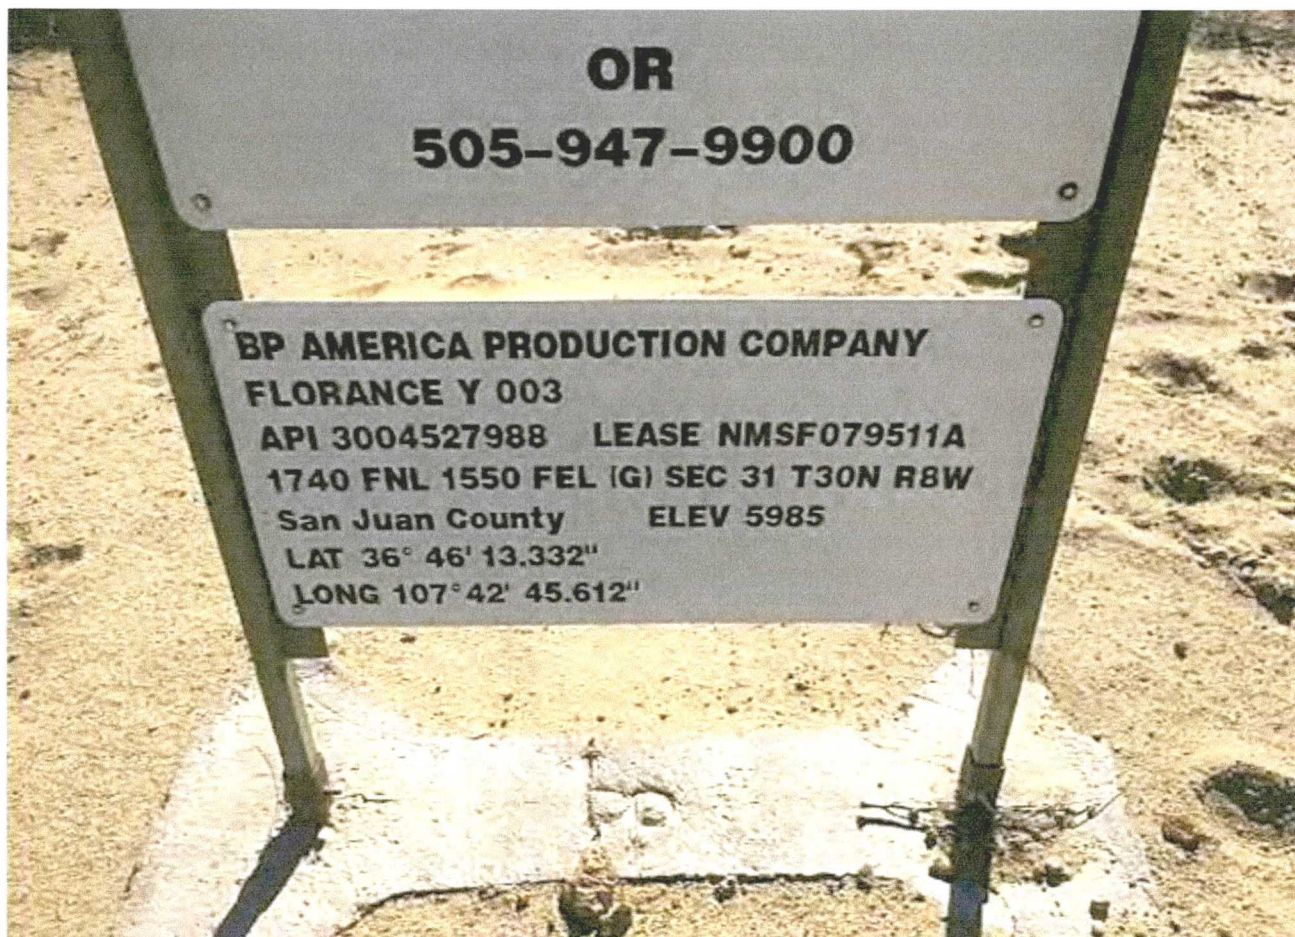
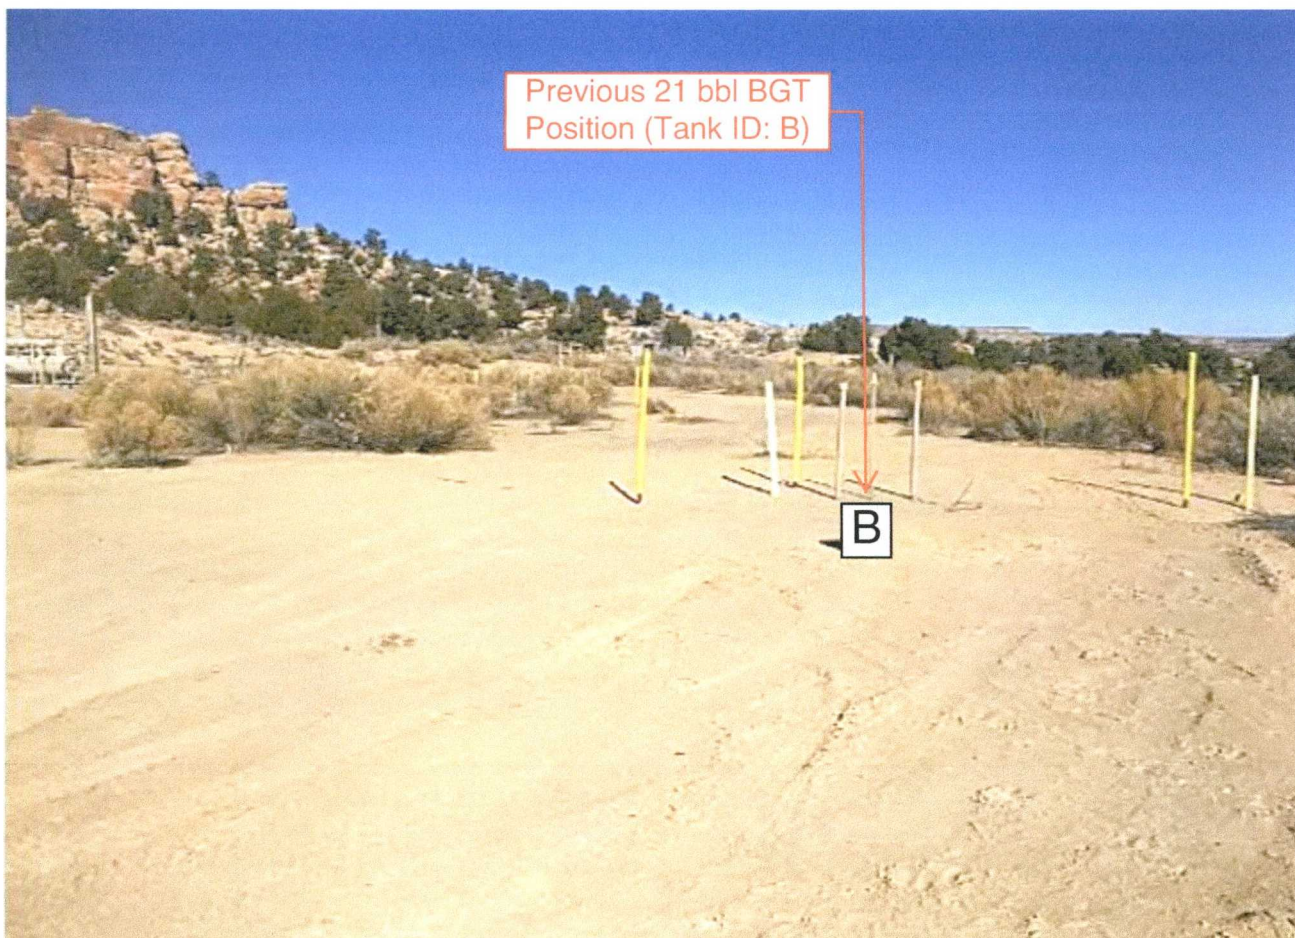
**Closure report on C-144 form is included & contains a photo of the reclamation completion.**
