## Release Notification

Site Name Pipeline near SJ 32-8 242	Site Type Gas Well
Date Release Discovered 10/24/2018 @ 10:00am	API# 30-045-28415

A release of ~15bbls of produced water was released due to internal corrosion of the produced water pipeline. Pipeline Tech found leak while performing Cathodic Protection survey on pipeline. Leak occurred within a pipeline corridor and stayed in the Pipeline ROW. Operator hydrovac'd the pipeline to confirm where leak was coming from.

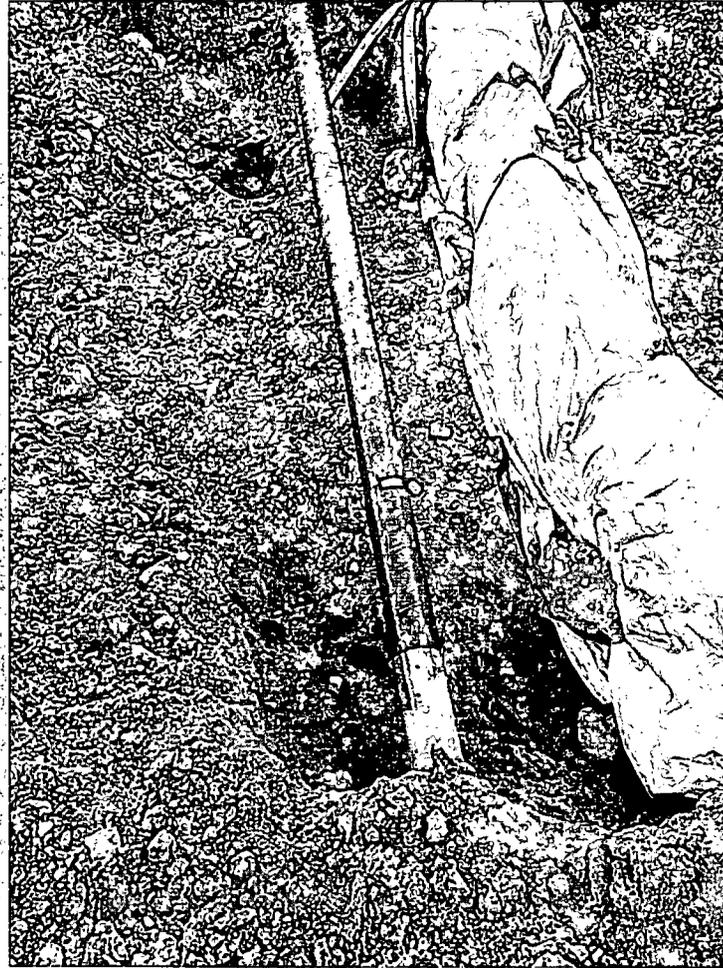
# Photographs – 11/9/18 Sampling Event

Four-point Composite Sample
