Release Notification

Site Name Navajo Tribe AR #006	Site Type Well Location
Date Release Discovered August 10, 2018	API# (if applicable) 30-045-21445

NAVAJO TRIBAL AR-6 SPILL AREA
30-045-21445

NAVAJO TRIBE AR #6
 O-27-T26N-R18W
 36.45369 -108.74407
 API # 30-045-21445

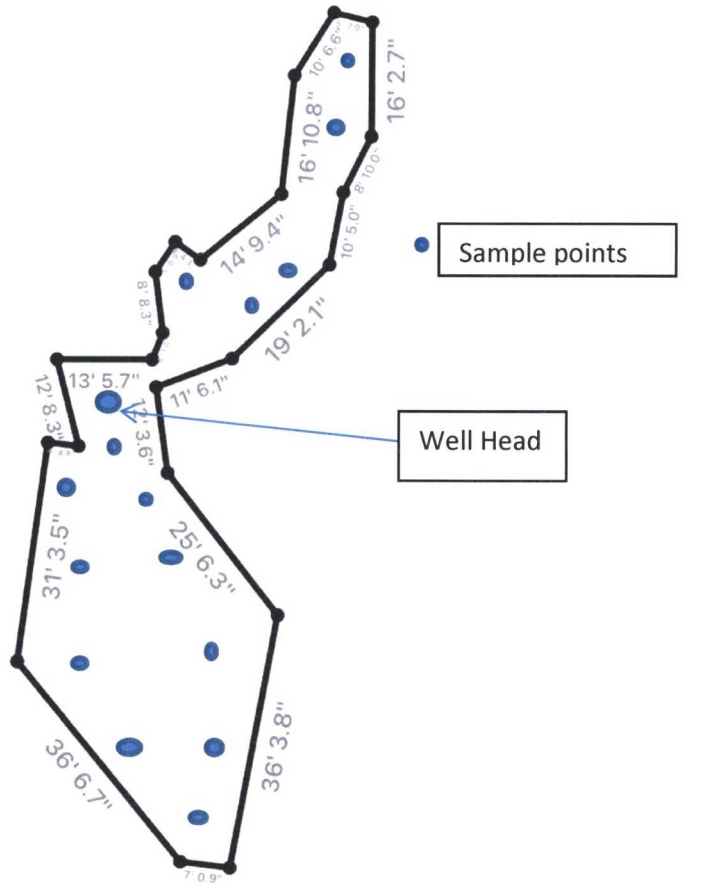
Plan 1 - Horizontal
2261.23 ft² / 315' 9.6"

Blue dots the south sample points

Yellow Middle sample points

Green north sample points

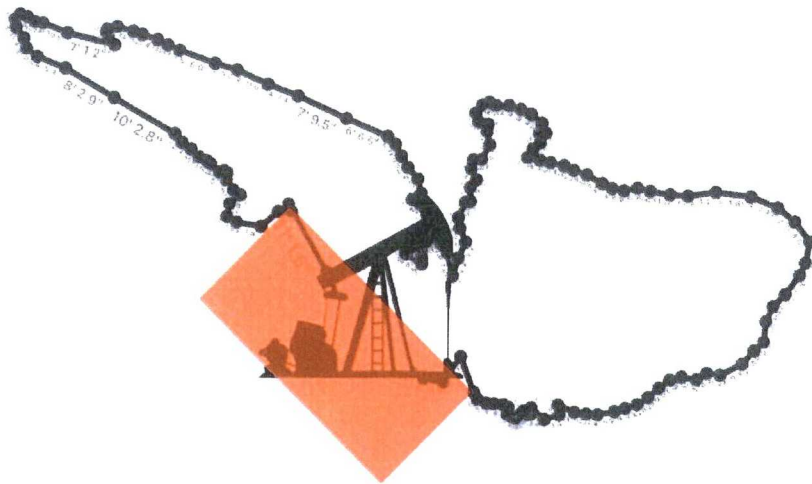
Approximately 83.75 bbls of produced water and crude oil (69.31 bbls water and 14.44 bbls oil) released from a wellhead stuffing box packing failure. Initial notice of a spill was @ 11:45am by NNOGC upper management... the fire department was on location and had used shovels to build small dirt berms to contain the spill and keep it on the well pad until the lease operator arrived. The pumping unit and wellhead was shut in @ 12:40pm by a lease operator. A HydroVac truck and backhoe were dispatched immediately but did not arrive to location until 3:20pm. The area of contaminated soil and standing water and oil was cleaned up with the HydroVac truck, a backhoe and 1 dumptruck. All contaminated soil along with pooled produced water and produced oil was hauled to Industrial Ecosystems' Landfarm.

Impacted soil will be removed and transported to IEI Landfarm for remediation. The wellhead stuffing box packing will be repaired.

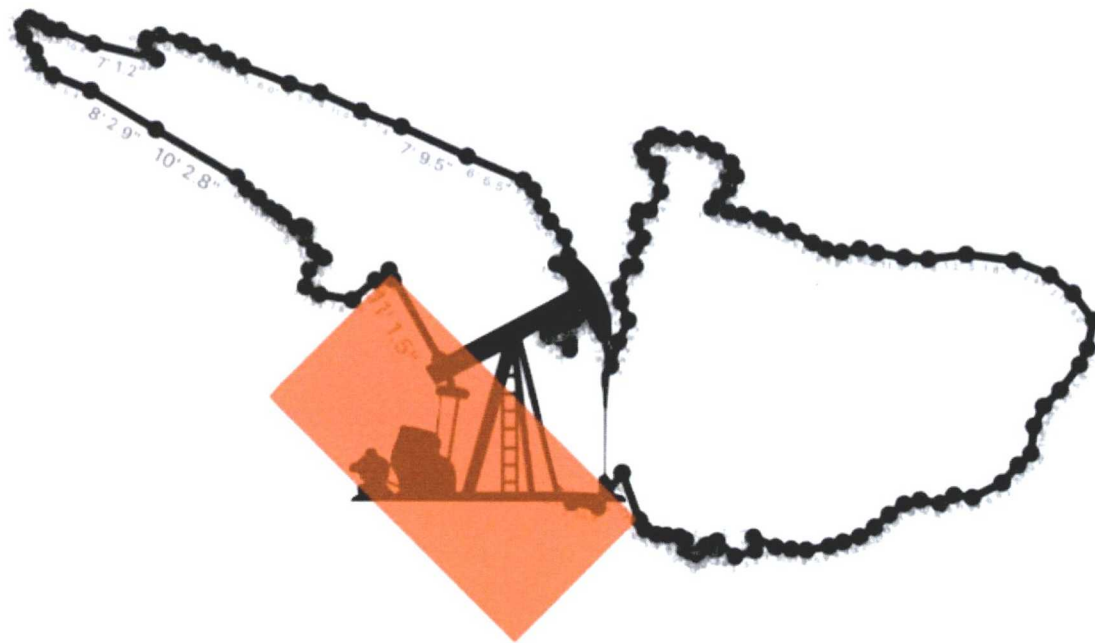
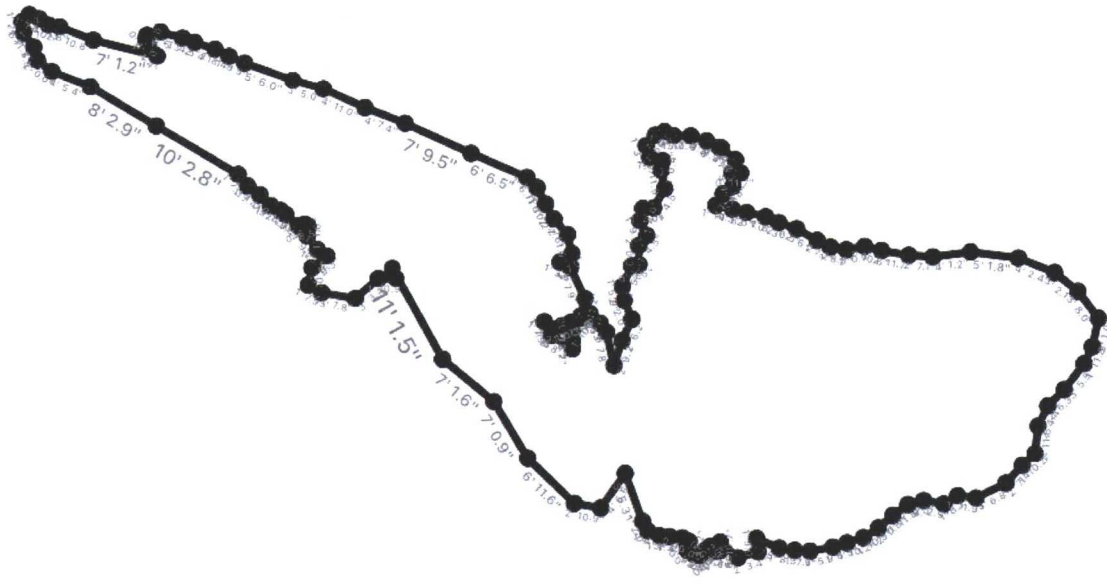
Plan 3 - Horizontal

2523.49 ft²

361' 8.7"
