## Release Notification

Responsible Party Hilcorp Energy	OGRID 372171
Contact Name Clara Cardoza	Contact Telephone 505-564-0733
Contact email <a href="mailto:ccardoza@hilcorp.com">ccardoza@hilcorp.com</a>	Incident # (assigned by OCD)
Contact mailing address 382 CR 3100 Aztec NM 87410	NCS 18339420 96

Site Name San Juan 29-7 Unit 191	Site Type Well Site
Date Release Discovered 11/13/2018	API# (if applicable) 30-039-27474

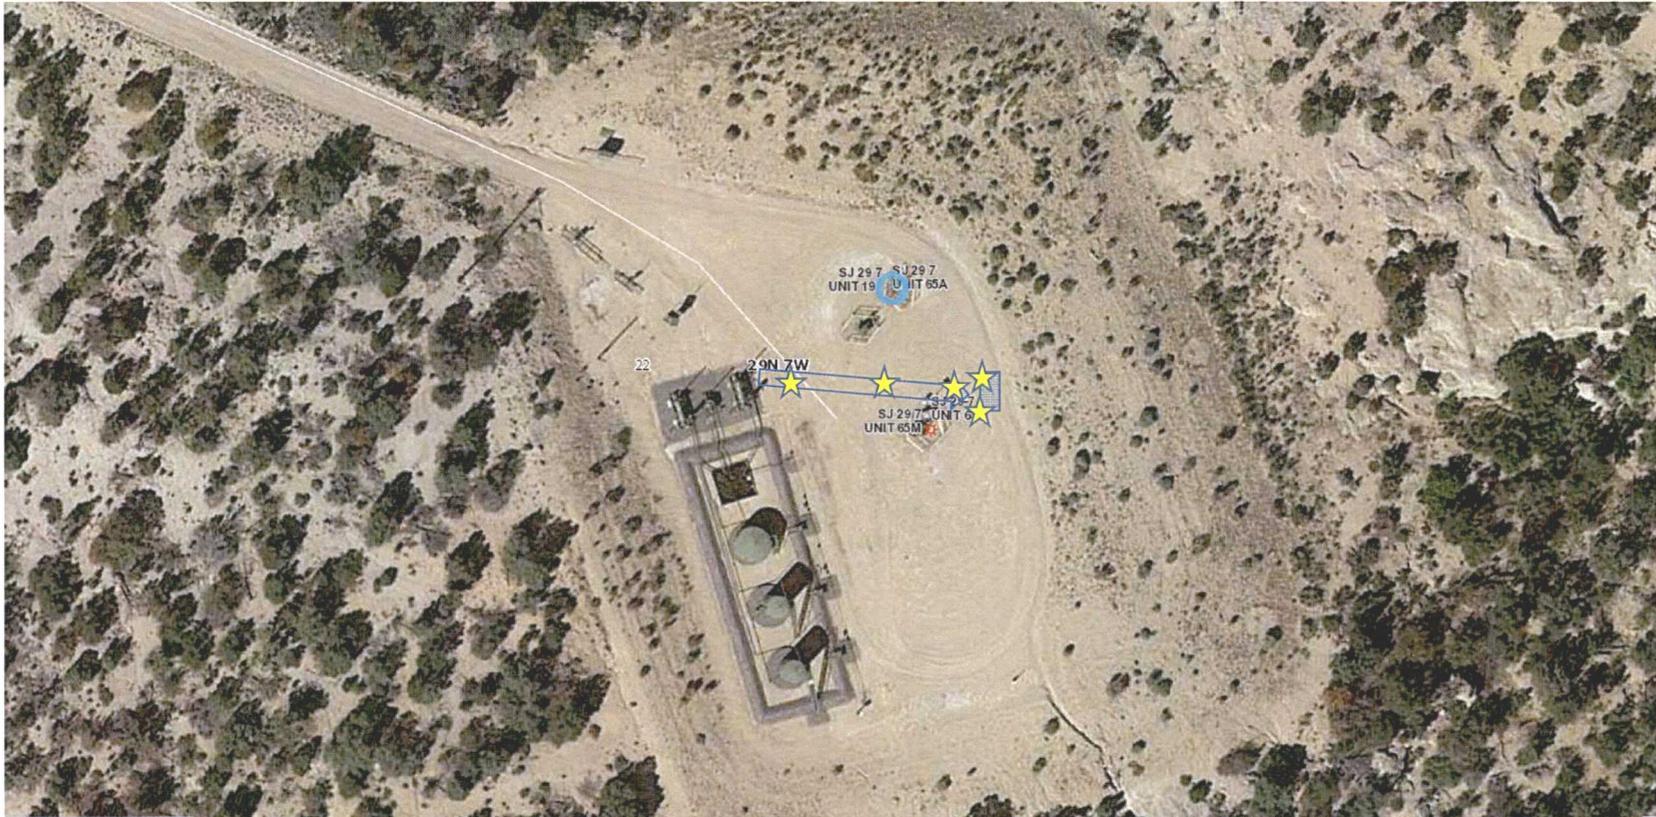
# Topographic/Aerial Map

Approximate projectile of equipment

Approximate resting spot on equipment

Approximate sample locations

Samples taken on 12/12/2018
