Site Name San Juan 27-5 Unit 110N	Site Type Gas
Date Release Discovered 11/29/17 12:50pm	API# (if applicable) 3003927767

NCS1733529093 SAN JUAN 27 5 UNIT #110N @ 30-039-27767

On 11/29/2017 Hilcorp had a release of 33bbls of condensate and 17 bbls of produced water on the San Juan 27-5 #110N. Hilcorp contracted Animas Environmental to delineate the release. Animas Environmental delineate the release on 12/11/2017 by hand auger, at 4.5 ft they hit auger refusal. On 1/8/18 a geoprobe was used to complete vertical and horizontal delineation of the site. Due to road conditions and distance to disposal facility, Hilcorp opted to remediate the release on site using bioremediation piles.

San Juan 27-5 110N

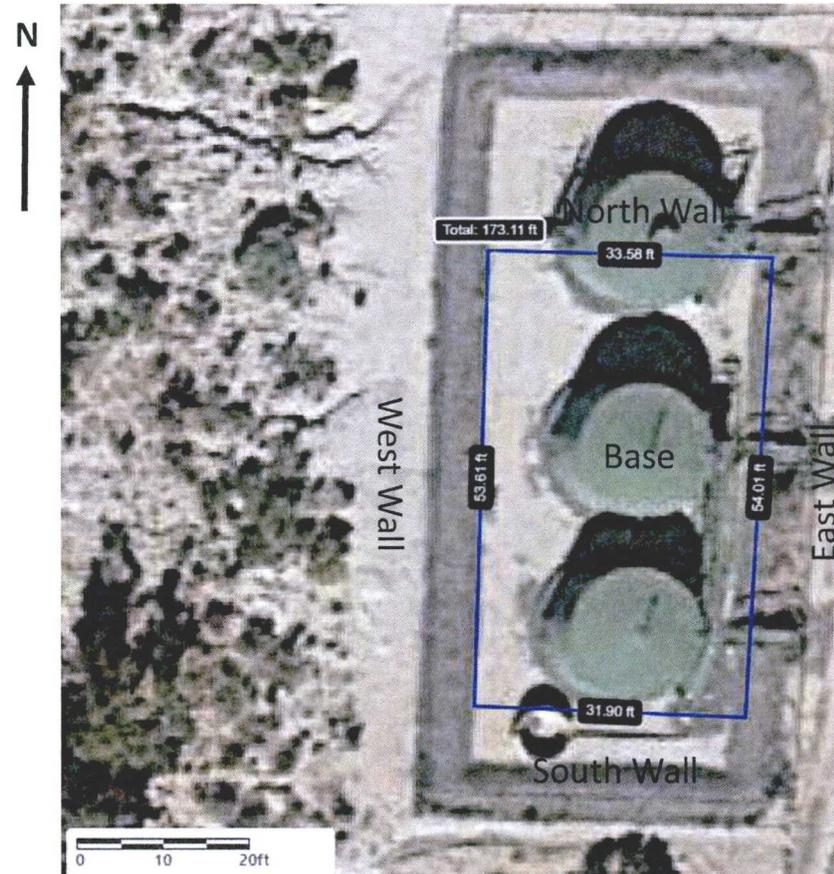
1/24/2018 Sampling Event – Base at 5.5'

On 1/22/18 Hilcorp notified NMOCD & SLO that excavation would begin and sampling of the side walls and base was scheduled on 1/24/18. The Base, South Wall, and East Wall were above NMOCD threshold. The soil from this excavation was remediated on site using bioremediation piles. A subsequent C-141 was submitted with bioremediation pile location, sampling & closure plan, and SDS for the fertilizer Hilcorp added to the bioremediation piles. The piles were turned weekly from 1/29/18 until 3/8/18.

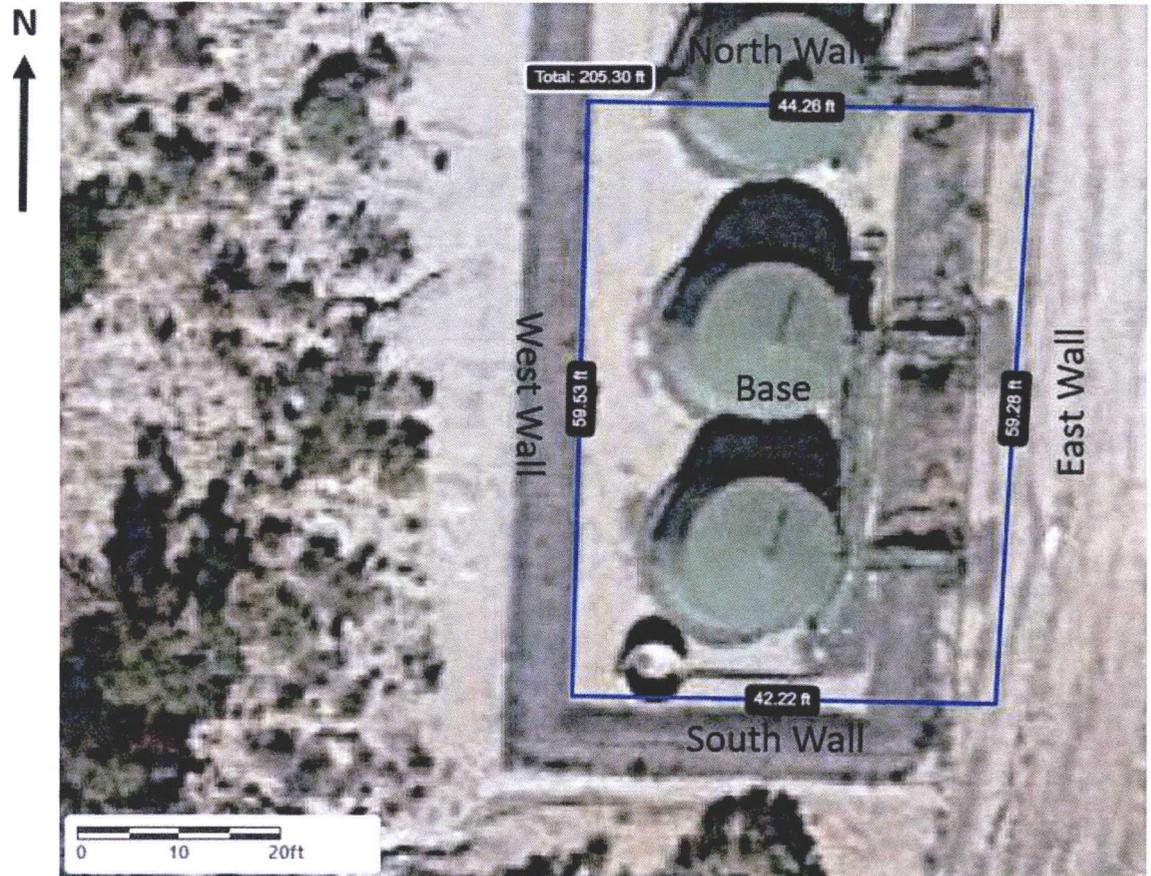
3/8/2018 Sampling Event – Base at 5.5-6'

On 3/6/18, Hilcorp notified NMOCD & SLO that the Base, South Wall & East Wall would be excavated further and sampling was scheduled for 3/8/18. On 3/8/18, Hilcorp excavated the Base, South Wall, and East Wall of the excavation, all walls were below NMOCD threshold. Also on 3/8/18, the North Pile and South Pile of the bioremediation piles were sampled, all results were below NMOCD threshold. The soil that was excavated on 3/8/18, was piled separately from the initial soil that was excavated on 1/24/18.

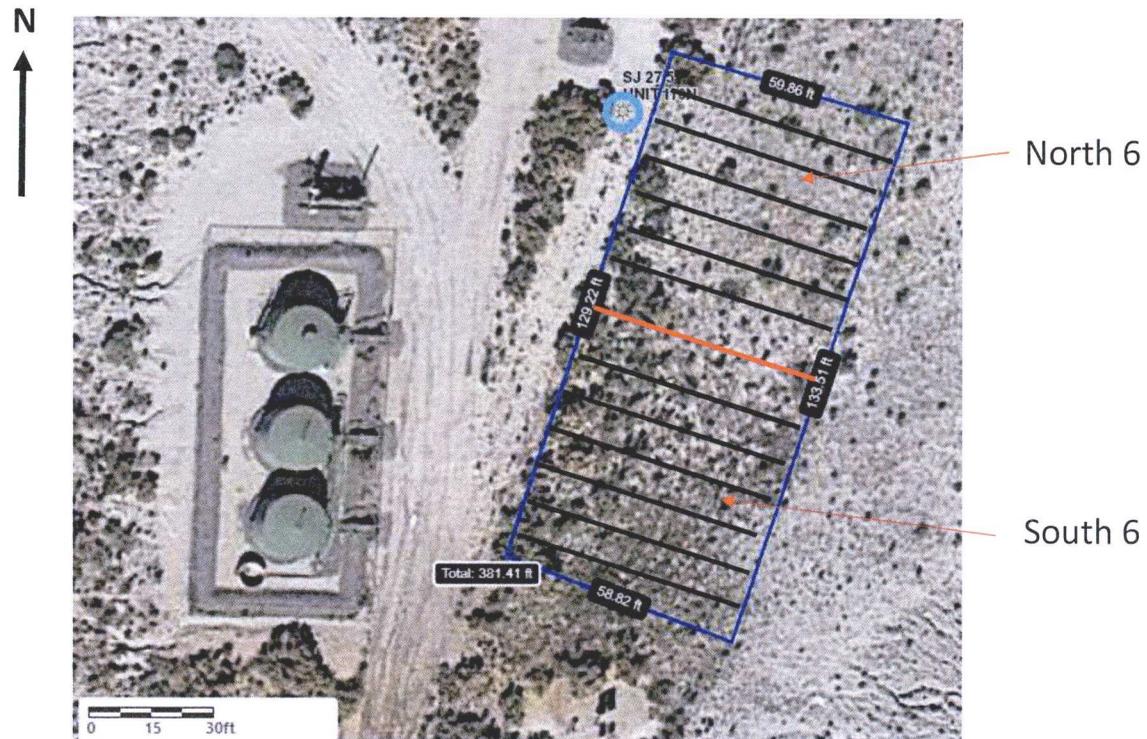
Biopile Sampling 4/26/18

The soil that was excavated on 3/8/18, was turned weekly until 4/26/18 when it was sampled. On 4/23/18, Hilcorp asked NMOCD for their availability that week to sample the biopile soil, NMOCD responded on 4/23/18. On 4/25/18, Hilcorp confirmed that sampling would occur on 4/26/18. Both the North 6 and South 6 samples were below NMOCD threshold. At this time the excavation was backfilled using the remaining soil. Approximately 600 cubic yard of contaminated soil were remediated on site using biopiles.

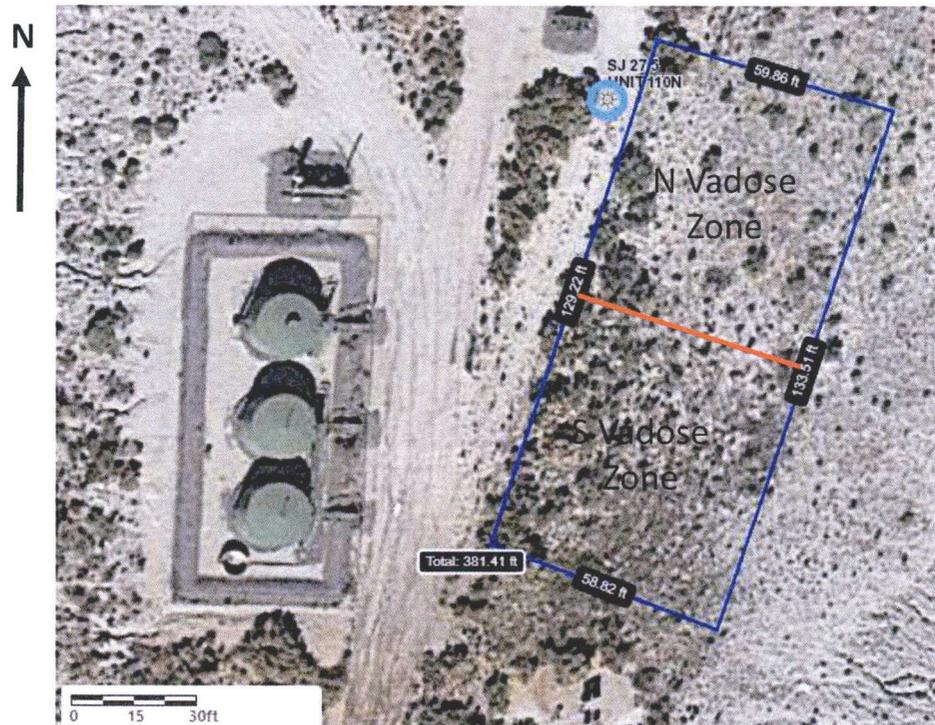
Vadose Zone Sampling 6/27/18

On 6/27/18, the vadose zone was sampled with NMOCD on site. Hilcorp does not have record of notification to NMOCD, but believes this was a phone conversation with Cory Smith from NMOCD. North and South Vadose Zone samples were below NMOCD threshold.
