## Release Notification

Site Name: San Juan 28-6 #148N	Site Type: Gas
Date Release Discovered: 1/19/18 8:30AM	API# (if applicable) 30-039-29890

# Area of Impact of Release

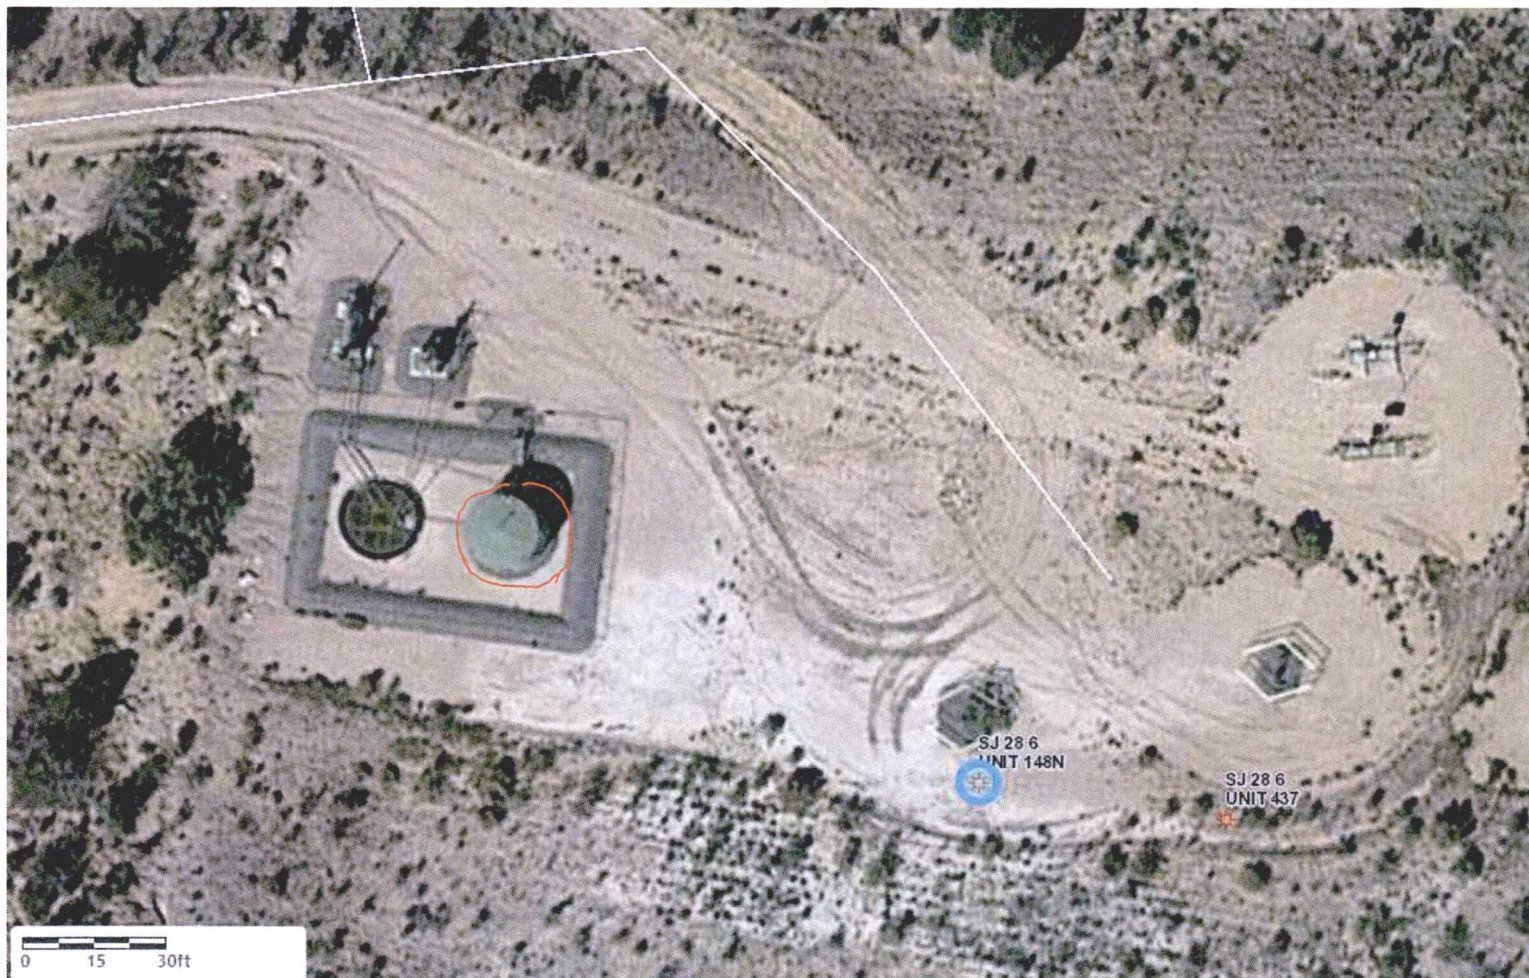
On 1/19/18 HEC discovered a release had occurred on the San Juan 28-6 148N well pad. The release was approximately 9 bbls of produced water from the bottom of the production tank. The corroded tank sits on a liner and during discovery the soil around the tank was saturated. On 1/22/18 samples around the tank were taken approximately 1' bgs and pictures were taken of the sampling. All samples were submitted for BTEX, TPH and Chlorides. Results and pictures are attached. No further action required.
