Release Notification

Site Name: N Escavada Unit 317H	Site Type: Wellsite
Date Release Discovered: 2/20/2019	API# (if applicable) 30-043-21295

North Escavada 317H Remediation Narrative

Enduring Resources, LLC
NEU 317H Tank Fire

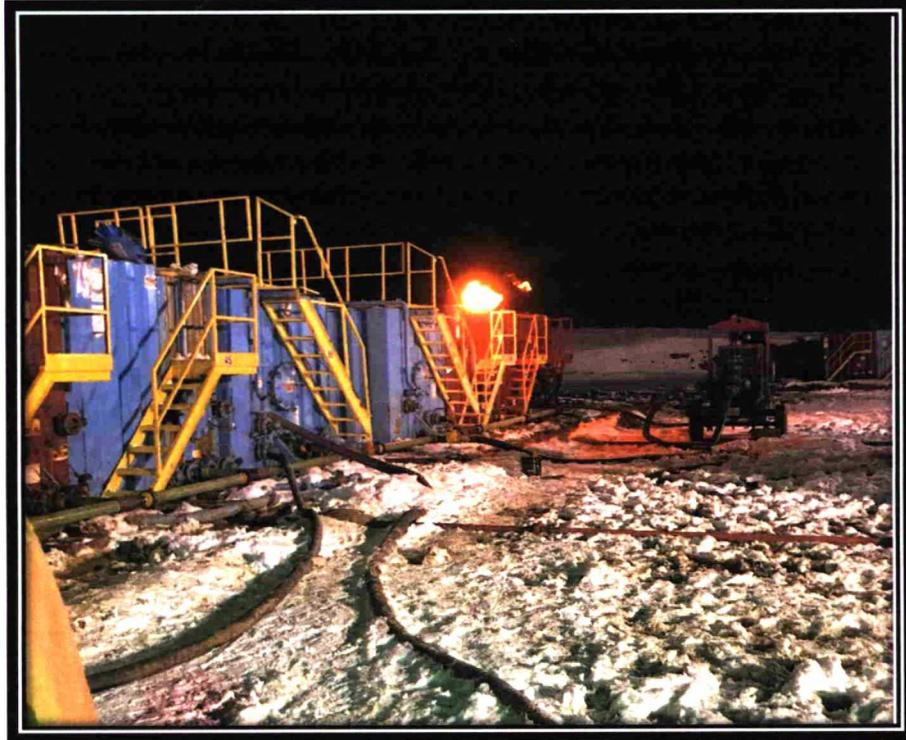
PHOTO 1: View of Fire and Position of Transfer Pump

A fire was discovered around 7:45pm at the NEU 317H wellsite. The fire occurred inside a flow back tank on-site used for well flow back activities. A vac truck was pulling liquids from an adjacent frac tank, and was not properly bonded, causing a static discharge that flashed vapors escaping from the flow back tank. The vapors ignited, and flashed into the open flow back tank, catching the tank contents on fire. No one was injured, and the fire was extinguished the same evening. Notice was provided to Cory Smith of the NMOCD at 9:55pm via phone call which a follow-up email was sent on 2/21/2019, see attached "*Email Notification*".

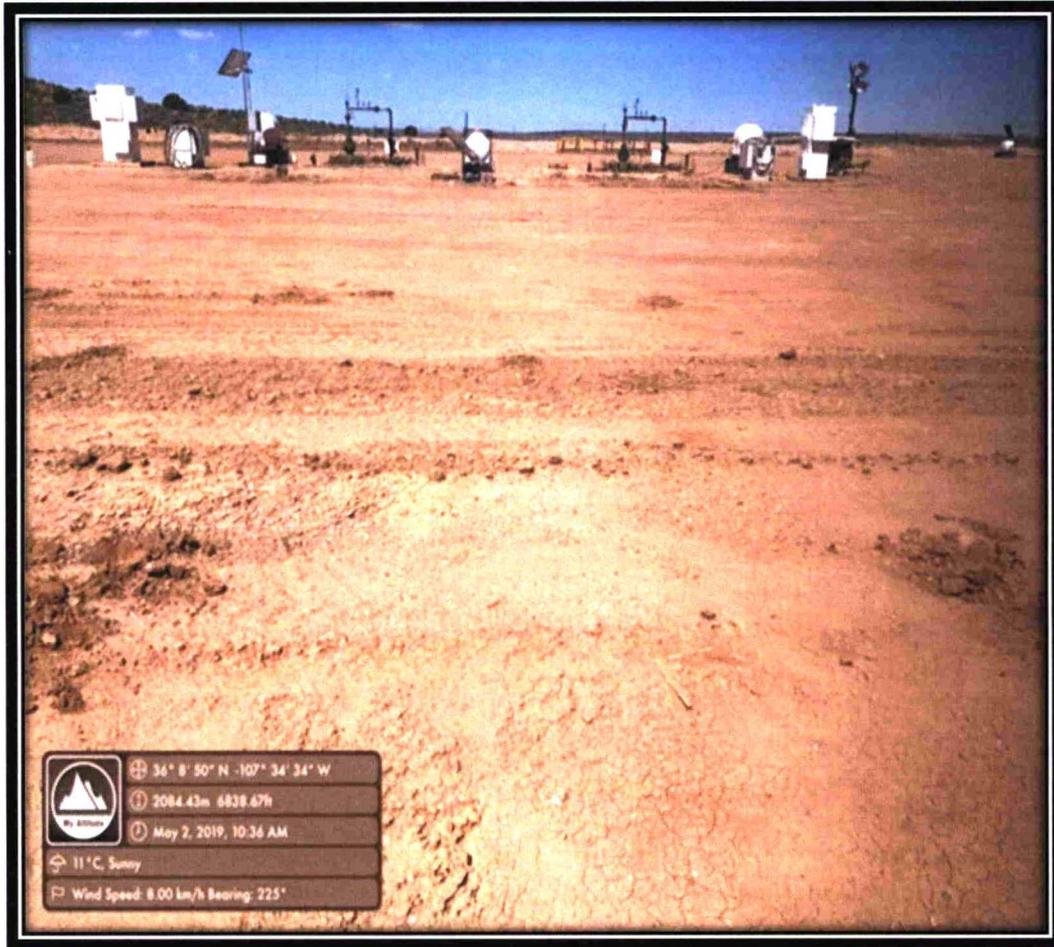
NEU 317H

NMOCD on site and noticed minimal staining on the back side of flow back tanks that would be addressed once completion of flow back activities, no free standing liquids were found during inspection.

Staining was scrapped up using a back hoe. Approximately 24 yards was removed from the pad and hauled off to a proper disposal facility.

Area of
Staining

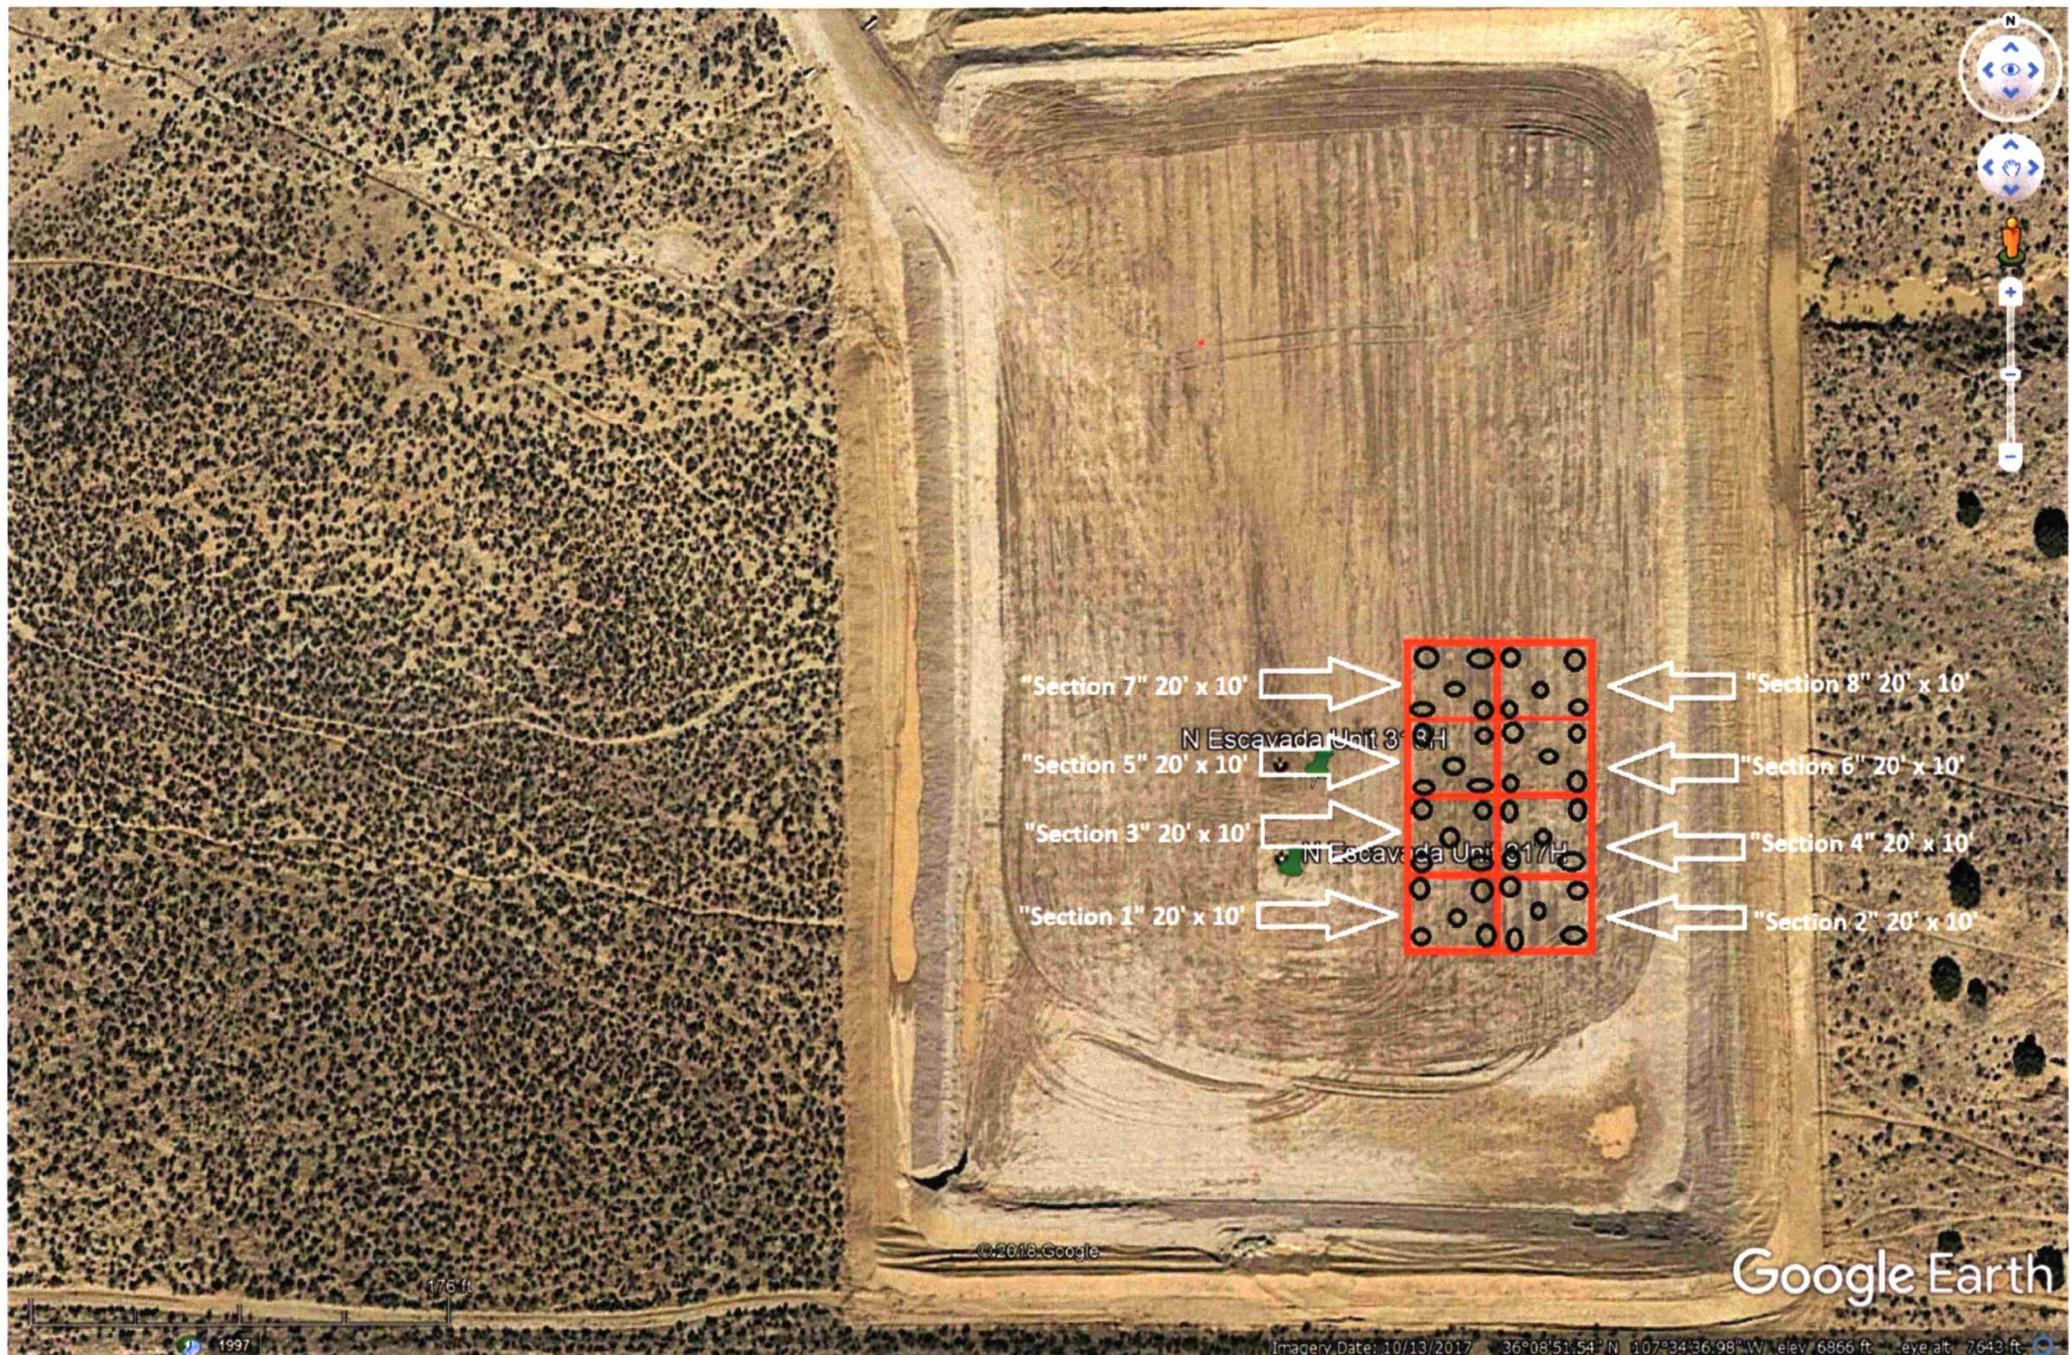
Confirmation sampling activities occurred, NMOCD rep was not on site to witness. Eight composite samples were collected from impacted area were each was in a 200 square foot area measuring out to 20' by 10'. Samples were sent in for analysis of BTEX, DRO/GRO/ORO, and Chlorides.

"Section 7" 20' x 10'

"Section 1" 20' x 10'

Analytical Report was received and all returned results were under closure standards for this site (BTEX: 50 ppm, TPH: 2500 ppm, and chlorides 20,000 ppm), see attached "*Analytical Report*" and "*Sample Results Table*". Site was ranked with ground water being over 100ft from surface by a cathodic that was drilled at a nearby location (NEU 329H) showing ground water to be over 340' from surface, see attached "*Ground bed Drilling Log*". No further action is required.
