Release Notification

Site Name Nordhaus 710 Pipeline	Site Type Pipeline
Date Release Discovered 4/18/19	API# (if applicable) 30-045-27703

From: Smith, Cory, EMNRD
Sent: Thursday, June 20, 2019 1:45 PM
To: 'Larissa Farrell'
Subject: Nordhaus 710 Pipeline,

LOGOS Operating, LLC – Nordhaus 710 Pipeline
Scaled Site and Sampling Diagram
Unit H, Section 1, T31N, R9W
Rio Arriba County, NM

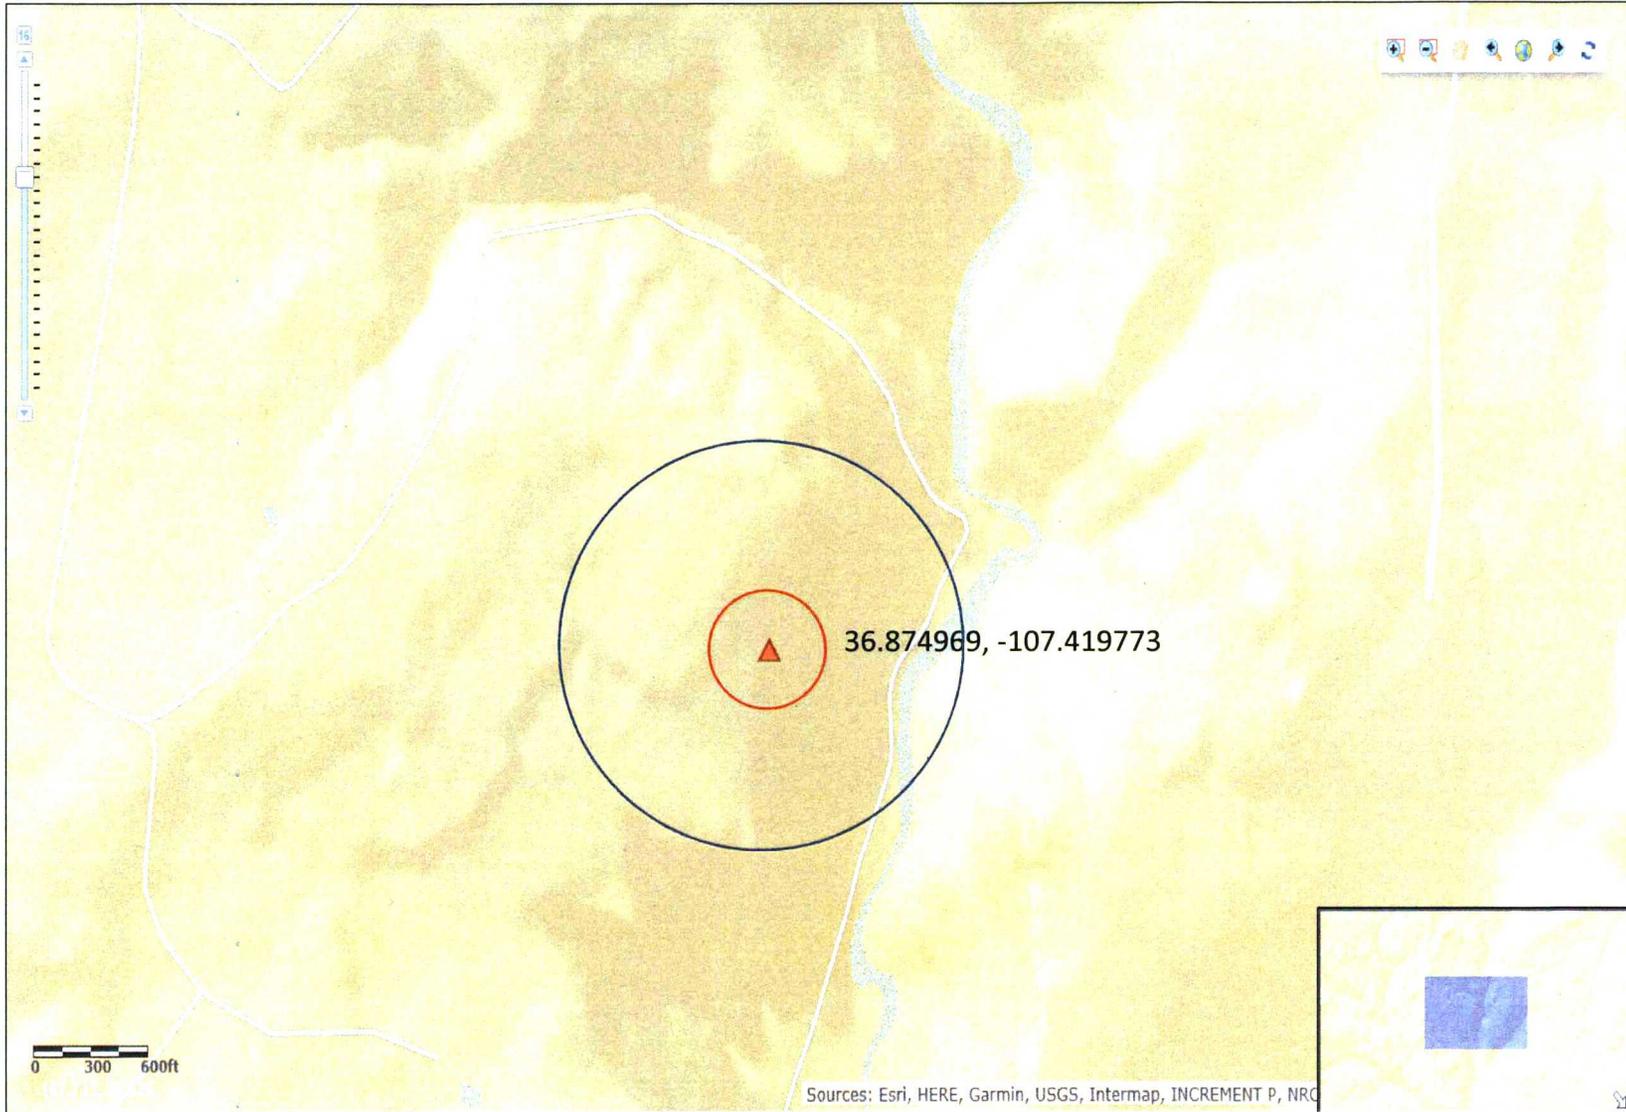
300' Buffer

1000' Buffer

Release site

- Incorrect Operator Ogrid Number#
- No sampling diagram
- The notes say 27' of excavation but the site diagram scale is so large OCD can not determine sampling points etc. The Picture doesn't show any type of excavation?
- No Notice to the OCD
- No description of remedial activities
- Operator did not provide siting characteristics per 19.15.29. 11 NMAC (Distance to significant water course, residences, etc.)

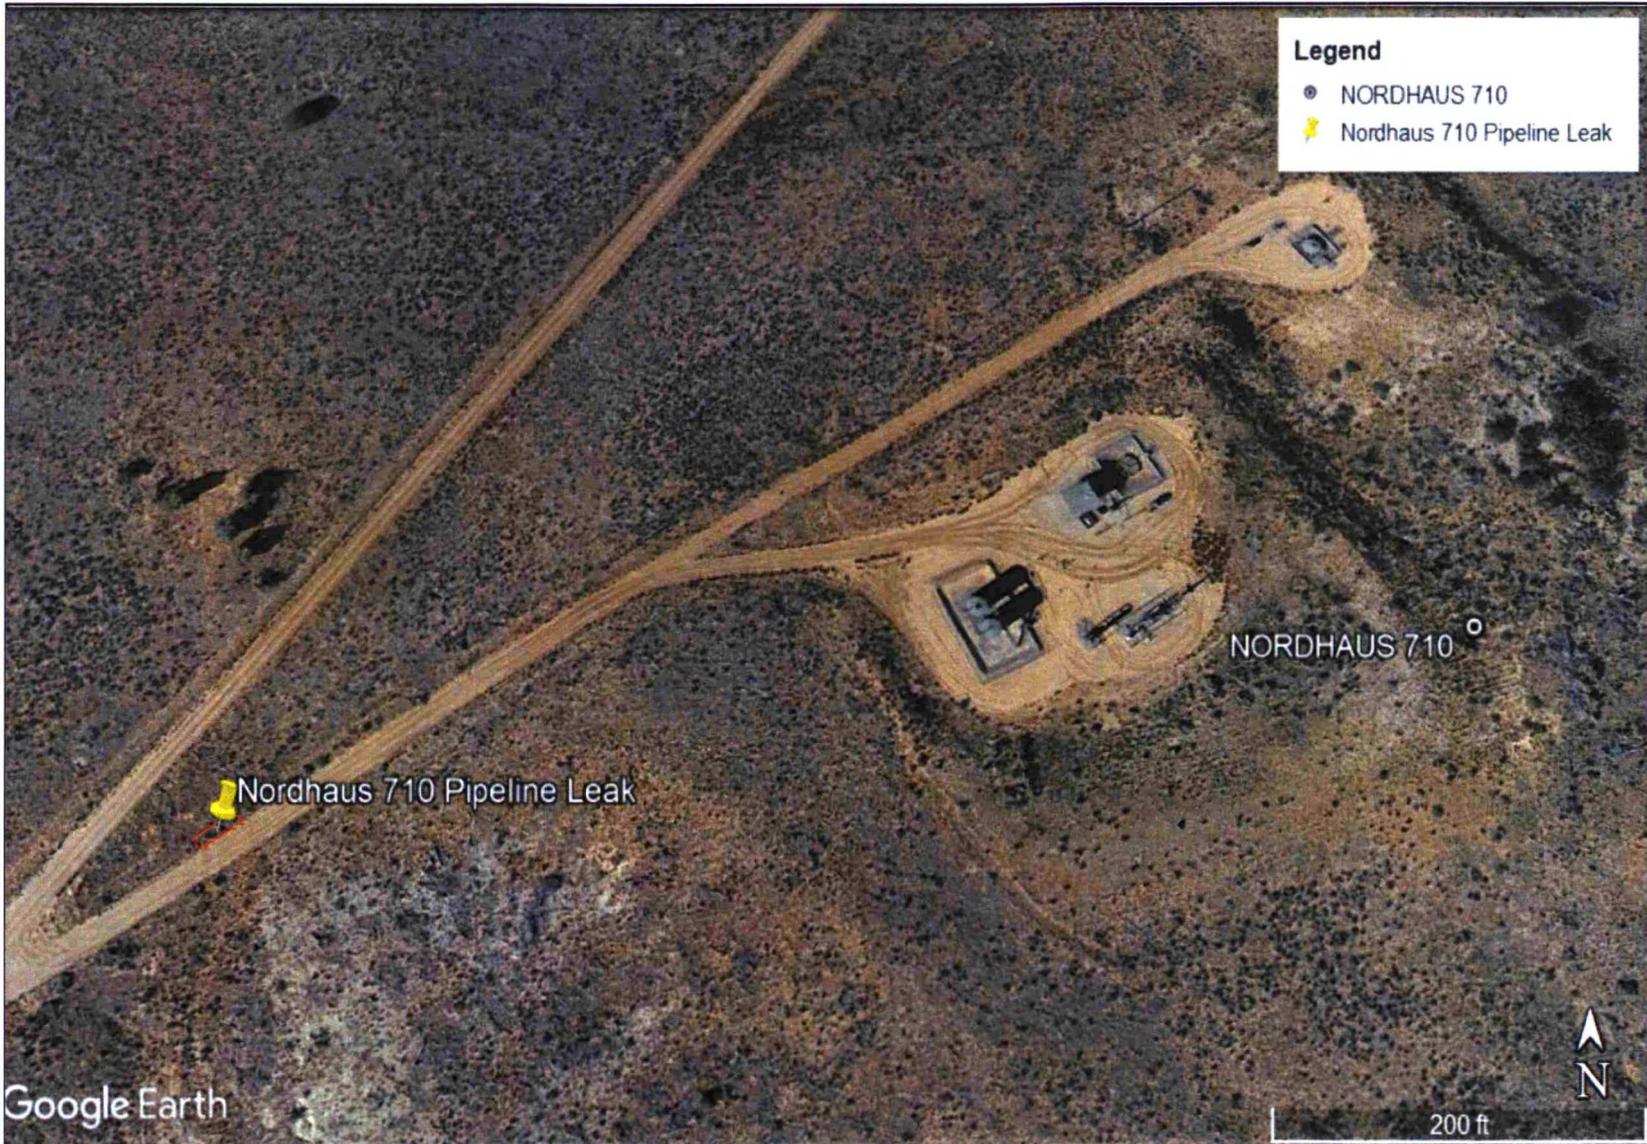
LOGOS Operating, LLC – Nordhaus 710 Pipeline
 Scaled Site and Sampling Diagram
 Unit H, Section 1, T31N, R9W
 San Juan County, NM

- NORDHAUS 710
- 📌 Nordhaus 710 Pipeline Leak

- Impacted Area
