Release Notification

| Site Name South Blanco 23 3 | Site Type Flowline |

Split in pipeline that backflowed from the South Blanco 23 3 to the South Blanco 23 4 (NOTE: The South Blanco 23 4 did not produce during this time.)

DJR Operating, LLC South Blanco 23 3 2nd Release Point
Date: Unknown Date
API: 30-045-28163
Location: Unit P Sec 23-T24N-R08W Lat: 36.293914 Long: -107.645414

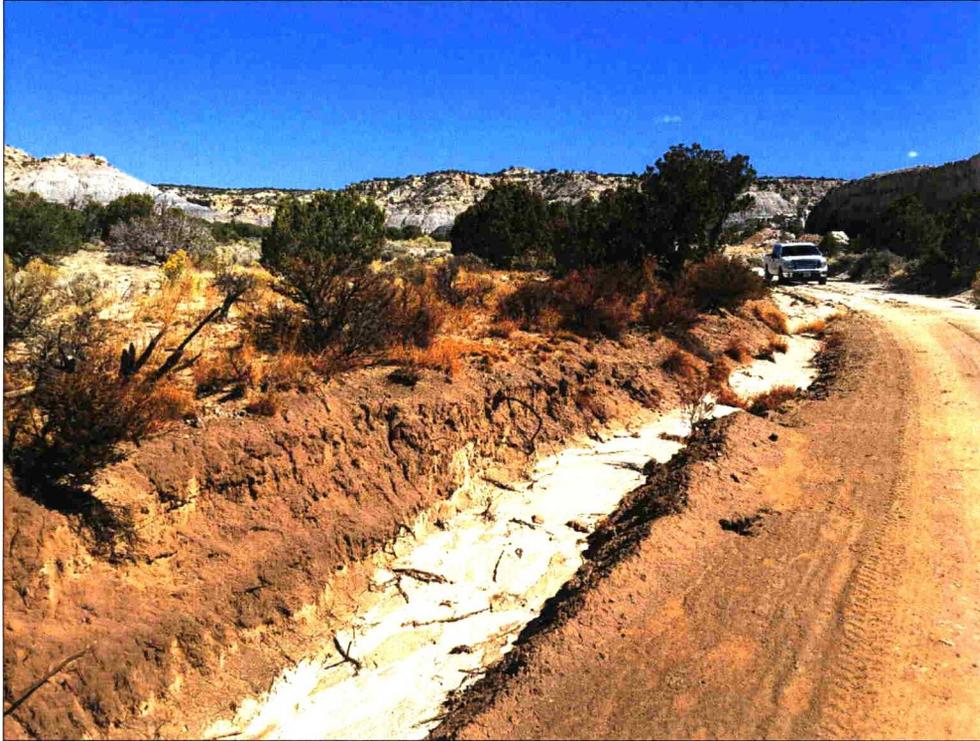
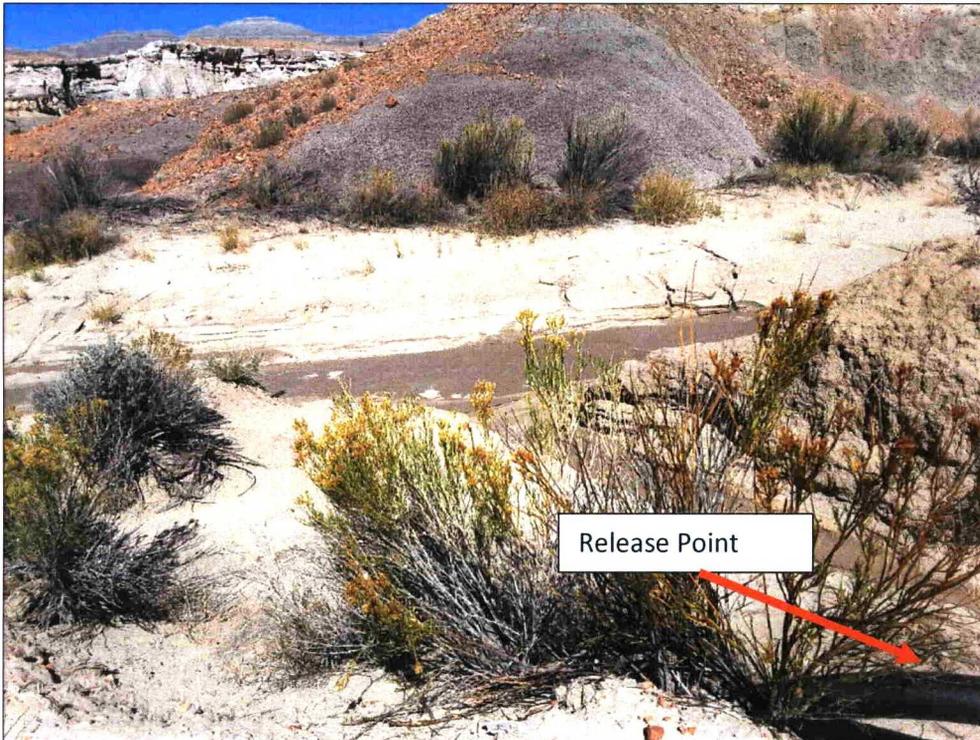
DJR Operating, LLC South Blanco 23 3 2nd Release Point

Date: Unknown Date

API: 30-045-28163

Location: Unit P Sec 23-T24N-R08W Lat: 36.293914 Long: -107.645414

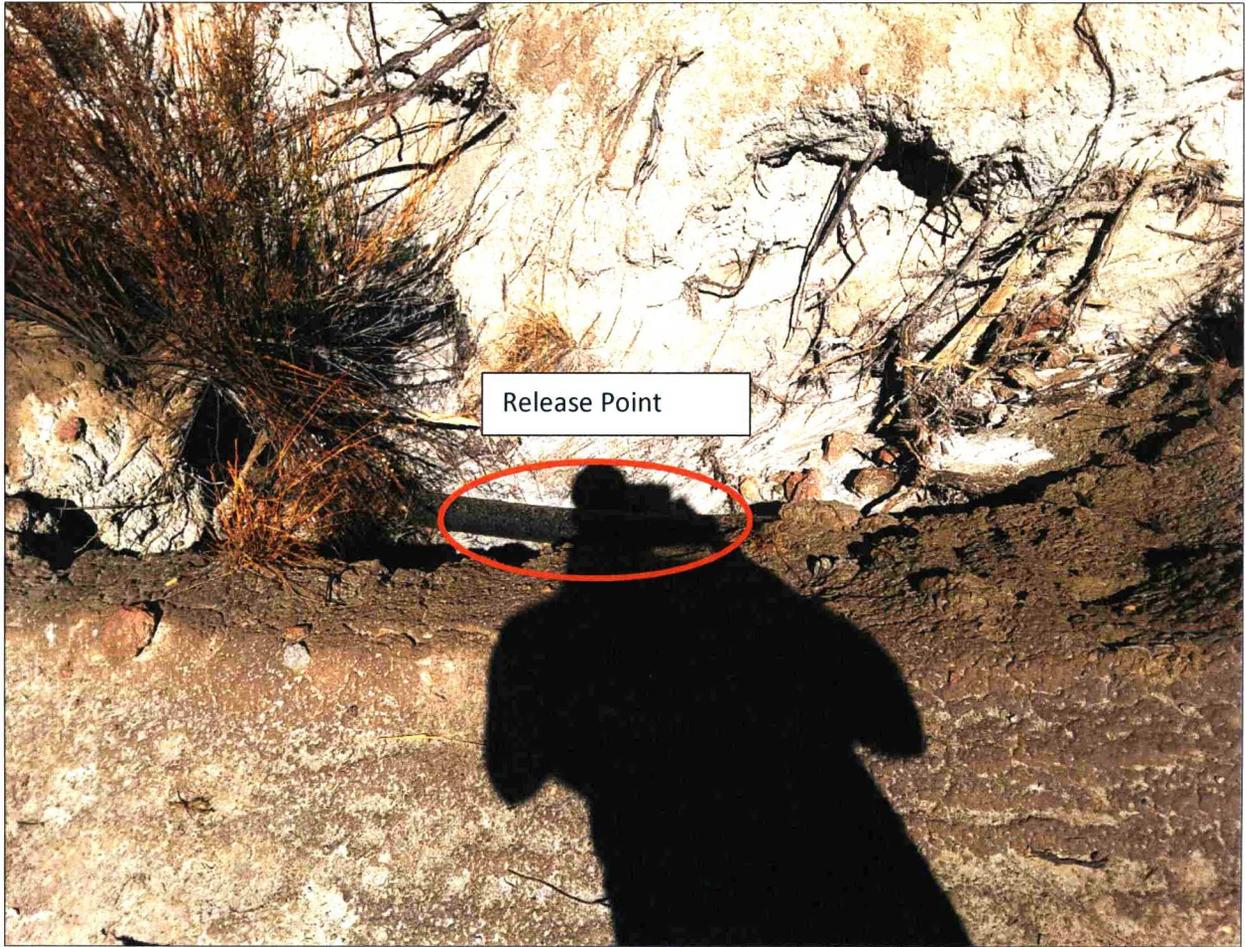
South Blanco 23 3

API: 30-045-28163
Lat: 36.293914 Long: -107.64514
San Juan County, NM

SBC 23 3 2nd release

SBC 23 3 Flowline Release Point
