**PIT REMEDIATION AND CLOSURE REPORT**

Facility Or: Storey C # 3 E API # : 30-045-25769  
Well Name

Location: Unit or Qtr/Qtr Sec J Sec 27 T 28N R 9W County San Juan

Pit Type: Separator            Dehydrator            Other            Tank Drain Pit

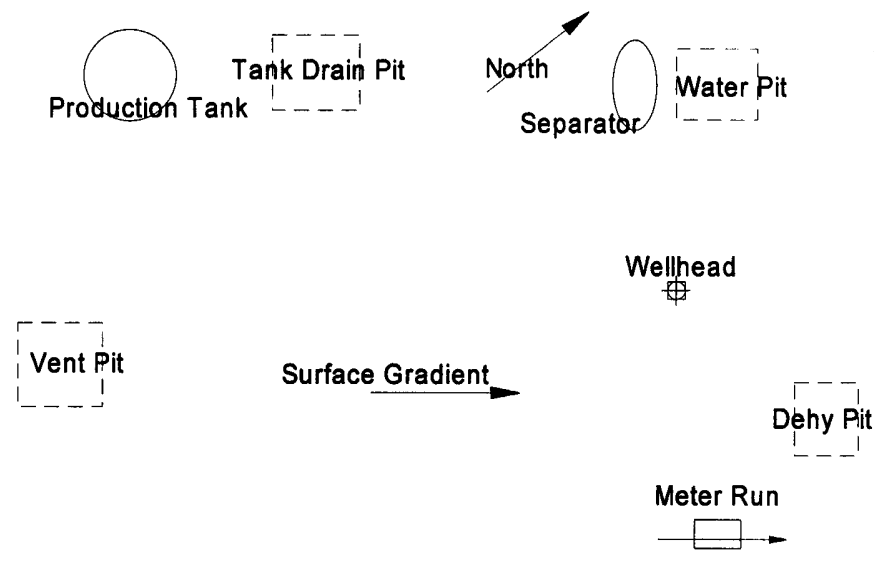
Site Diagram:

Sample location Center of pit, 6-ft below surface level (3-ft. below pit bottom)

Sample depth 3-ft. below pit bottom

A soil sample was extracted at 6-ft below ground level (3-ft. below pit bottom). The sample was analyzed for GRO/DRO and BTEX analysis. All analyses were within BLM and NMOCD requirements.
