## EL PASO FIELD SERVICES

### FIELD PIT SITE ASSESSMENT FORM

| 9 | <b>GENERAL</b> | <p>Meter: <u>71428</u> Location: <u>Bolack C 456</u></p> <p>Operator #: _____ Operator Name: <u>Amoco</u> P/L District: <u>Ballard</u></p> <p>Coordinates: Letter: <u>J</u> Section <u>31</u> Township: <u>27</u> Range: <u>8</u></p> <p>Or Latitude _____ Longitude _____</p> <p>Pit Type: Dehydrator _____ Location Drip: <input checked="" type="checkbox"/> Line Drip: _____ Other: _____</p> <p>Site Assessment Date: <u>6-16-94</u> Area: <u>11</u> Run: <u>62</u></p> |

# FIELD PIT REMEDIATION/CLOSURE FORM

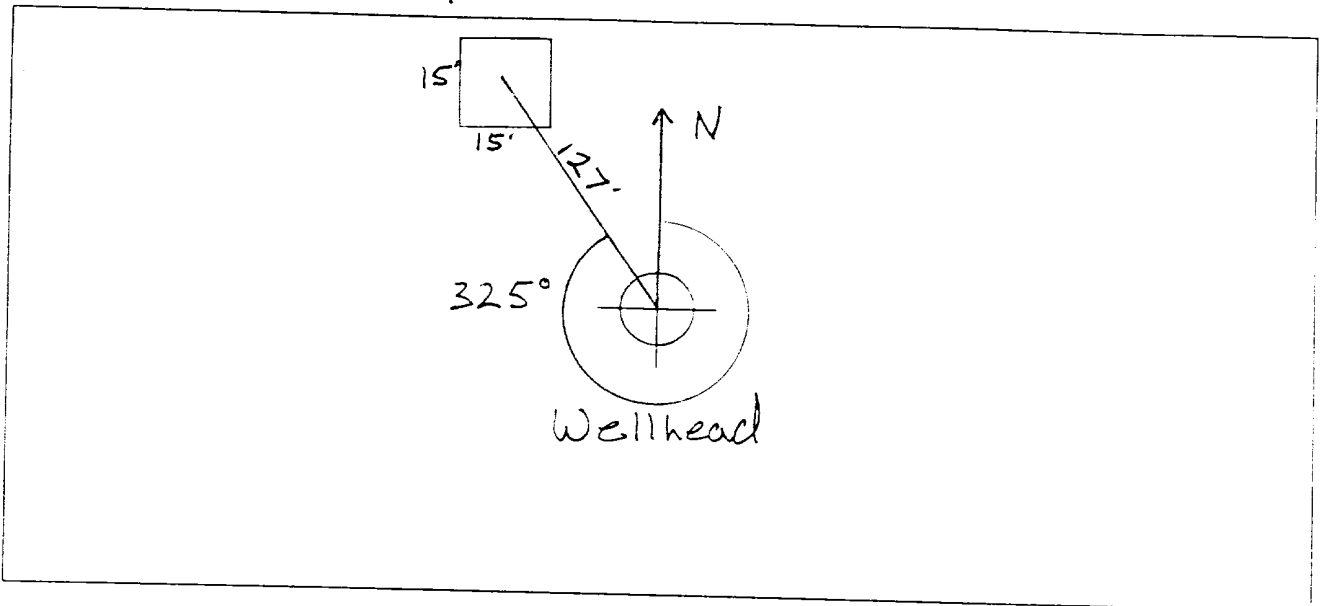
### ORIGINAL PIT LOCATION

Original Pit : a) Degrees from North 325 Footage from Wellhead 127  
b) Length : 15 Width : 15 Depth : 4

Remarks :

Photos - 1337
