PIT REMEDIATION AND CLOSURE REPORT

Operator: PNM Gas Services ( Cross Timbers ) Telephone: 324-3764

Facility or Well Name: EH Pipken #5

Location: Unit B Sec 36 T 28 N R 11 W County San Juan

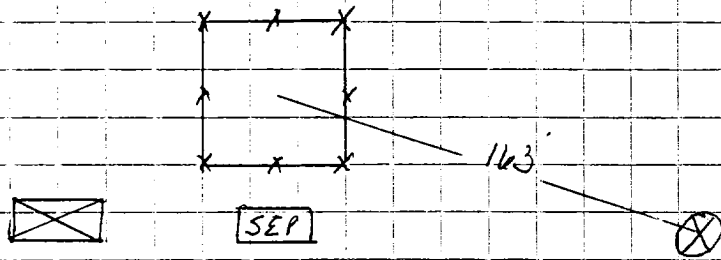
start of excavation:

Excavated contaminated soil to a pit size of 14' X 14' X 17' and landfarmed soil onsite within a bermed area at a depth of 6" to 12". Soil was aerated by disking/plowing until soil met regulatory levels.

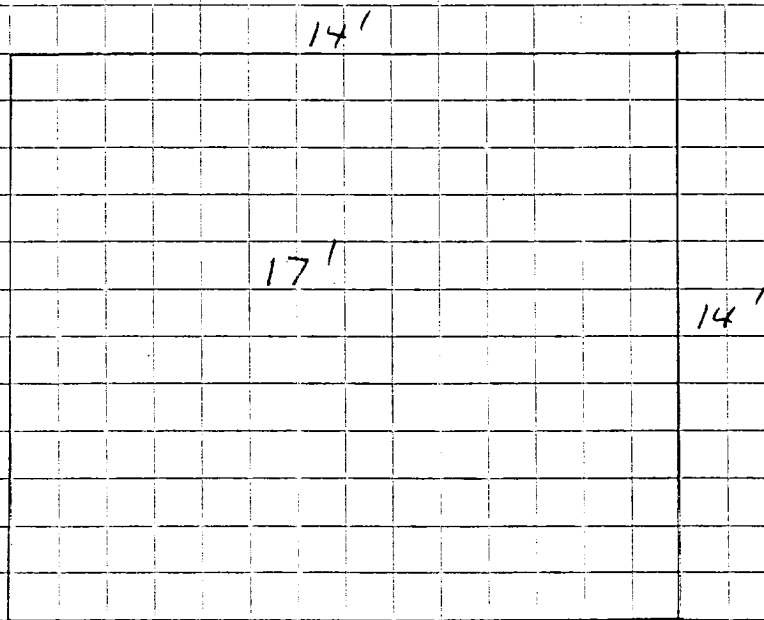
End of excavation:

walls & bottom all clean

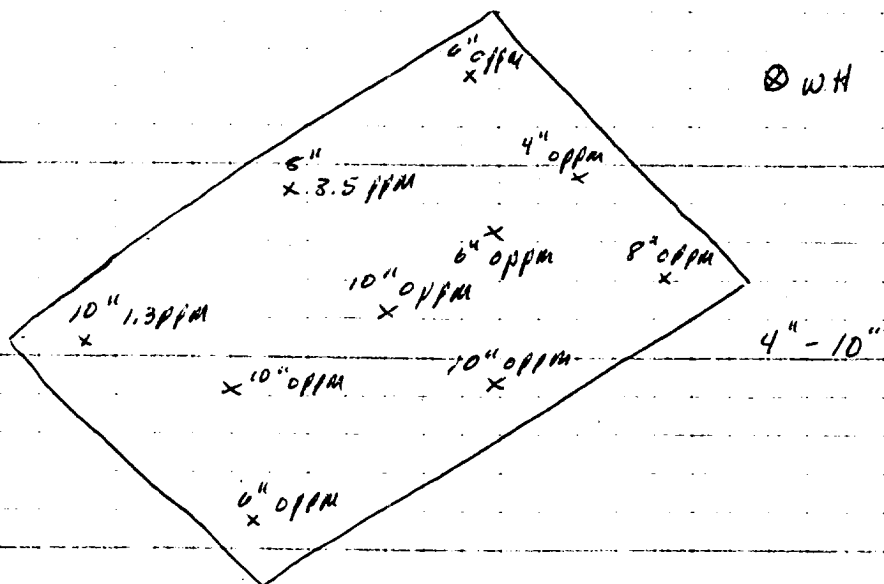
E.H. Pinkerton #5  
NW/4 NE/4  
(B) 3628N-11W  
San Juan  
Cross Timbers  
Lab Sample #  
Field head space

9805210900  
8.3 ppm

All zero's

7 pt comp.

head space = 0 ppm
