PIT REMEDIATION AND CLOSURE REPORT

Operator: <u>PNM Gas Services (Greystone)</u>		Telephone: <u>324-3764</u>	
Address: <u>603 W. Elm Street Farmington, NM 87401</u>			
Facility or Well Name: <u>Gross #1</u>			
Location:	Unit <u>N</u>	Sec <u>7</u>	T <u>31 N</u> R <u>12 W</u> County <u>San Juan</u>
Pit Type:	Separator <input type="checkbox"/>	Dehydrator <input type="checkbox"/>	Other <u>No equipment</u>
Land Type:	BLM <input type="checkbox"/>	State <input type="checkbox"/>	Fee <input checked="" type="checkbox"/> Other <u> </u>
Pit Location: Pit dimensions: length <u>11</u> ' width <u>11</u> ' depth <u>3</u> '			
(Attach diagram)	Reference: wellhead <input checked="" type="checkbox"/> other <u> </u>		
Footage from reference: <u>126</u> '			
Direction from reference: <u>84</u> Degrees <input checked="" type="checkbox"/> East <input type="checkbox"/> West of North <input checked="" type="checkbox"/> South <u> </u>			
Depth to Ground Water:

Gross #1

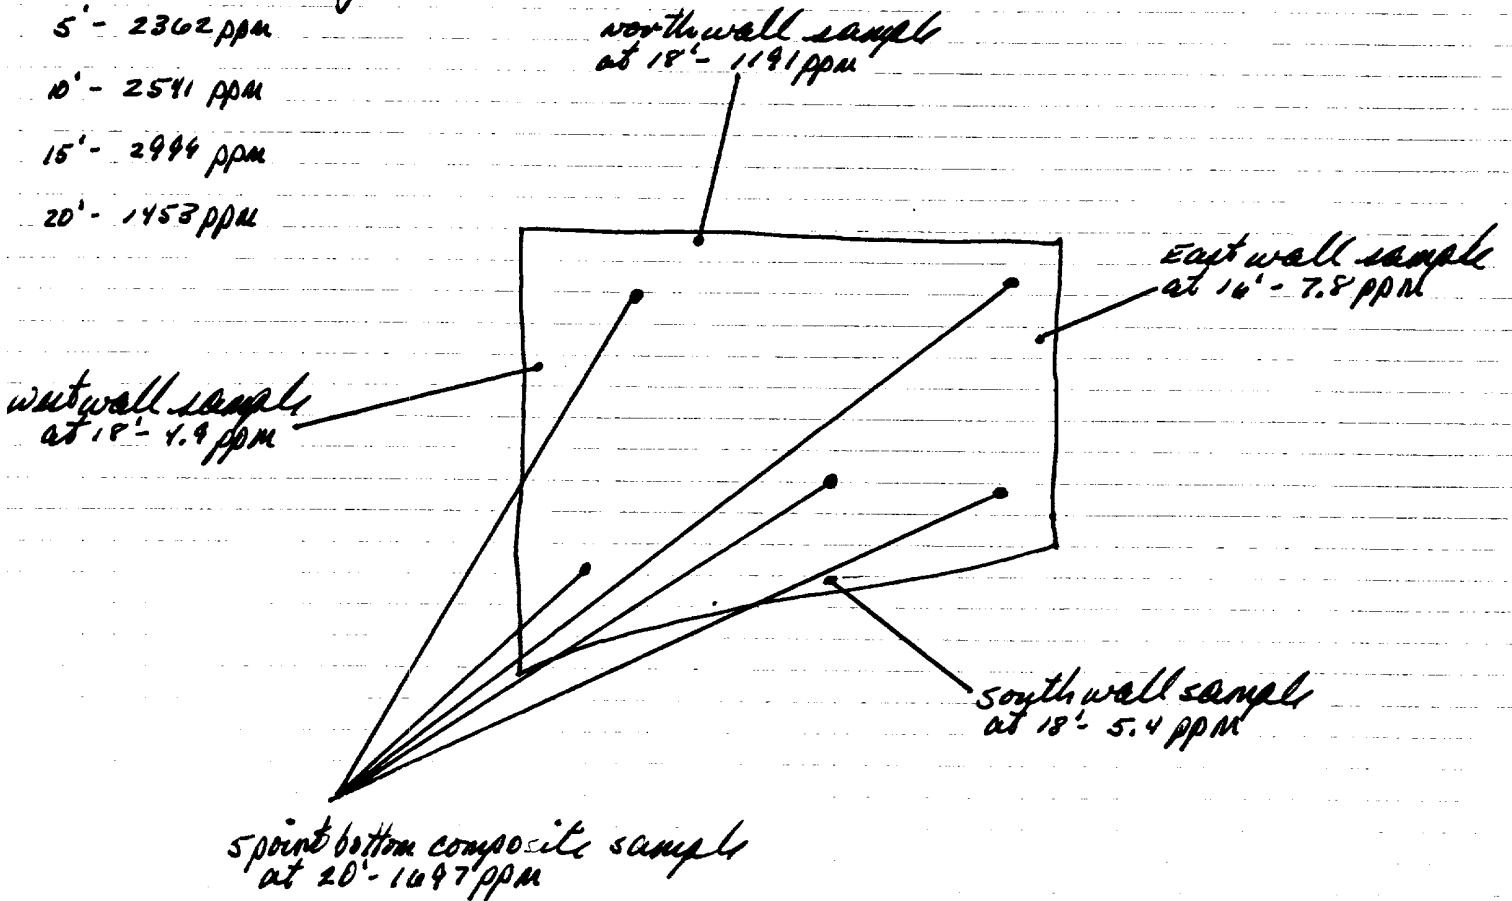
Excavation Sampling PID Reading

5' - 2362 ppm
 10' - 2541 ppm
 15' - 2944 ppm
 20' - 1453 ppm

31' (W+S) x 50.5' (E+W) x 20' (D)
 Field headspace: 110 ppm (walls)

Excavated contaminated soil to a pit size of 31' X 50.5' X 20' and landfarmed soil onsite within a bermed area at a depth of 6" to 12". Soil was aerated by disking/plowing until soil met regulatory levels.

*** Sandstone was encountered at 20'. See attached risk analysis form.

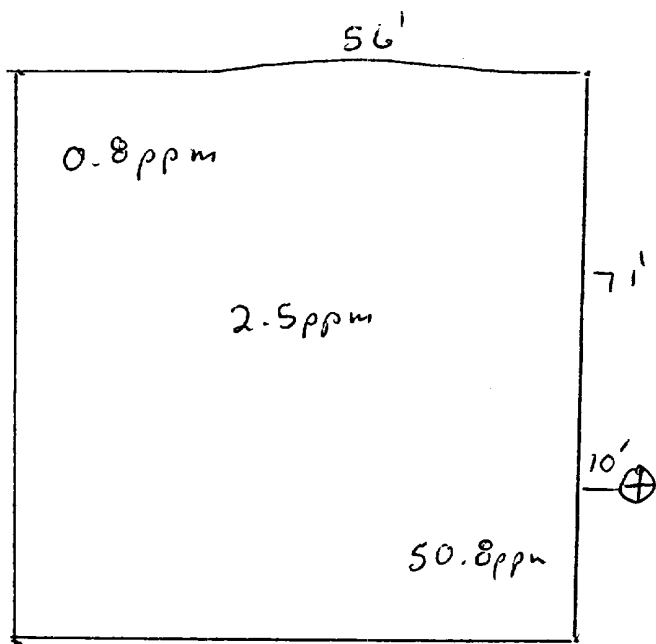
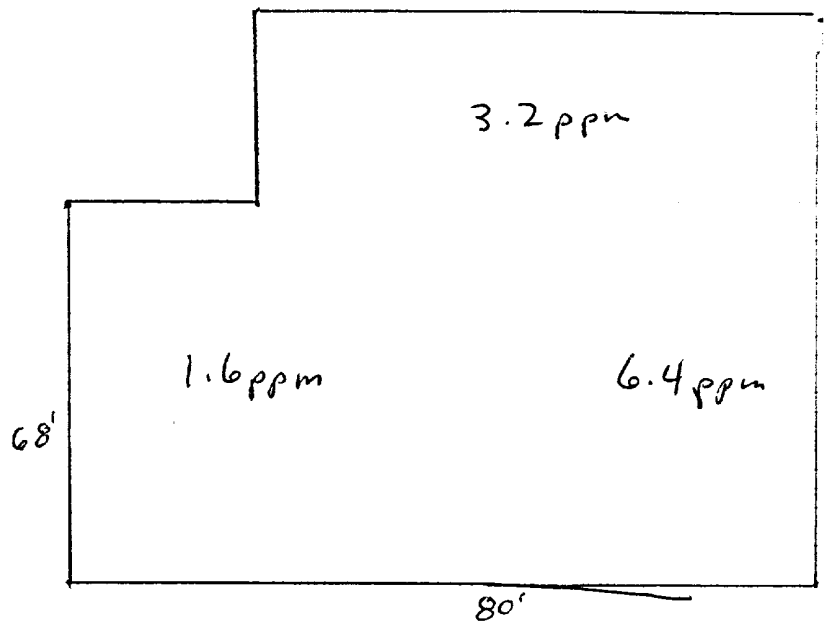
LAND Farm Drawing #1

2" to 12" Depth
Headspace 19.2 ppm
Sample # 9907011210

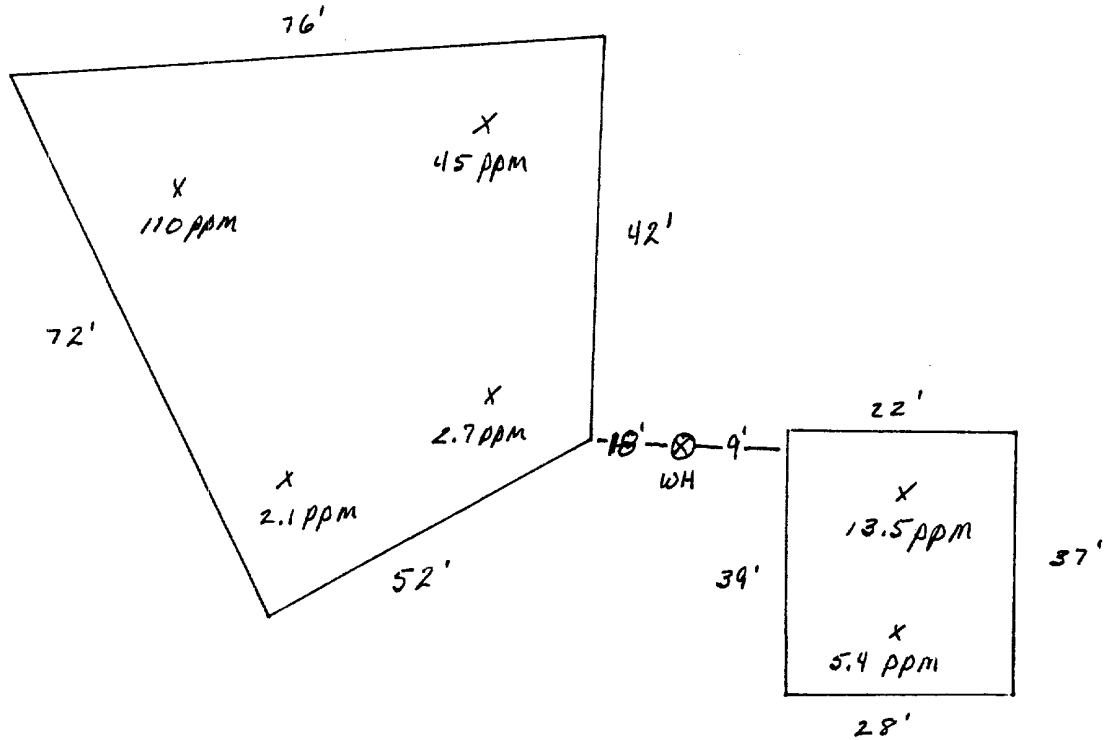
Landfarm #3 Drawing

Head Space - 27.9 ppm

Sample # - 9408121230
