PIT REMEDIATION AND CLOSURE REPORT

Facility or Well Name: Davis #3

Location: Unit E Sec 1 T 31 N R 12 W County San Juan

Davis # 3
Burlington Resources
Sec. 1, 31N, 12W, E

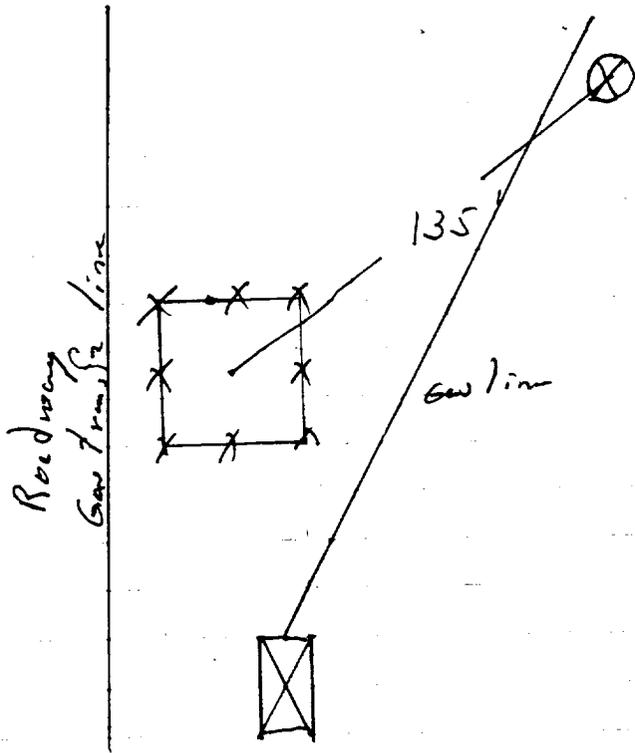
start:

Excavated contaminated soil to a pit size of 13' X 15' X 10' and landfarmed soil onsite within a bermed area at a depth of 6" to 12". Soil was aerated by disking/plowing until soil met regulatory levels.

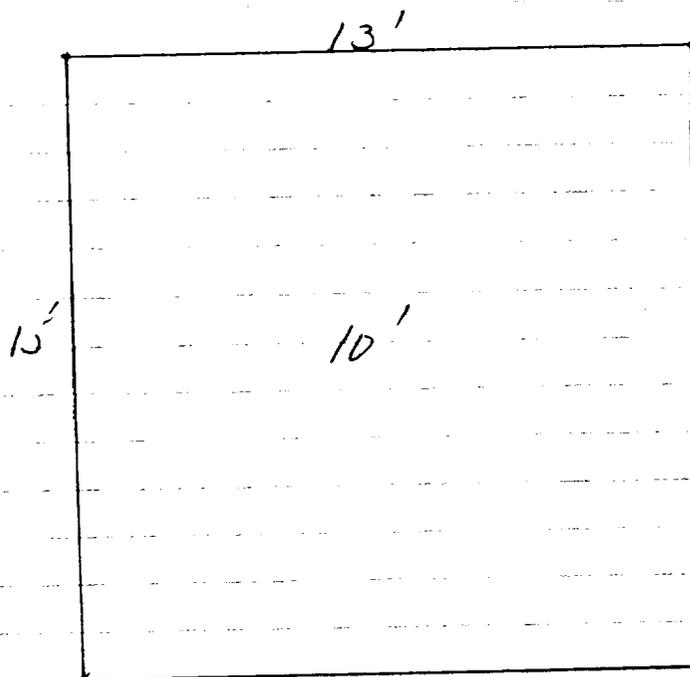
End of excavation

Sample Location Bottom of excavation.

Sample depth 10'

Benzene (ppm) 0.0018

Total BTEX (ppm) 0.0041

TPH (ppm) < 25.00 Method 8015

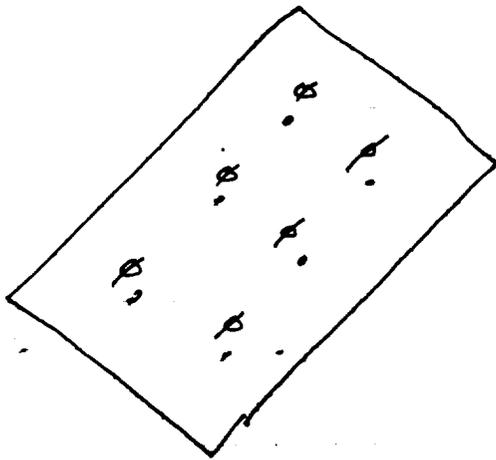
Land farm:

72 yards

9806300830
2"-12" depth

soil vapor headspace = 2.1 ppm
