**PIT REMEDIATION AND CLOSURE REPORT**

Richardson #9E

**General Description of Remedial Action:**

Excavated contaminated soil to a pit size of 18' X 21' X 10' and landfarmed soil onsite within a bermed area at a depth of 6" to 12". Soil was aerated by disking/plowing until soil met regulatory levels.

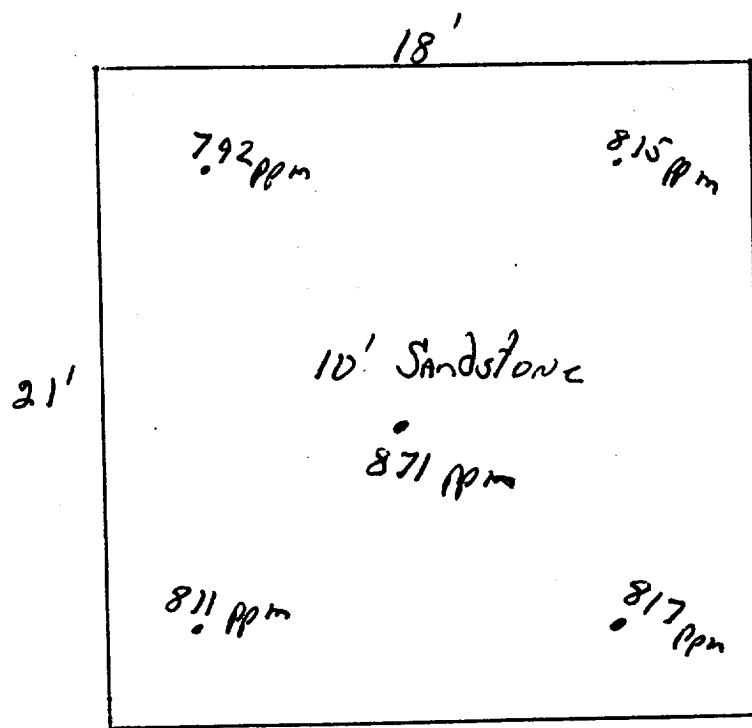
End of excavation:

Sample Location 5 pt composite-bottom

Sample depth 10'

not to scale

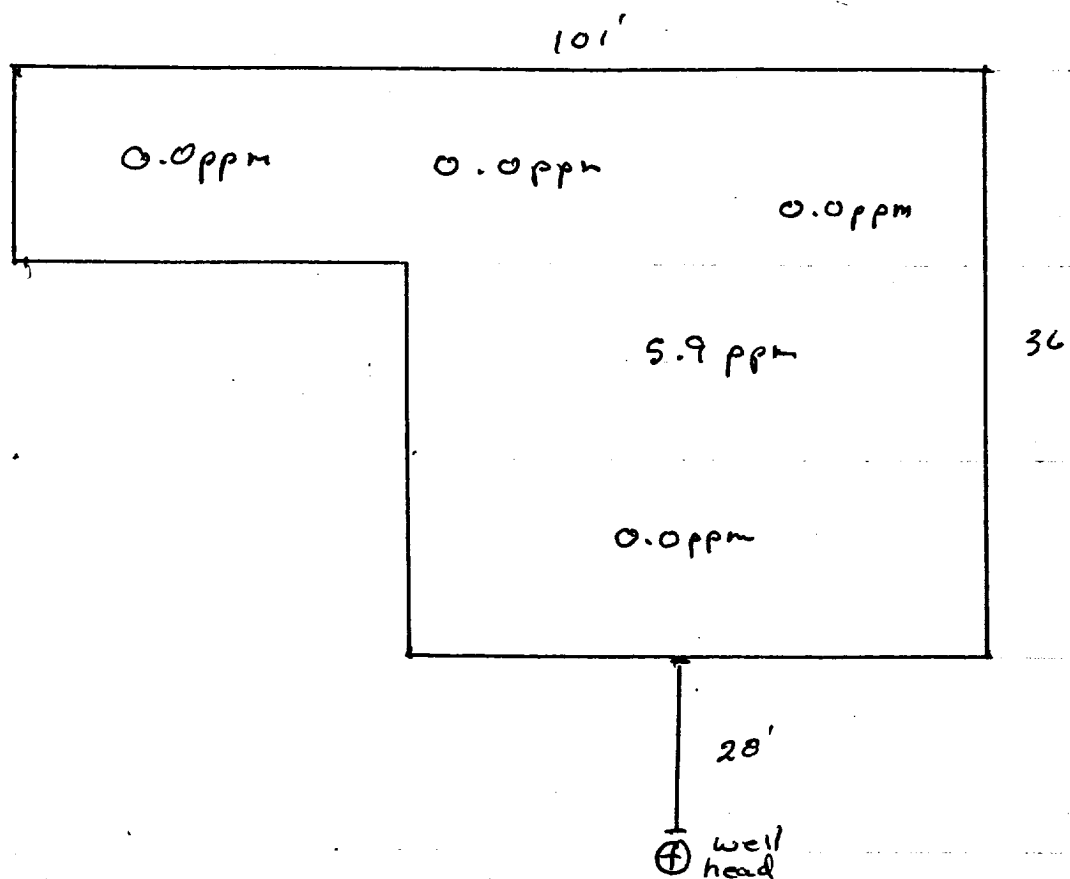
# Landfarm Drawing

App 100 cu. yds

2" to 12" Depth  
Headspace 23.0 ppm  
Sample # 9907130920

Not to Scale
