CLOSURE PROPOSAL

SS LINE 20"

DEFS REF: 130012

LEA COUNTY, NEW MEXICO

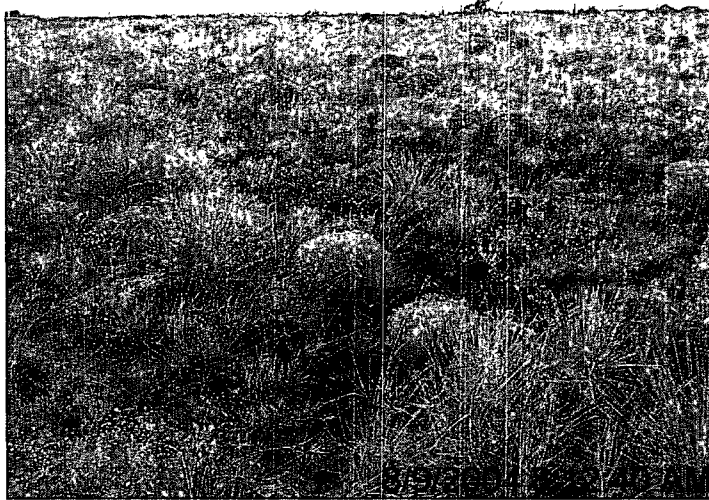
Photo #1: Release area, looking easterly along the pipeline.
Notice soil staining in center of photo.

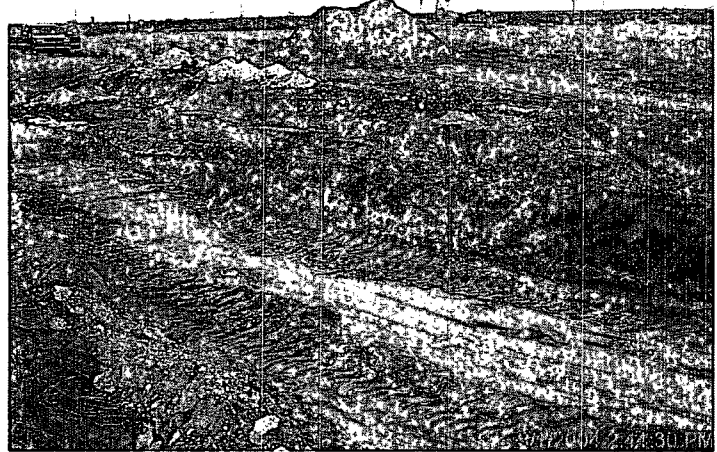
Photo #2: Initial excavation activity, looking northerly.

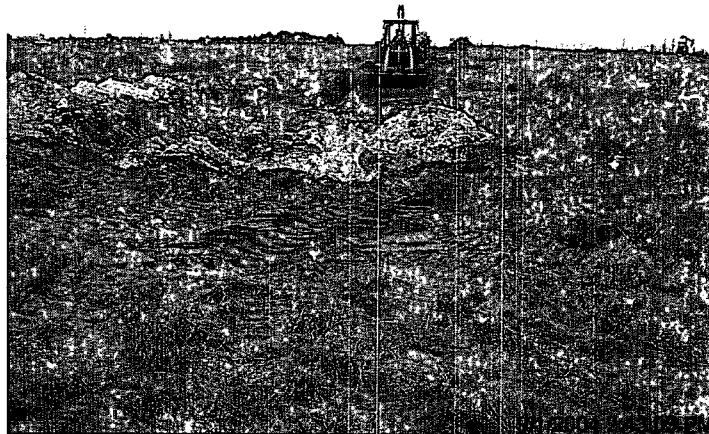
Photo #3: Initial excavation activities, looking northerly.

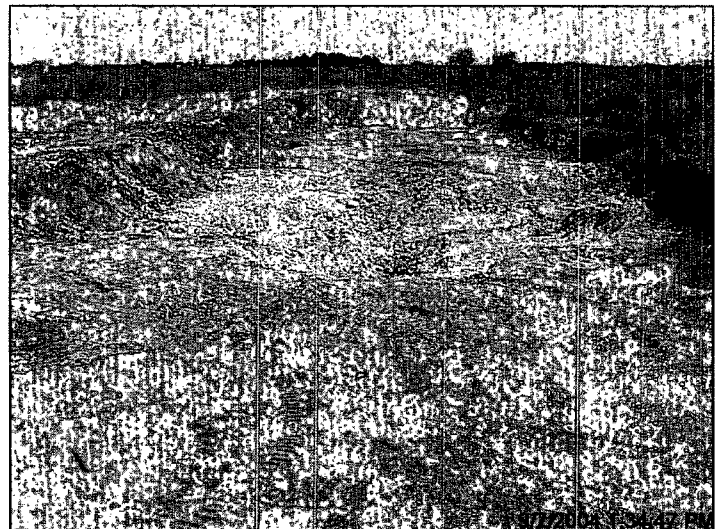
Photo #4: Initial excavation, looking easterly.

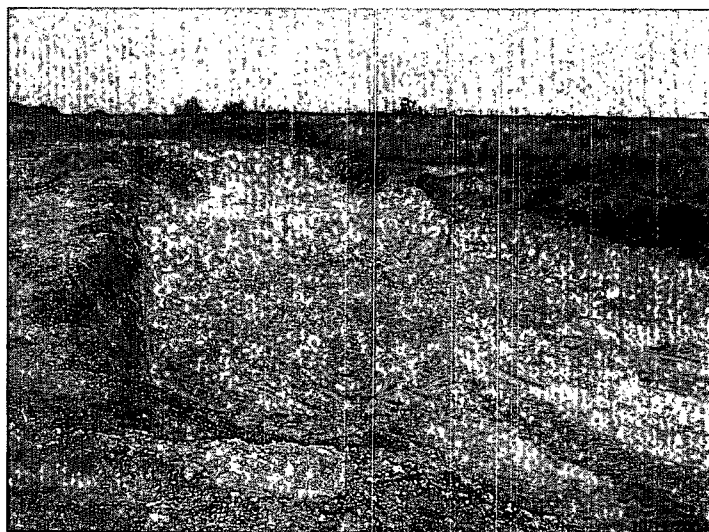
Photo #5: Initial excavation, looking northerly.
