**SITE CHARACTERIZATION
AND
CLOSURE PROPOSAL**

STATE C-20 BATTERY RELEASE SITE

(REF. #150006)

~8 MILES WEST-NORTHWEST OF EUNICE, LEA COUNTY, NEW MEXICO

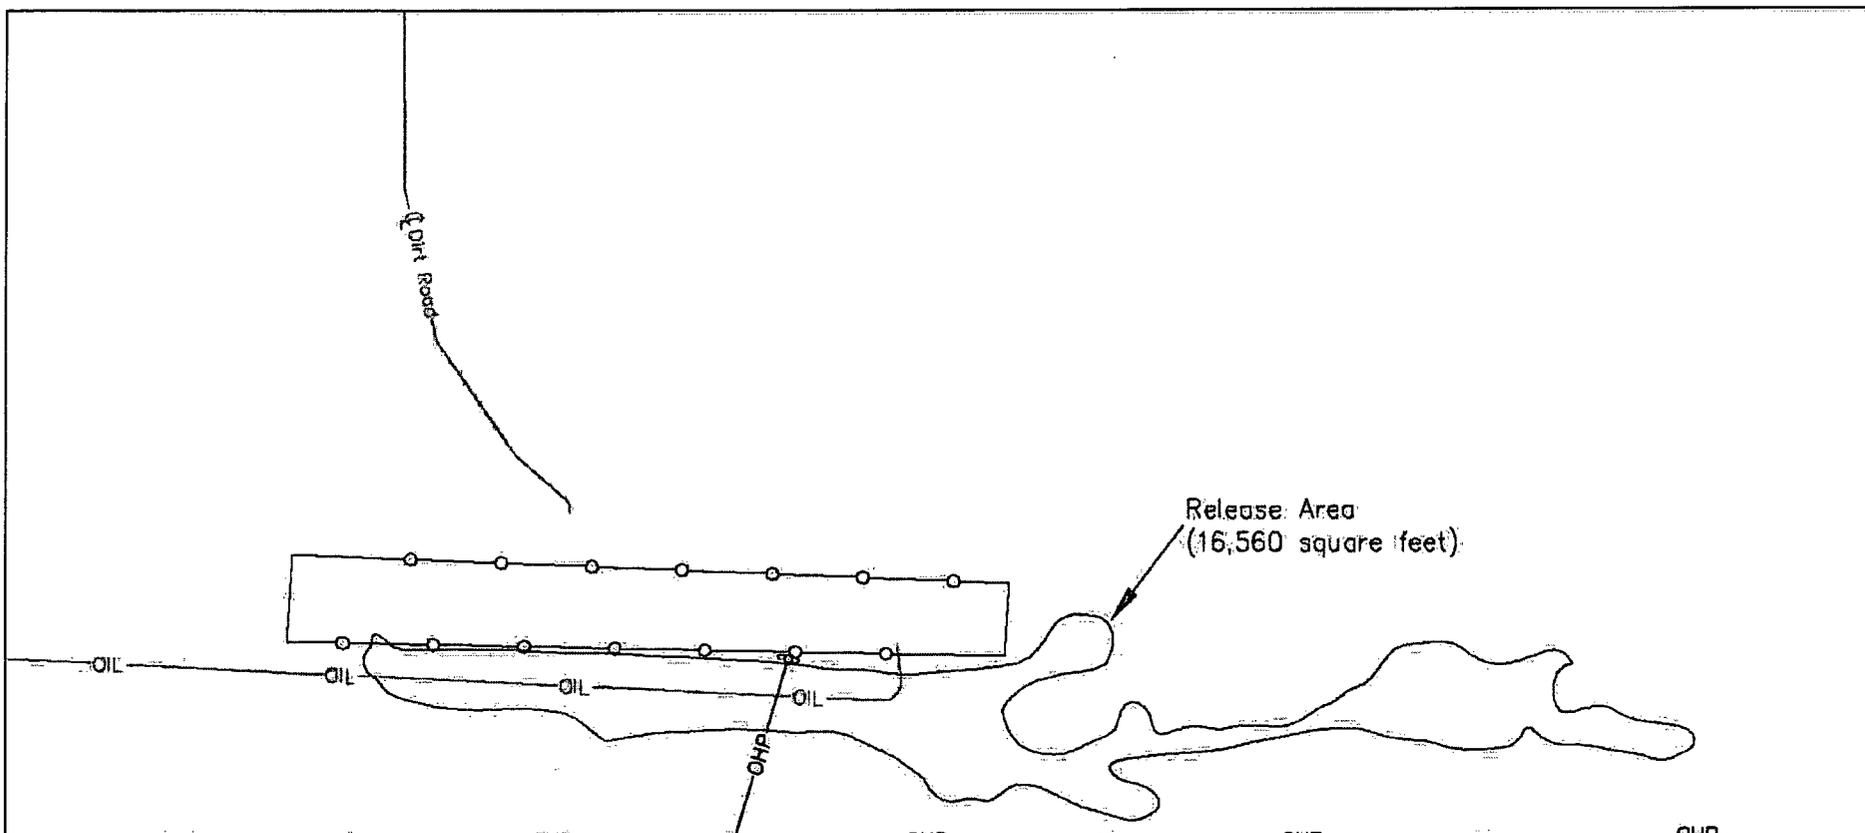
Figure 3
 Site Map
 Conoco Phillips
 State C-20 Battery

This report addresses the site investigation and remedial activities of the ConocoPhillips State C-20 Battery release site. On September 27, 2004, a release of approximately 32 barrels of production fluid occurred as a result of the loss of electrical power. ConocoPhillips recovered approximately 30 barrels, and utilized a backhoe to back drag the release area to soak up the remaining fluid. This site is located approximately 8 miles East-Northeast of Eunice, Lea County, New Mexico (reference *Figure 1*). Environmental Plus, Inc. (EPI) was retained by ConocoPhillips in October 2004 to delineate the site and remediate soil impacted above New Mexico Oil Conservation Division (NMOCD) remedial thresholds. EPI performed GPS surveying, photography and characterization of the site on October 29, 2004. The initial site consisted of an approximate 16,650 square feet (ft²) visibly affected surface area (reference *Figure 3*).

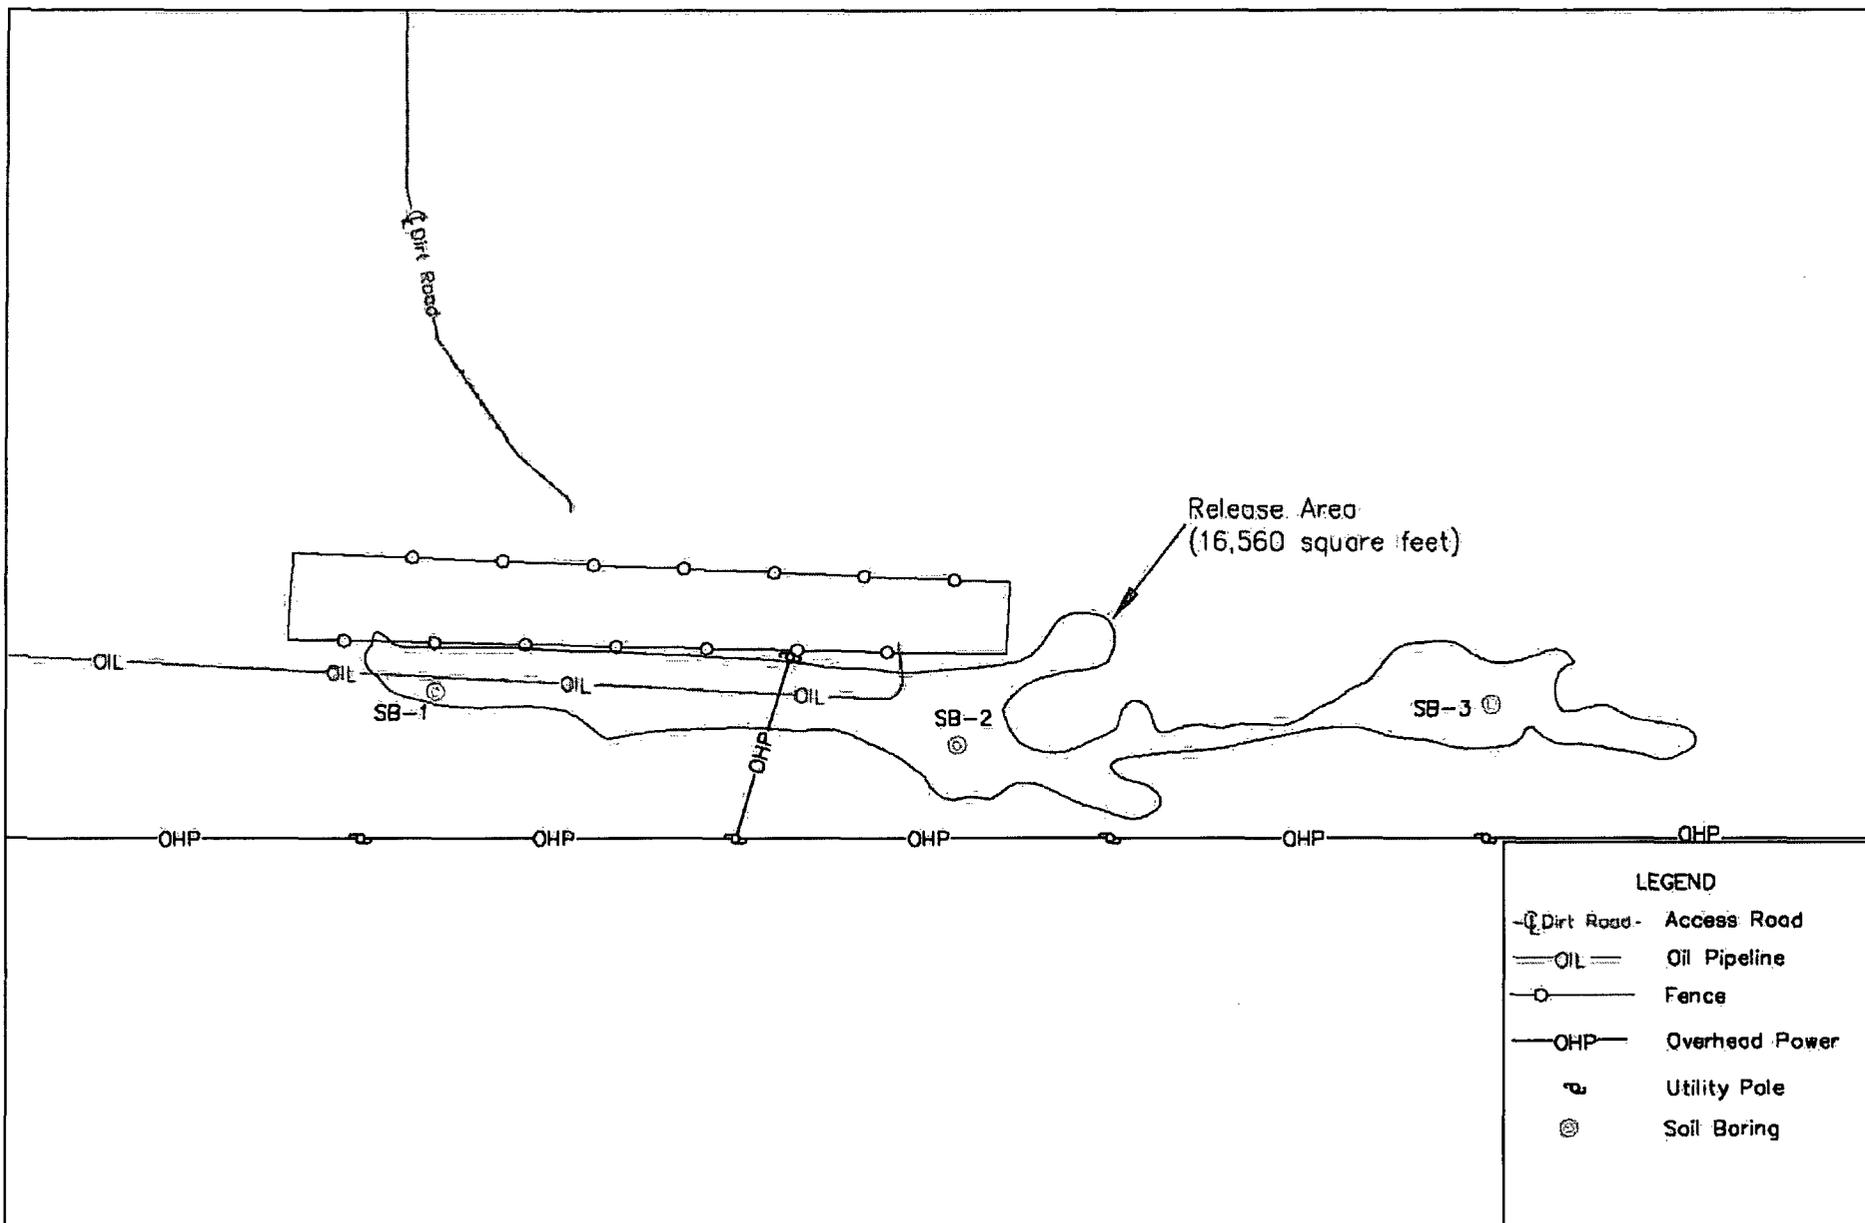
Figure 4
Soil Boring Location Map
Conoco Phillips
State C-20 Battery

To delineate the vertical extent of contamination, three soil borings were advanced on November 23, 2004 within the perimeter of the release area. During the advancement of the soil borings, samples were collected at five-foot intervals. A portion of each sample was placed in a self sealing polyethylene bag and set in a heated environment (i.e., truck cabin) to allow for volatilization of organic vapors. After the samples had been allowed to equilibrate to $\approx 70^{\circ}$ F, they were analyzed in the field for the presence of organic vapors utilizing a UltraRae Photoionization Detector (PID) equipped with a 9.8 electron-volt (eV) lamp. The remaining portion of each sample was placed in a laboratory provided container, set on ice for transport and submitted for laboratory quantification of total petroleum hydrocarbons (TPH) and benzene, toluene, ethylbenzene, and total xylenes (BTEX). Analytical results indicated that impacted soil was limited within five-feet below ground surface (bgs).

The vertical extent of hydrocarbon contamination at the site was determined with the advancement of three soil borings on November 23, 2004 within the perimeter of the release area. Soil borings were advanced to a maximum depth of ten-feet bgs with samples collected at five-foot intervals. A portion of each sample was analyzed in the field utilizing an UltraRae PID equipped with a 9.8 eV lamp. Field analyses indicated soil organic vapor concentrations ranged from 0.0 to 61.4 ppm. The remaining portion of each sample was submitted for laboratory quantification of TPH, and BTEX concentrations. Lateral extents of hydrocarbon impacts were determined visually as the excavation progressed, with confirmatory samples collected upon the completion of excavation activities.

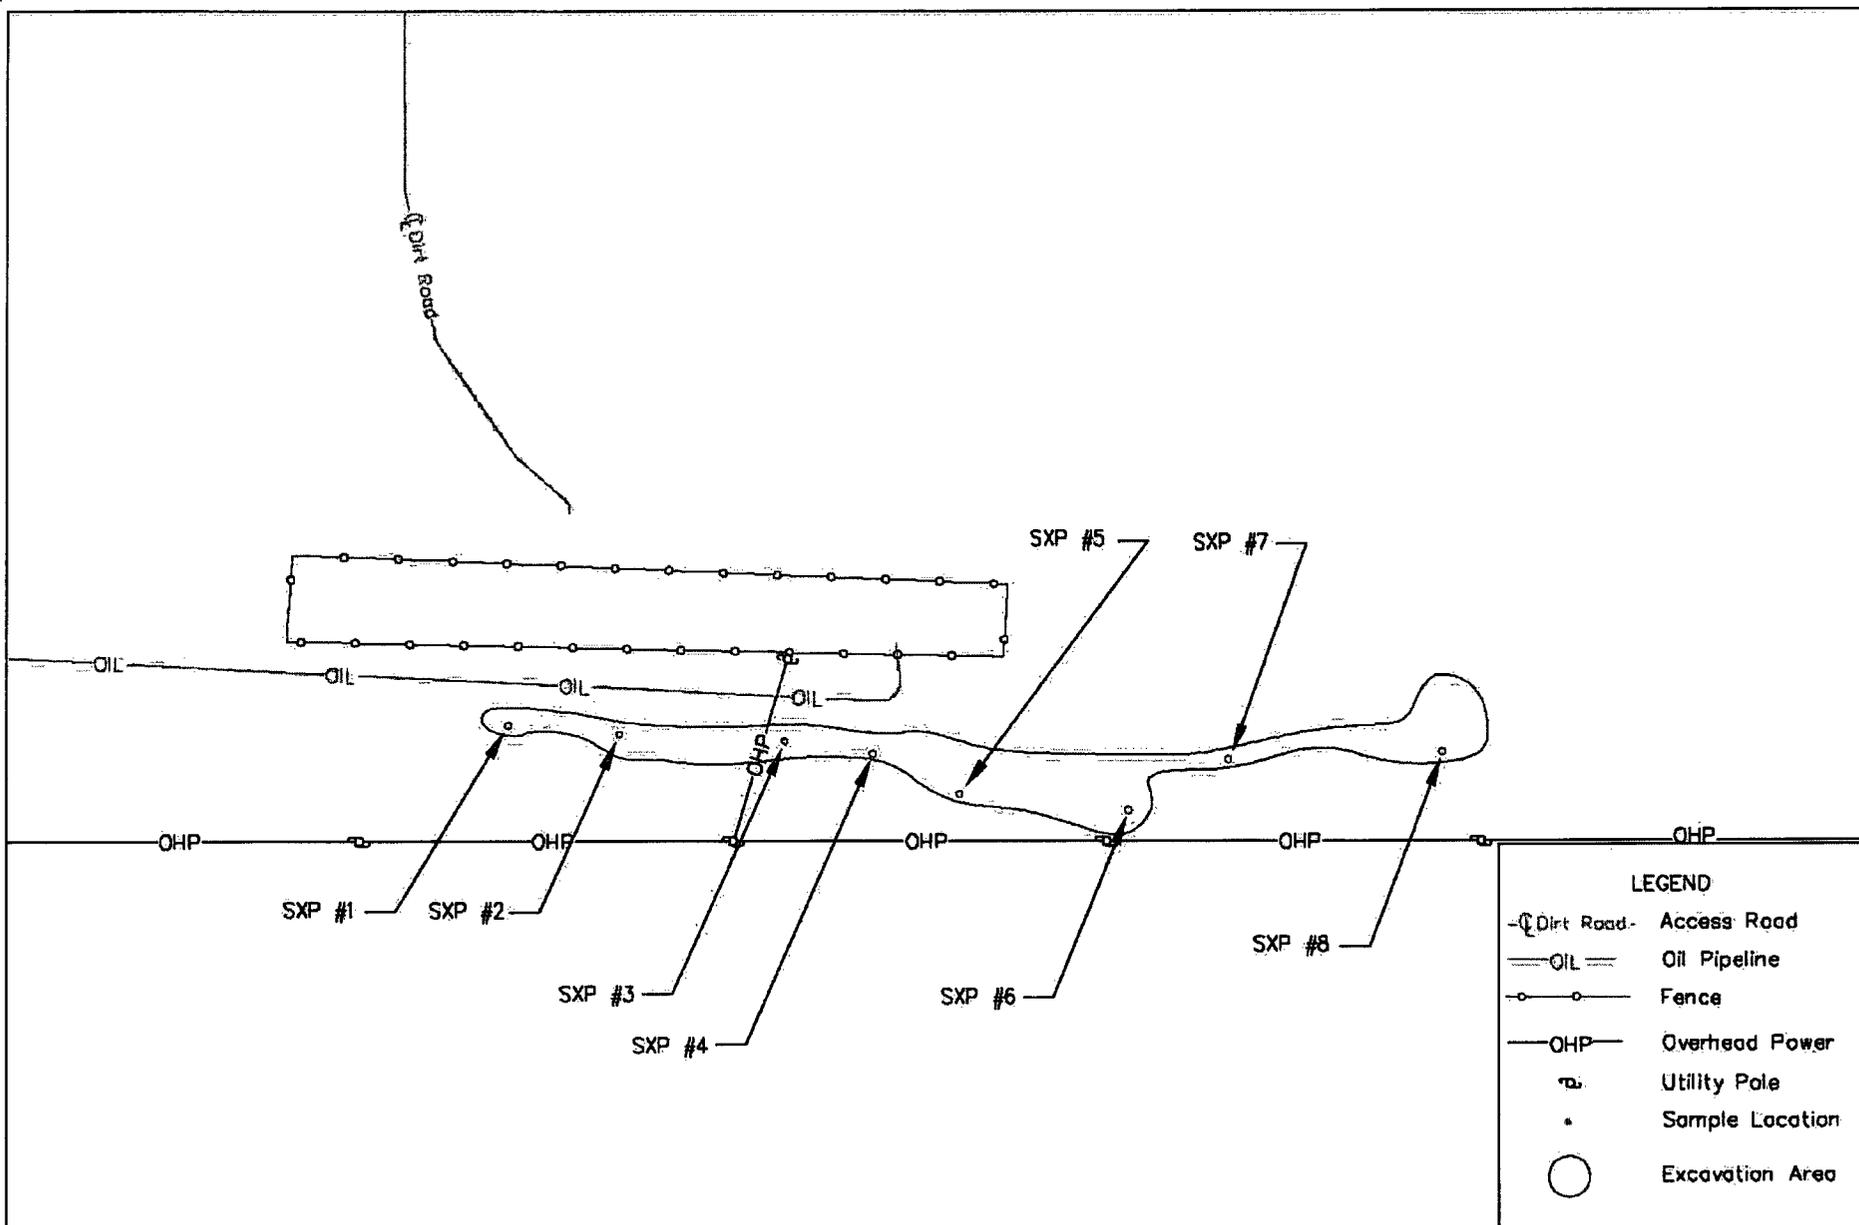
Figure 5
 Sample Location Map
 Conoco Phillips
 State C-20 Battery

Upon excavation of soil to previously delineated extents, confirmatory composite soil samples were collected from the excavation on May 23, 2005 and analyzed in the field to verify remedial limits had been achieved. Organic vapor concentrations ranged from 2.3 to 156 ppm with an average concentration of 46 ppm (*reference Table 2*). In addition, samples were submitted to an independent laboratory for quantification of TPH, BTEX constituents, and chloride concentrations. Analytical results indicated excavation hydrocarbon concentrations for all analytes were below the NMOCD remedial thresholds for all samples. Chloride concentrations ranged from 48 to 160 mg/Kg, with an average of 110 mg/Kg (*reference Table 2*).

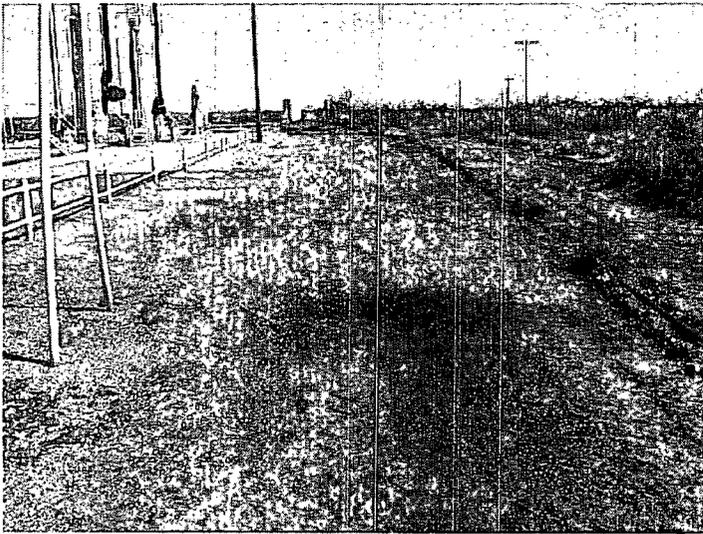
Photo #1: Release area, looking easterly. Dark stained soil indicates contamination.

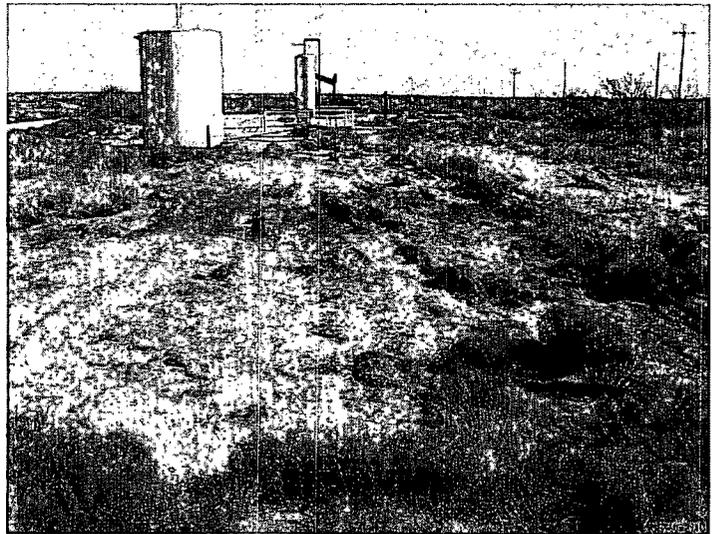
Photo #2: Release area, looking easterly. Notice soil staining in central portion of the photograph.

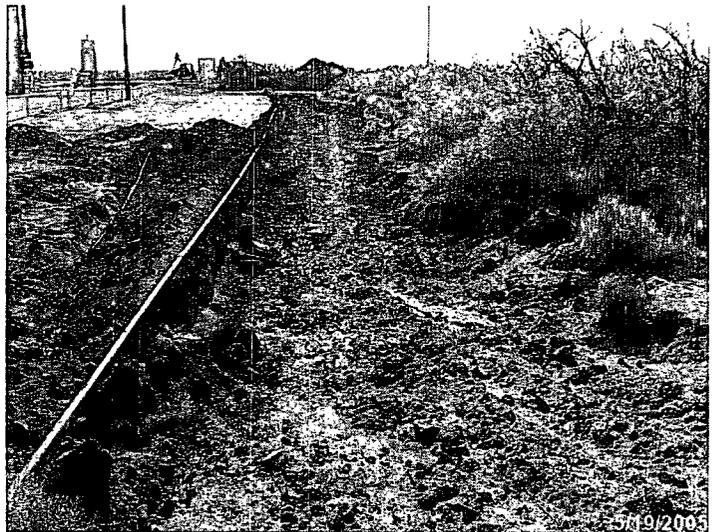
Photo #4: Excavation, looking easterly.

Remediation of the site commenced on April 29, 2004 and continued through May 23, 2004. Remedial activities at the site consisted of excavation of approximately 1,200 yd³ of contaminated soil from the site. Approximately 140 yd³ of impacted soil was transported to J&L Land Farm for treatment. The remaining contaminated soil was blended with clean soil purchased from the State of New Mexico and obtained from State Pit number 562 to below NMOCD remedial thresholds. Laboratory analyses of samples CPSC20BSSPC, CPSC20BNSPC and CPSC20BNSP-1-4 confirmed blending activities had achieved NMOCD remedial goals (*reference Table 2 and Appendix 1*). Field and laboratory analyses of soil samples obtained from the excavation on May 23, 2005 indicated that all remedial goals had been achieved.

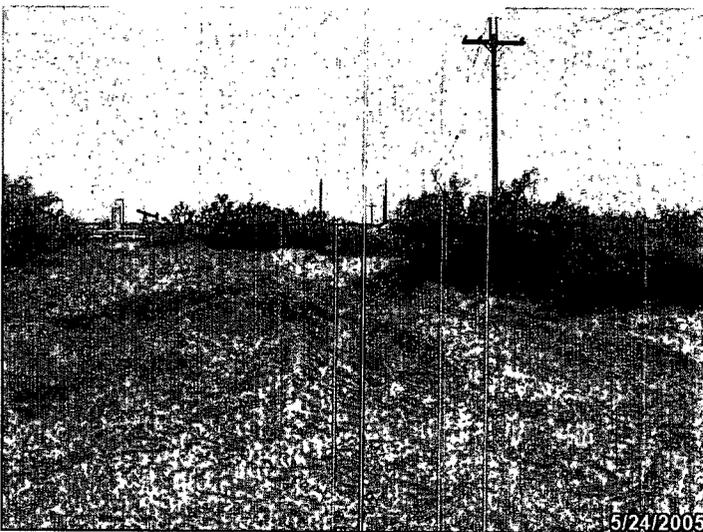
Photo #5: Current status of excavation, looking easterly.

This report documents successful treatment of impacted soil above the remedial thresholds discussed in Section 3 above and confirmed via laboratory analyses for this release site. The impacted soil was excavated with a portion transported to a land farm for treatment; the remaining impacted soil was blended with clean soil to achieve NMOCD remedial goals. Based on the data presented in this report, Environmental Plus, Inc. recommends the excavation be backfilled with the remediated/blended soil, contoured and graded to allow natural drainage and seeded with a native range type grass.
