REMEDIATION SUMMARY & SITE CLOSURE REQUEST

SOUTHERN UNION GAS SERVICES

TRUNK "O" #4 (1RP-1510)

NMOCD Reference # 1RP-1510

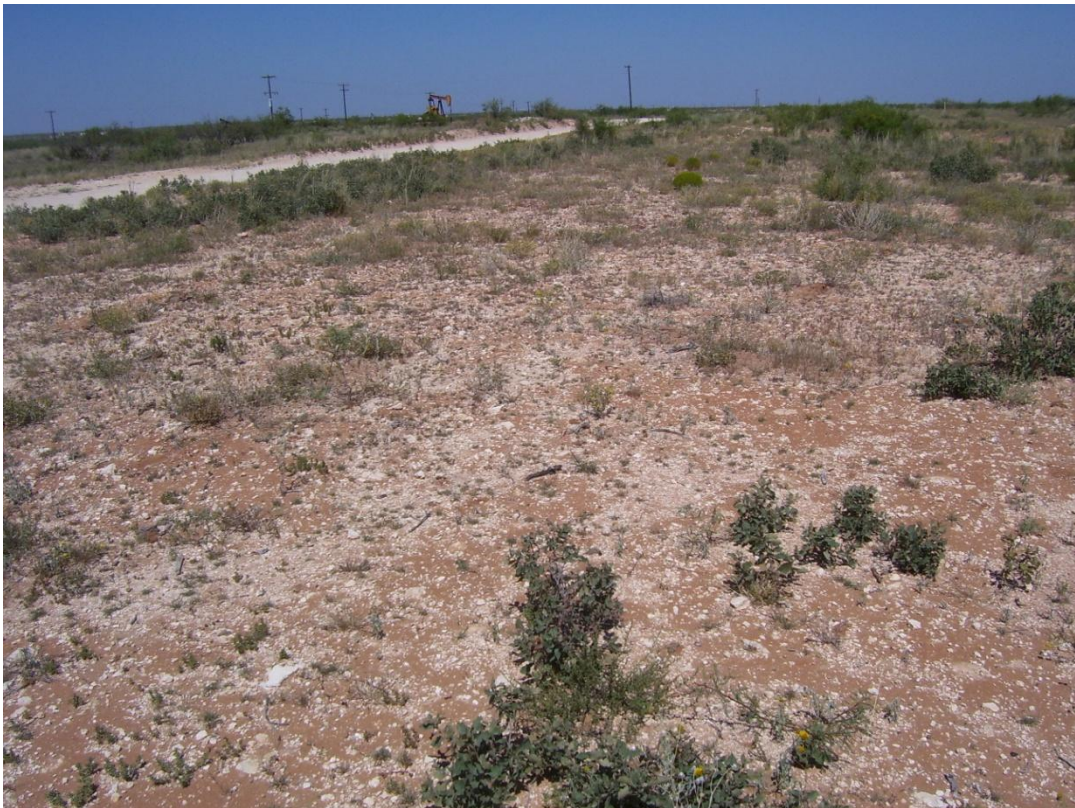
Photograph of the disturbed area at the Trunk "O" #4 Historical Release Site.

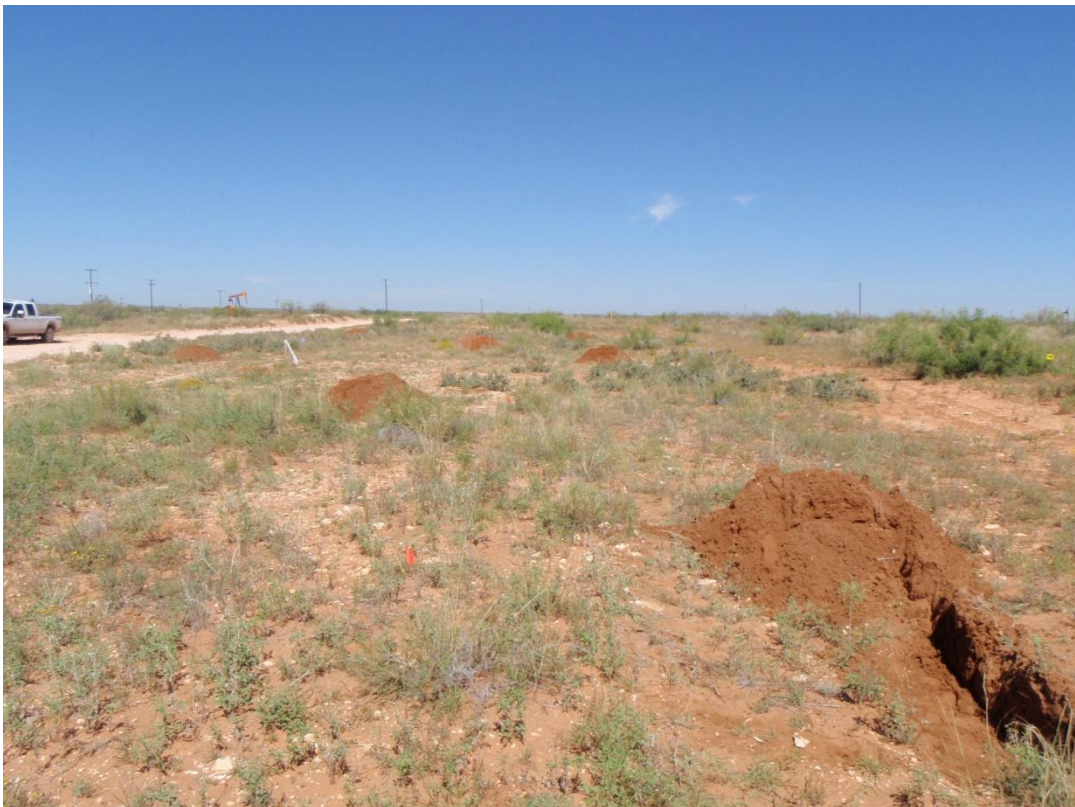
Photograph of delineation activities at the Trunk "O" #4 Historical Release Site.

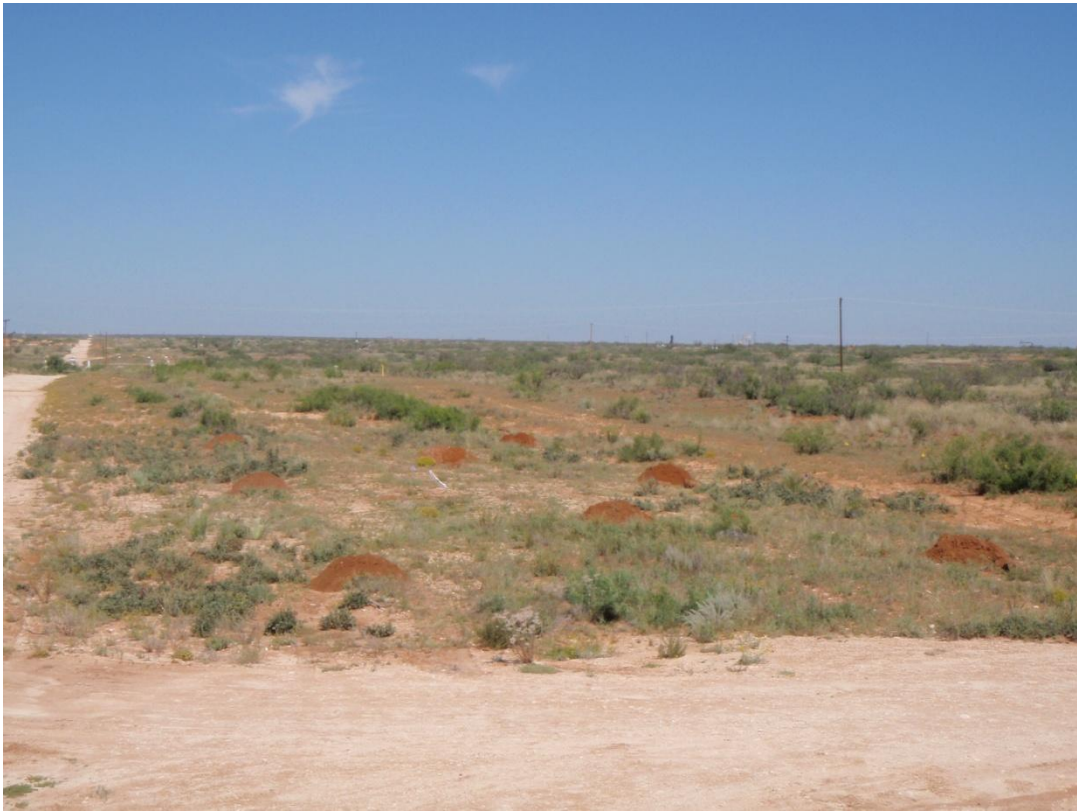
Photograph of the eight (8) Test Trenches advanced at the Trunk "O" #4 Historical Release Site.

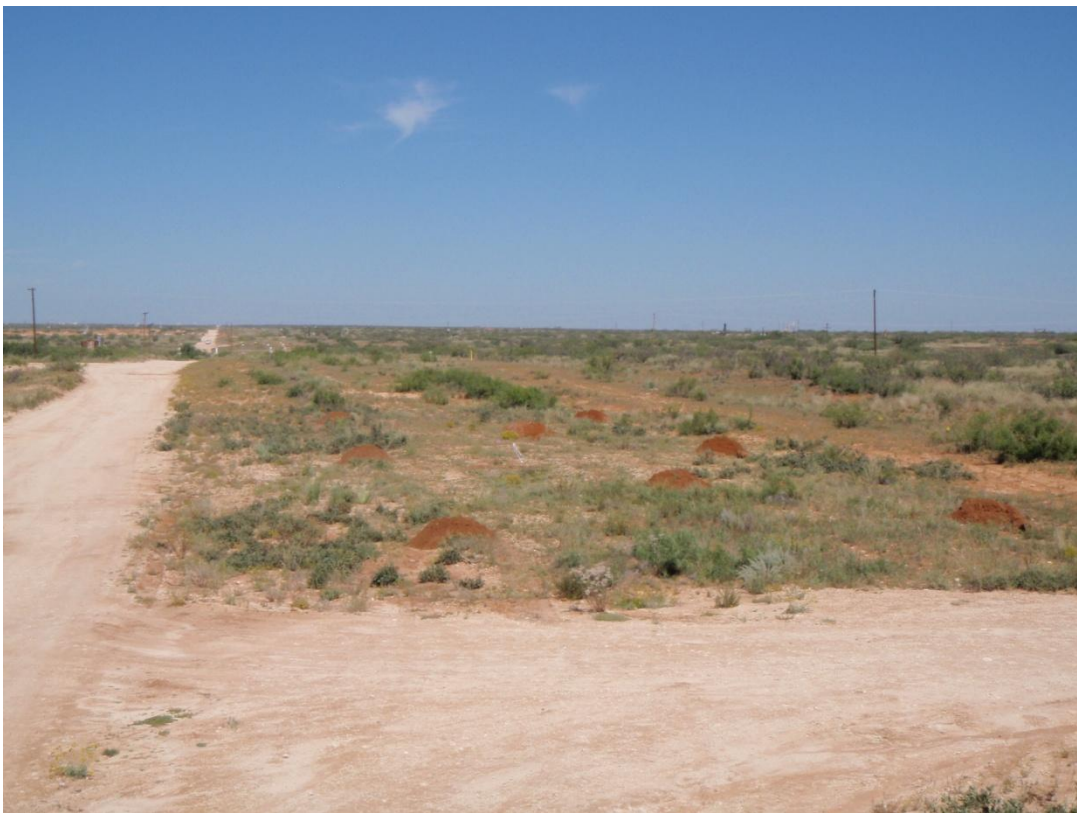
Photograph of the eight (8) Test Trenches advanced at the Trunk "O" #4 Historical Release Site.
