REMEDIATION SUMMARY & SITE CLOSURE REQUEST

**SOUTHERN UNION GAS SERVICES
MA-DOOM**

Lea County, New Mexico

NMOCD Reference # 1RP-2899

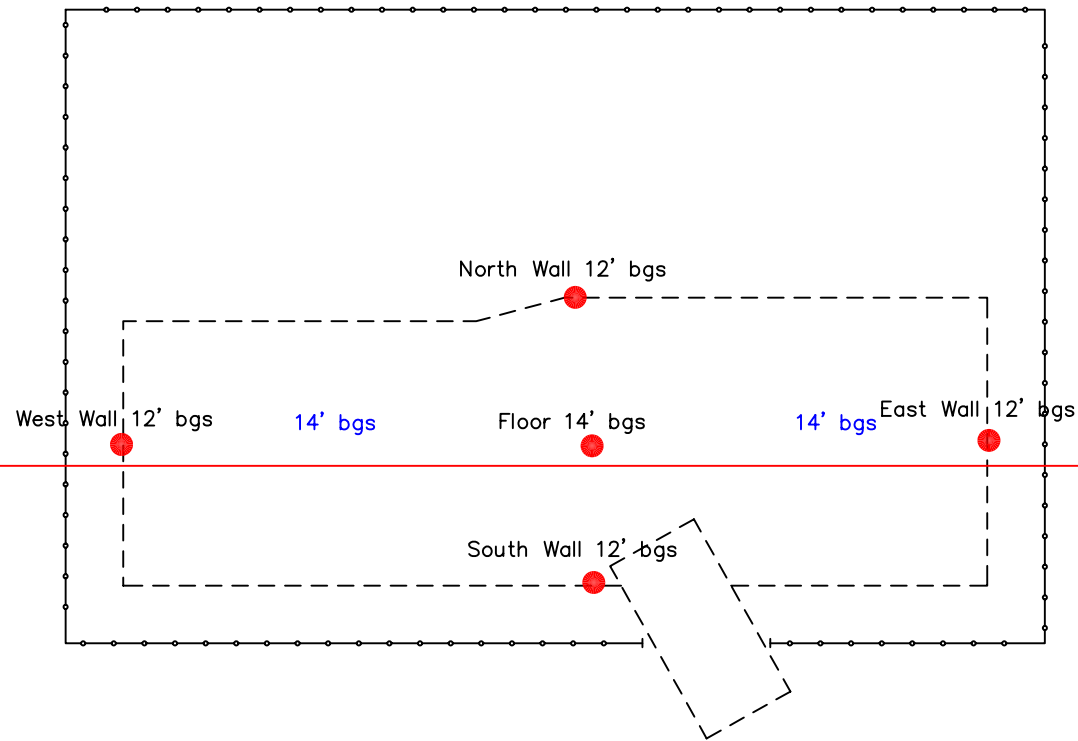
- Sample Location
- Fence
- - - Excavation Extent
- Pipeline

On December 4, 2012, Basin began delineation activities at the release site. A test trench was advanced within the stained area to approximately three feet (3') bgs. During the advancement of the test trench, two soil samples (SP#1 @ Surface and SP#1 @ 3') were collected and submitted to Xenco Laboratories Inc., of Odessa, Texas, for analysis of TPH and chloride concentrations in accordance with EPA Methods SW 846-8015M and 300.1, respectively. Laboratory analytical results indicated TPH concentrations ranged 1,060 mg/Kg for soil sample SP#1 @ 3' to 16,300 mg/Kg for soil sample SP#1 @ Surface. Analytical results indicated chloride concentrations ranged from 165 mg/Kg for soil sample SP#1 @ 3' to 672 mg/Kg in soil SP#1 @ Surface. Table 1 summarizes the "Concentrations of Benzene, BTEX, TPH & Chloride in Soil". Soil sample locations are depicted in Figure 2, "Site & Sample Location Map". Laboratory analytical reports are provided as Appendix B.

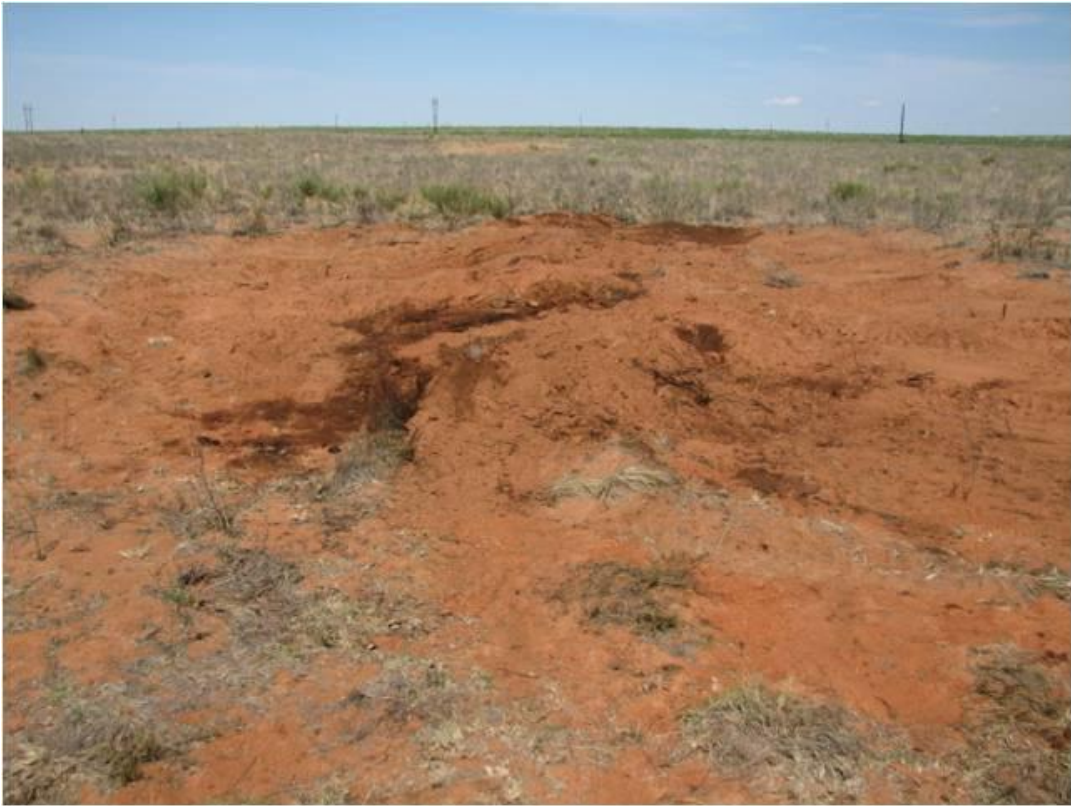
Photograph of the initial release at the MA-Doom Historical Release Site.

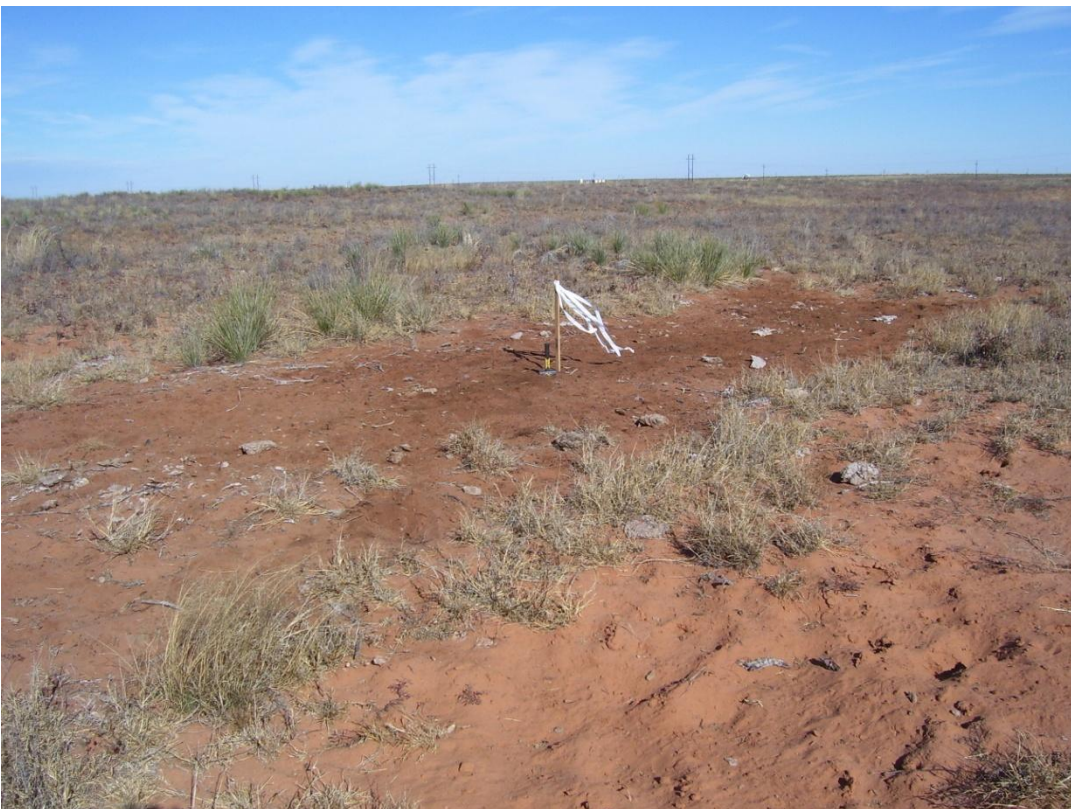
Photograph of the initial release at the MA-Doom Historical Release Site.

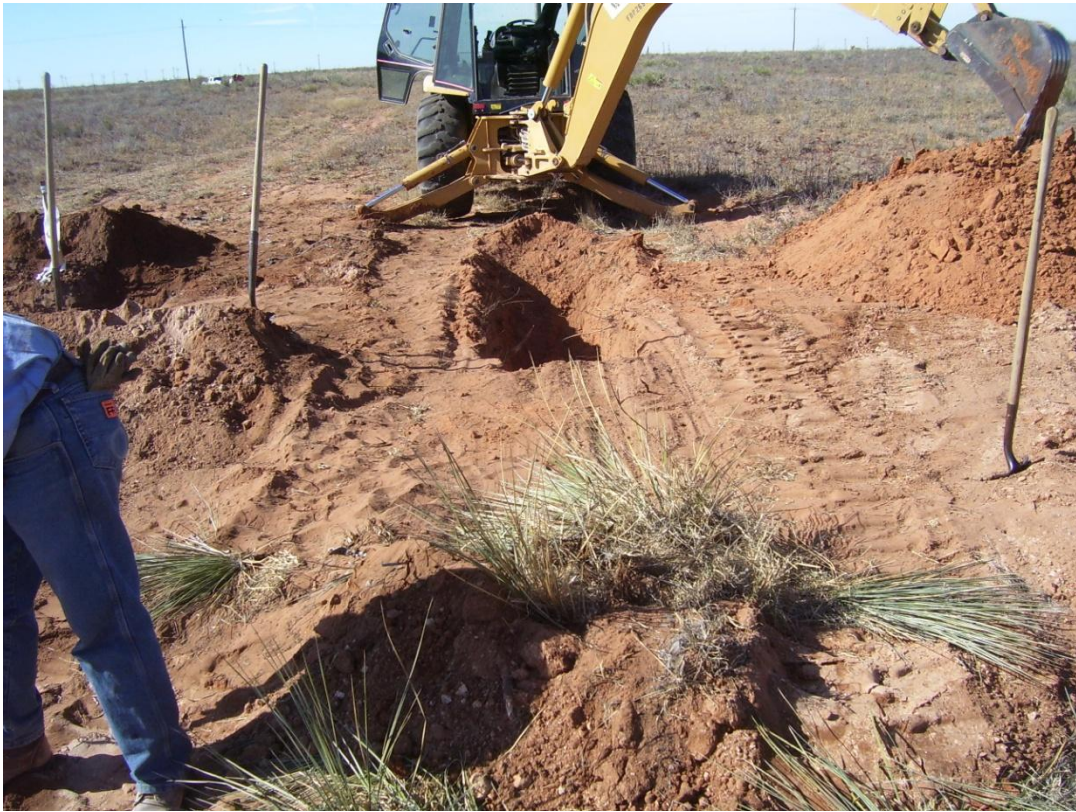
Photograph of delineation activities at the MA-Doom Historical Release Site.

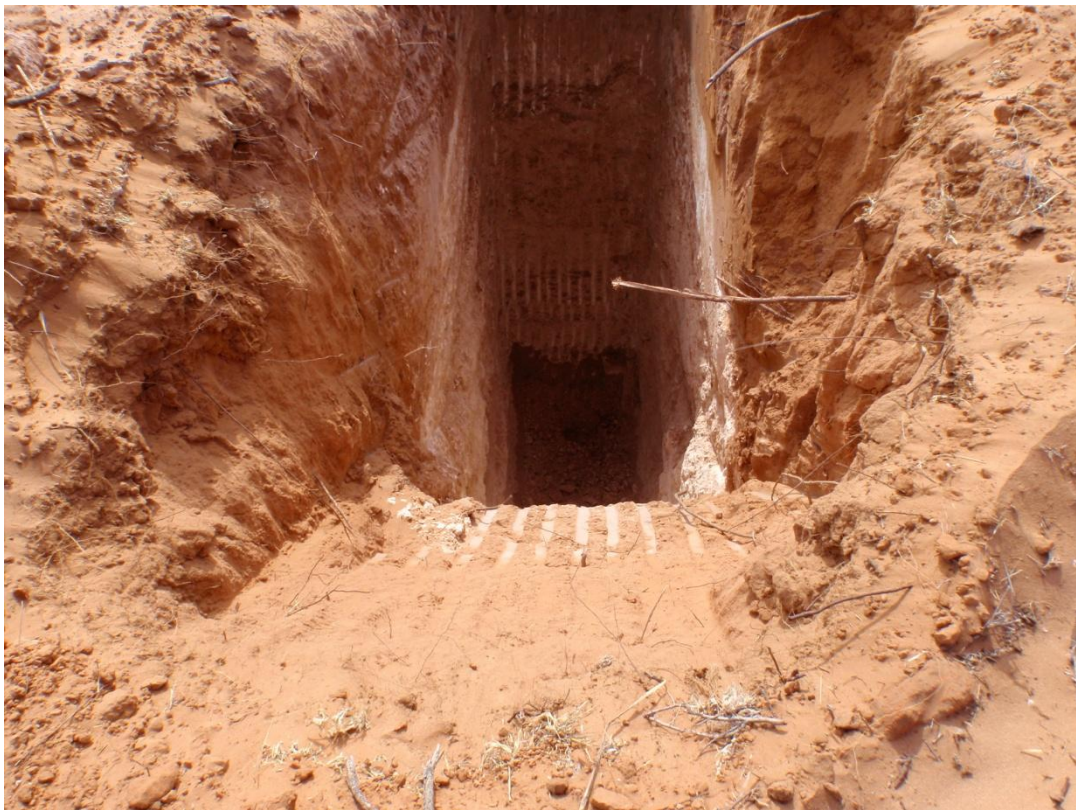
Photograph of delineation activities at the MA-Doom Historical Release Site.

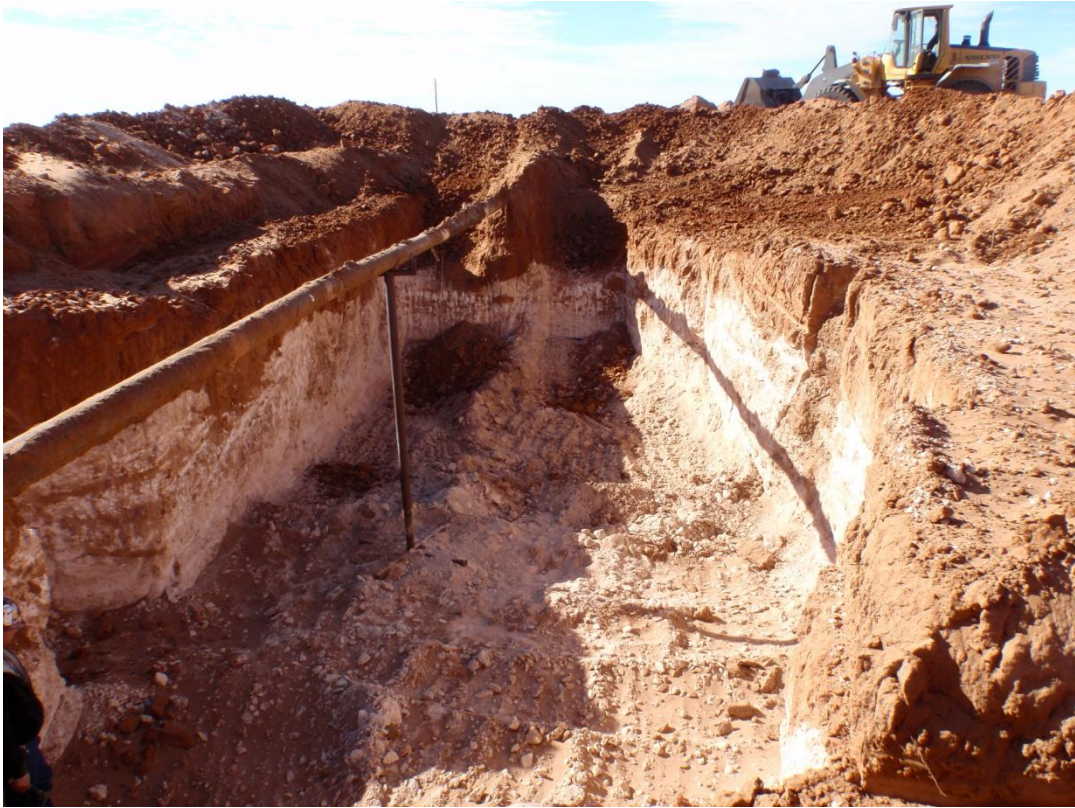
Photograph of the MA-Doom Historical Release Site excavation.

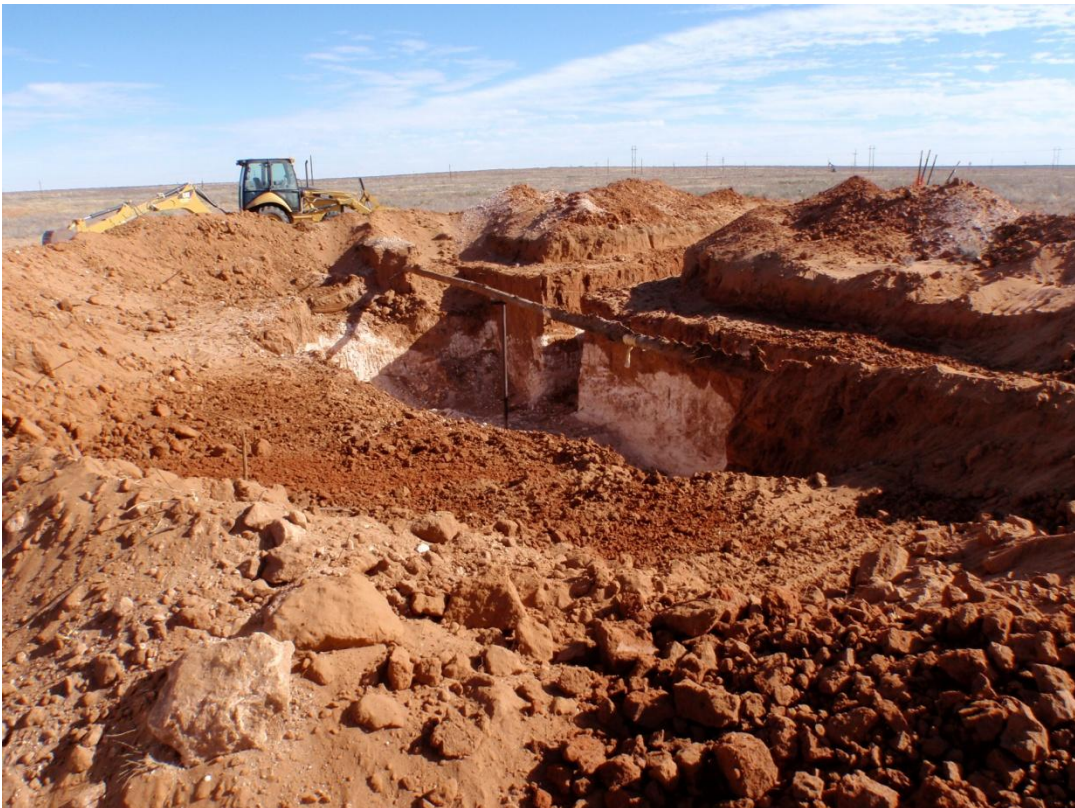
Photograph of the MA-Doom Historical Release Site excavation.

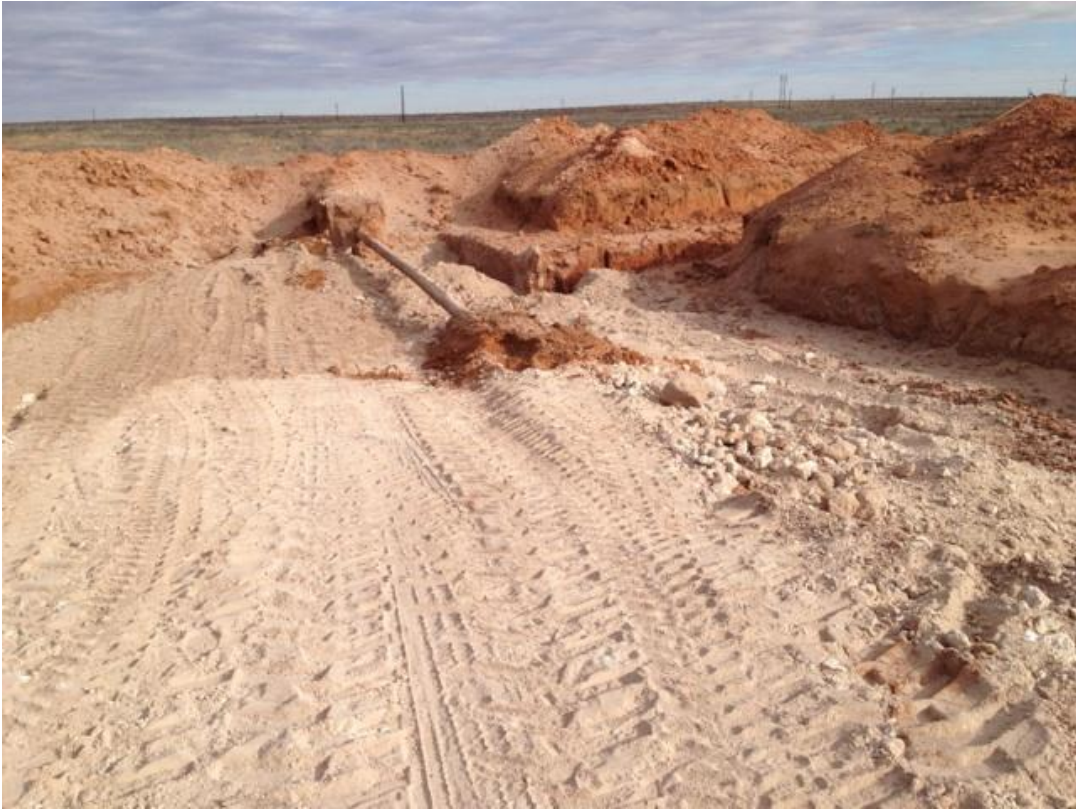
Photograph of backfilling activities at the MA-Doom Historical Release Site.

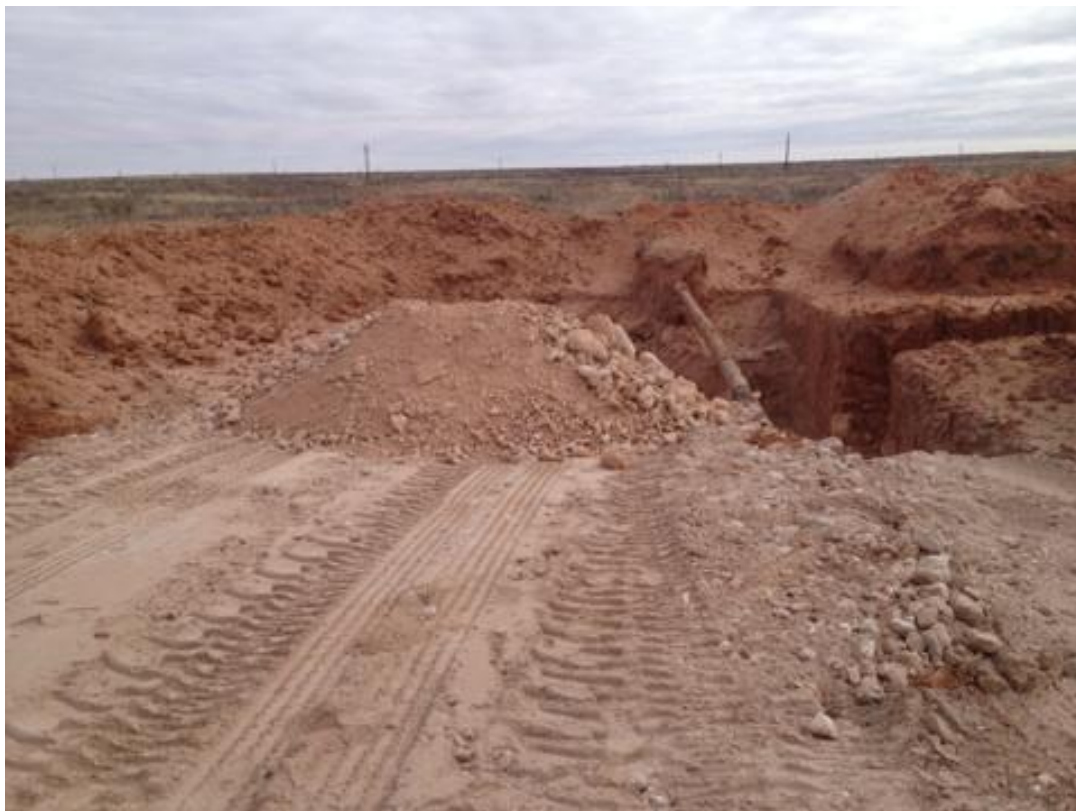
Photograph of backfilling activities at the MA-Doom Historical Release Site.

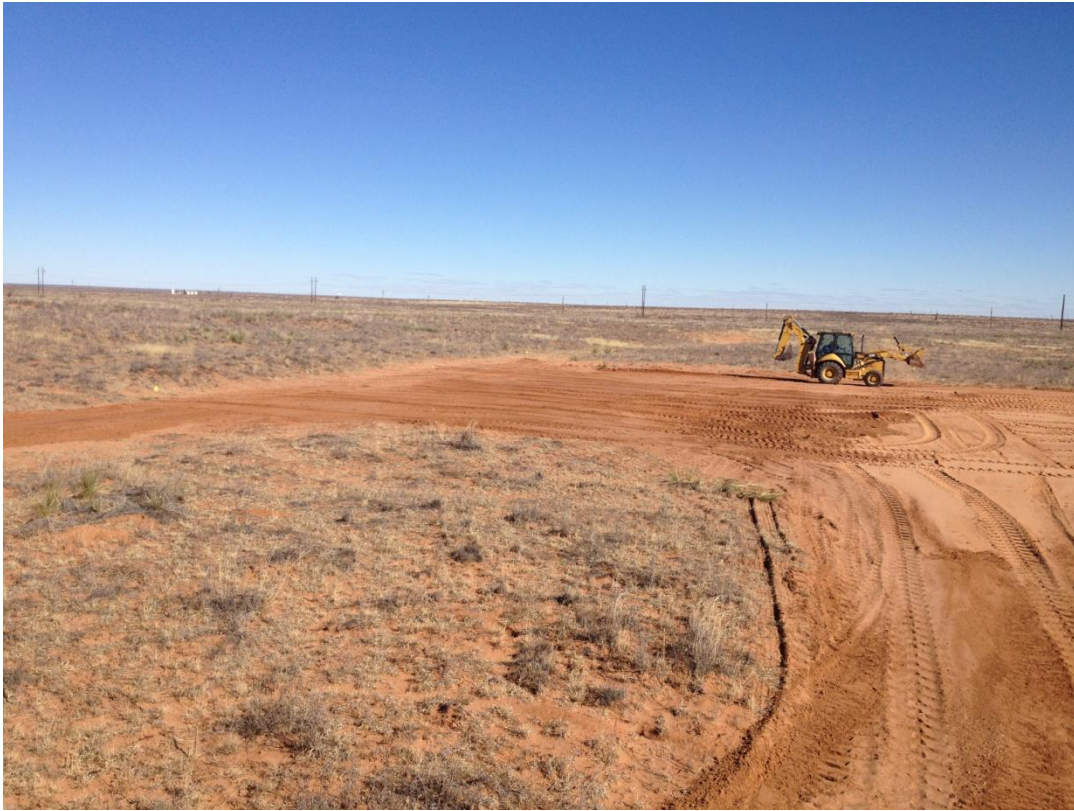
Photograph of the MA-Doom Historical Release Site after being backfilled.

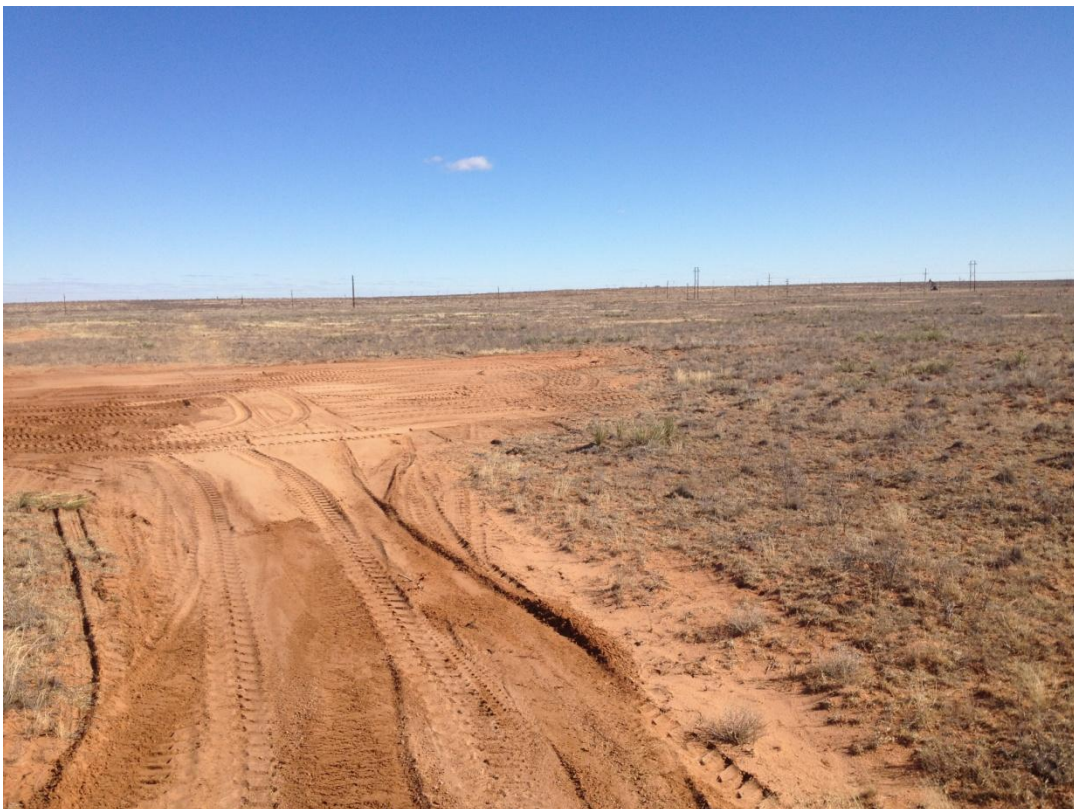
Photograph of the MA-Doom Historical Release Site after being backfilled.
