Termination Request

**RE: Termination Request
ConocoPhillips MCA #126 (1RP-3542)
UL/A sec. 26 T17S R32E
API No. 30-025-12709**

CONOCOPHILLIPS MCA #126

1RP-3542

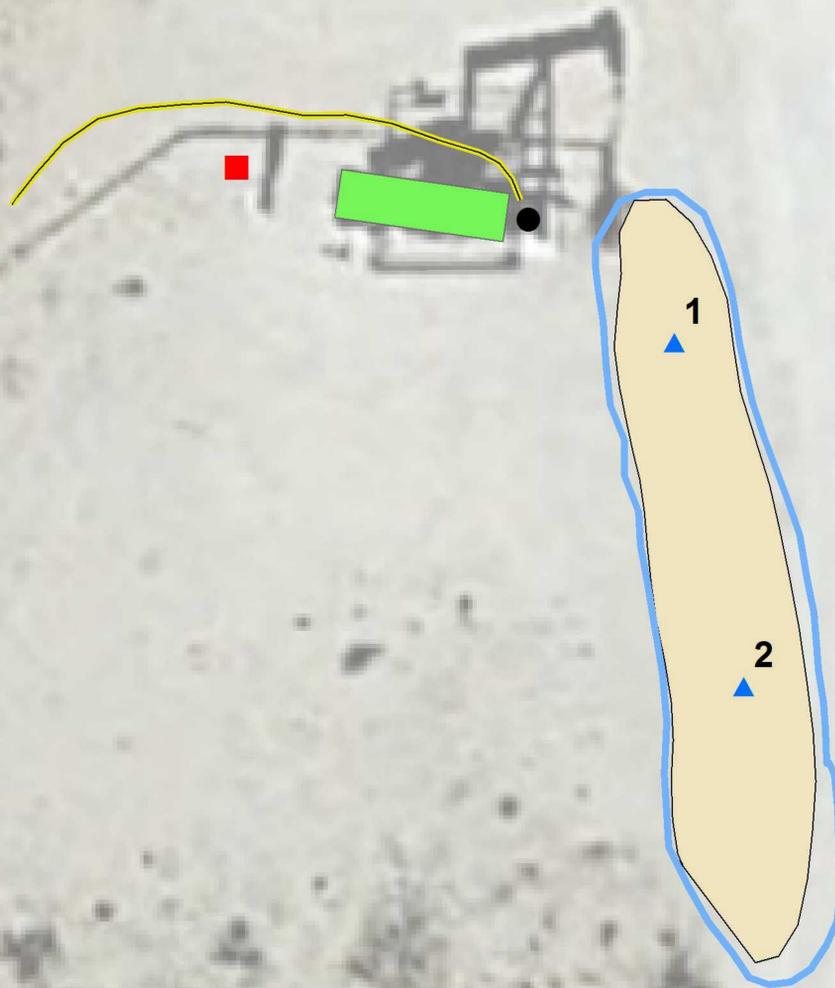
Figure 1

On December 16th, 2015, Basin personnel were on site to assess the release. The release was mapped and photographed. Two points within the release area were sampled with depth (Figure 1). All samples were field tested for chlorides and organic vapors, and representative samples were taken to a commercial laboratory for analysis (Appendix B). Laboratory analysis for Point 1 returned a chloride concentration of 144 mg/kg at 6 in bgs. Gasoline Range Organics (GRO) returned a value of non-detect, and Diesel Range Organics (DRO) returned an elevated value of 833 mg/kg. Benzene, Toluene, Ethylbenzene and Xylene (BTEX) all returned values of non-detect. Laboratory analysis of Point 2 revealed chloride values of 528 mg/kg at 6 in bgs and 176 mg/kg at 1 ft, GRO values of non-detect at the surface and at 6 in and 1 ft bgs, and DRO values of 528 mg/kg at 6 in bgs and 131 mg/kg at 1 ft bgs. BTEX values at both depths were non-detect.

Initial Sampling

Vertical 1									
Depth	Cl-	PID	GRO	DRO	B	T	E	X	TOTAL
SS	852	4.5							
6"	144	29.2	<10	833	<0.05	<0.05	<0.05	<0.15	<0.3

Vertical 2									
Depth	Cl-	PID	GRO	DRO	B	T	E	X	TOTAL
SS	409	2.1							
6"	528	2.8	<10	669	<0.05	<0.05	<0.05	<0.15	<0.3
1'	176	1.2	<10	131	<0.05	<0.05	<0.05	<0.15	<0.3

CAP activities began January 15th, 2016. The release area was scraped to 6 in bgs (Figure 1). A total of approximately 12 cubic yards of contaminated soil were exported and disposed of at a NMOCD approved facility. A total of 12 cubic yards of caliche were imported for backfill. A sample of the imported soil was taken and sent to a commercial laboratory for analysis. Laboratory analysis returned a chloride level of 32 mg/kg. The site was backfilled with the clean, imported caliche and contoured to the surrounding pad.

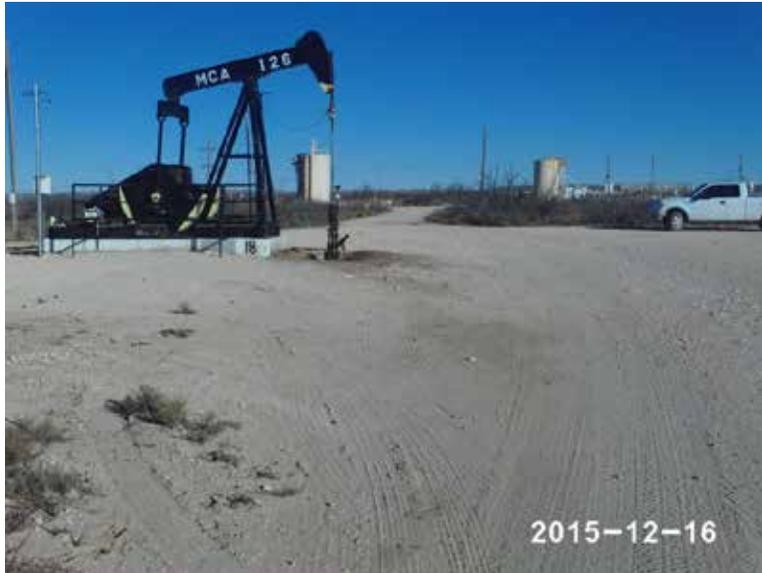
Initial release area, facing north

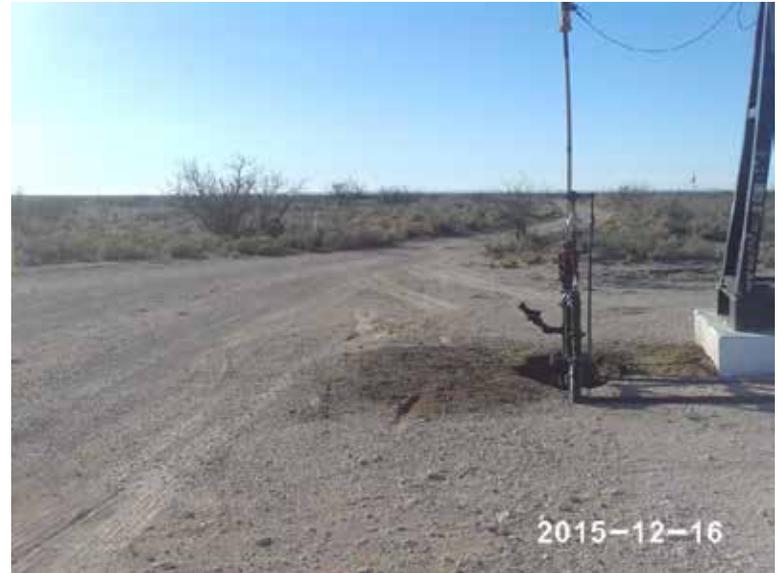
Initial release area, facing south

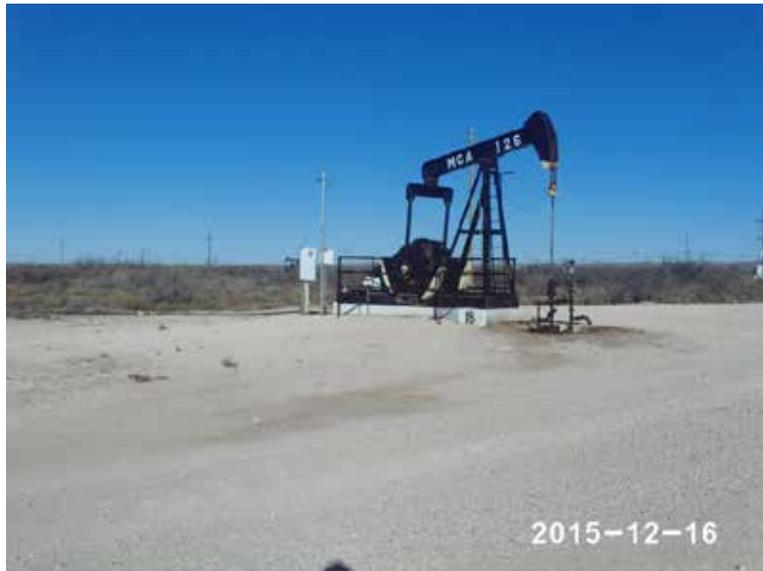
Initial release area, facing northwest
