## DELINEATION WORKPLAN

### CHEVRON – LOVINGTON PADDOCK UNIT (Leak Date: 12/25/16)

**RP # 1RP-4567  
API # 30-025-03833**

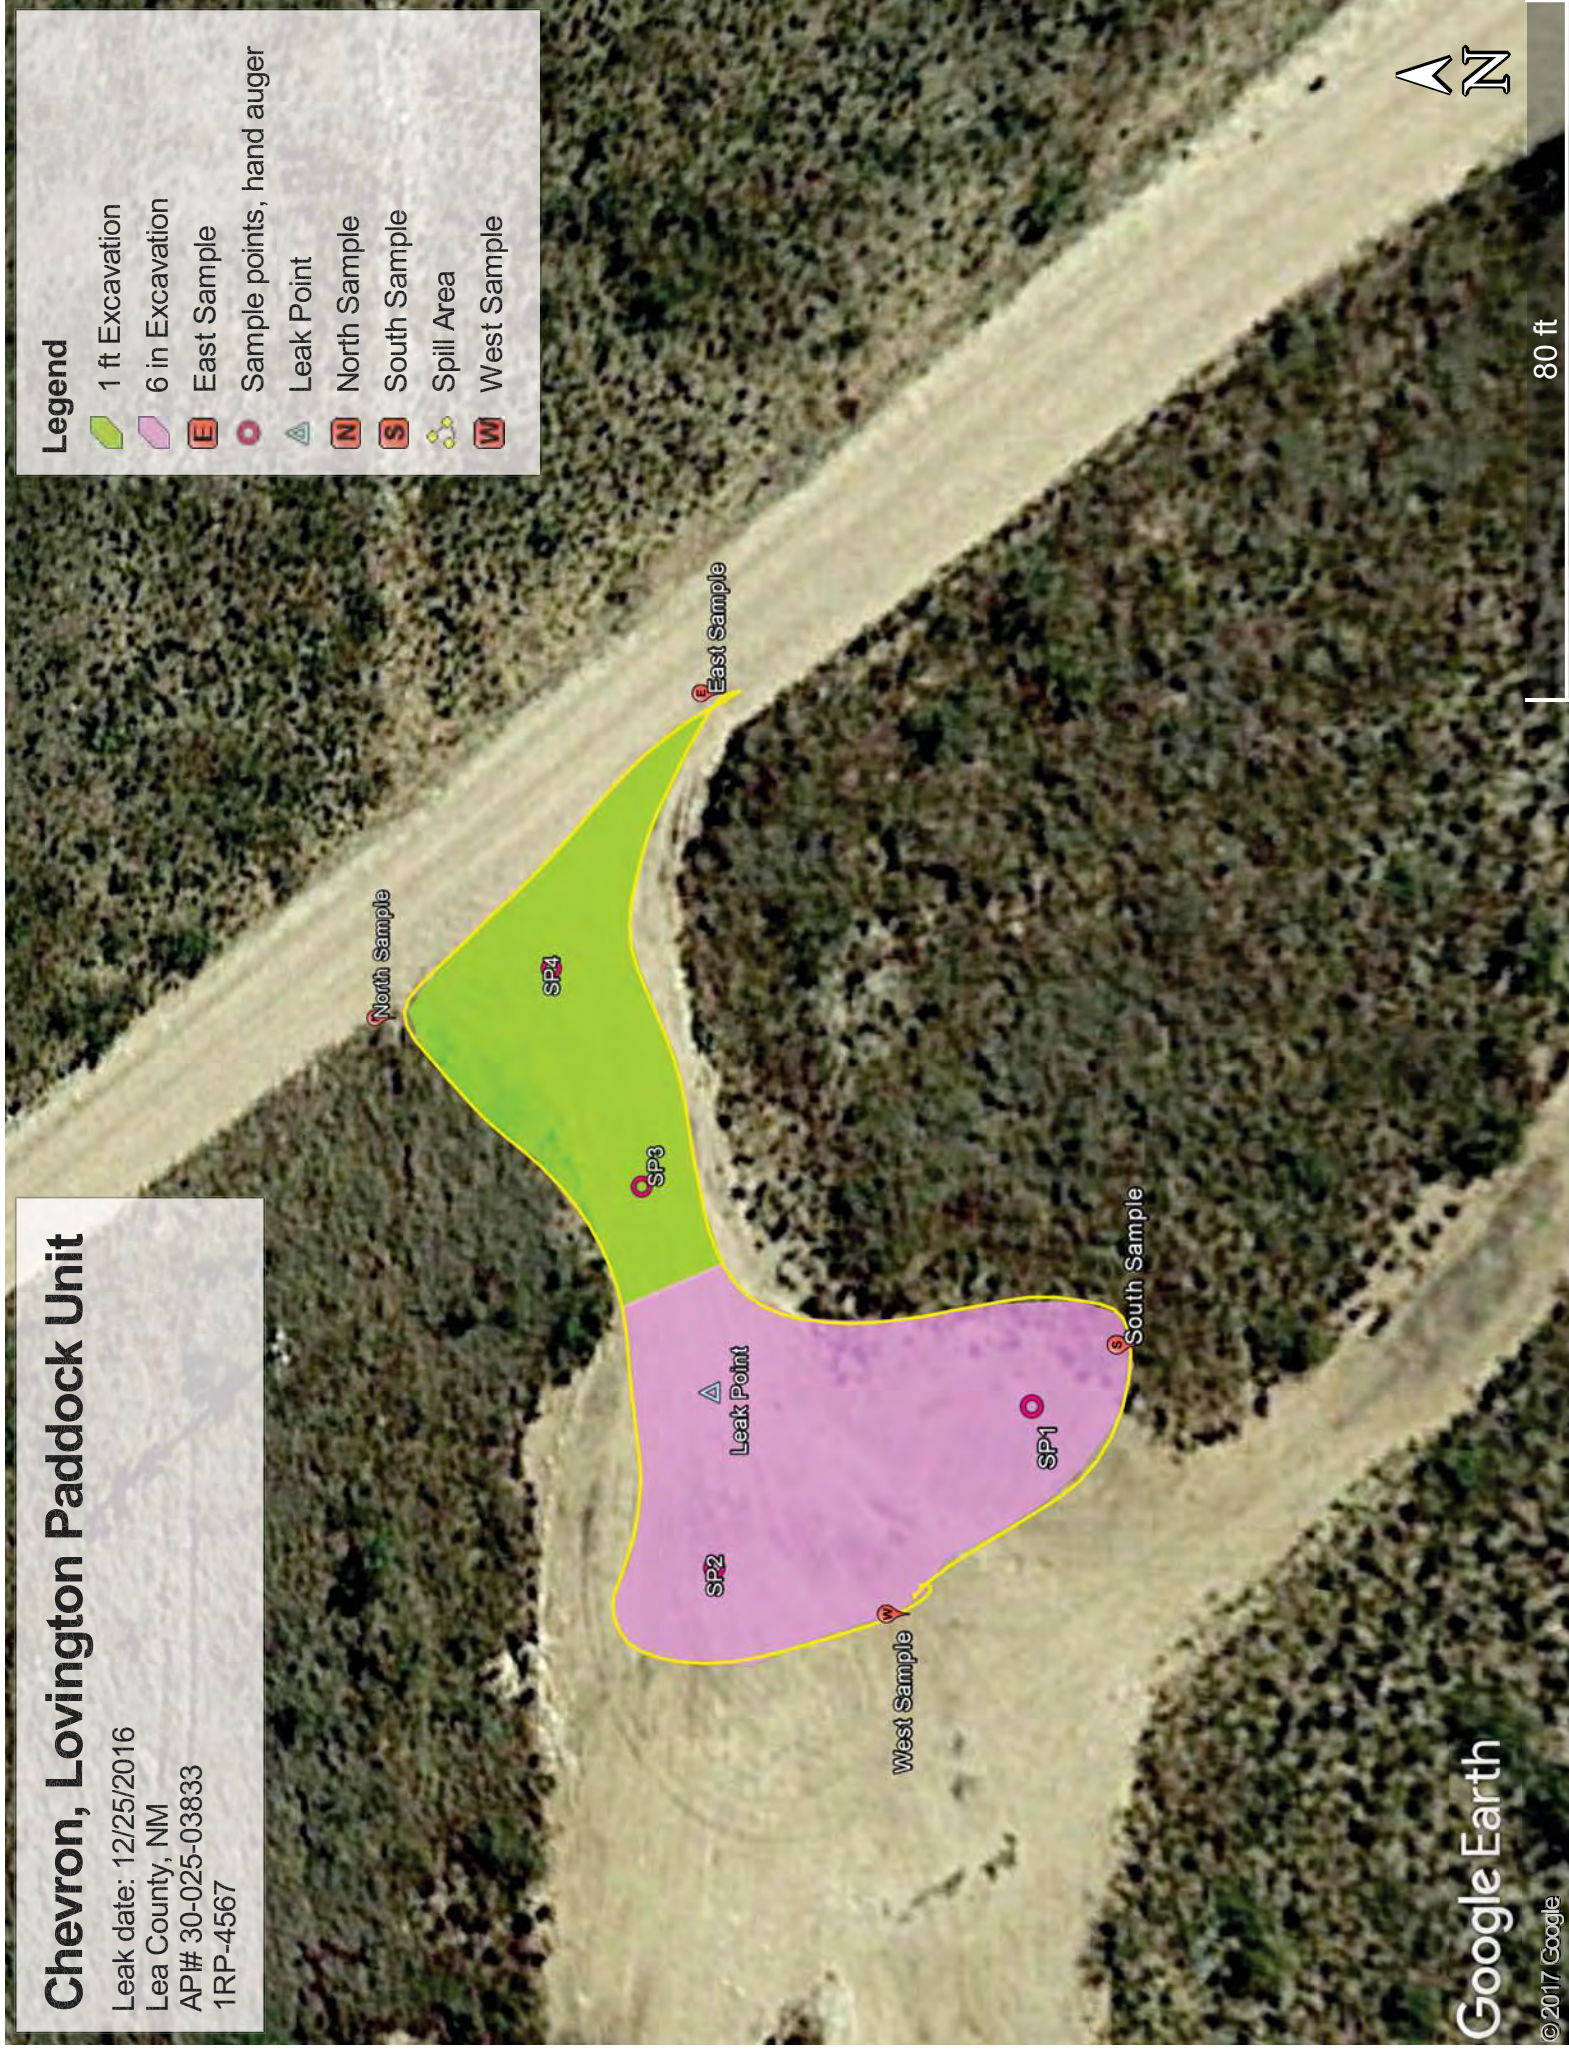
# Chevron, Lovington Paddock Unit

***CHEVRON will excavate the spill area as depicted on the following site diagram. The leak area near SP1 and SP2 will be excavated to a depth of 6 inches. The leak area around SP3 and SP4 will be excavated to a depth of 1 foot.***

- 1 ft Excavation
- 6 in Excavation
- East Sample
- Sample points, hand auger
- Leak Point
- North Sample
- South Sample
- Spill Area
- West Sample

The entire site will then be backfilled with clean soil and the area off location near SP3 and SP4 will be revegetated to the standards of the appropriate regulatory agency or private surface owner.

NMOCD approves of the delineation completed for 1RP-4567 and the proposed remediation with these conditions: bottom and sidewall/edge confirmation samples at no greater than 50 ft. apart. One sample must be located at the border between SP1/2 & SP3/4.
