SUBJECT: WORK PLAN FOR INCIDENT, Barr None Federal #1  
UNIT E SECTION 10-T22S-R32E NMPM, API# 30-025-32221, LEA COUNTY, NEW MEXICO

# SOIL REMEDIATION WORK PLAN FOR INCIDENT 1RP-TBD

JUDAH OIL, LLC

BARR NONE FEDERAL #1  
UL E, SECTION 10, T22S R32E, NMPM  
API #30-025-32221  
LEA COUNTY, NM

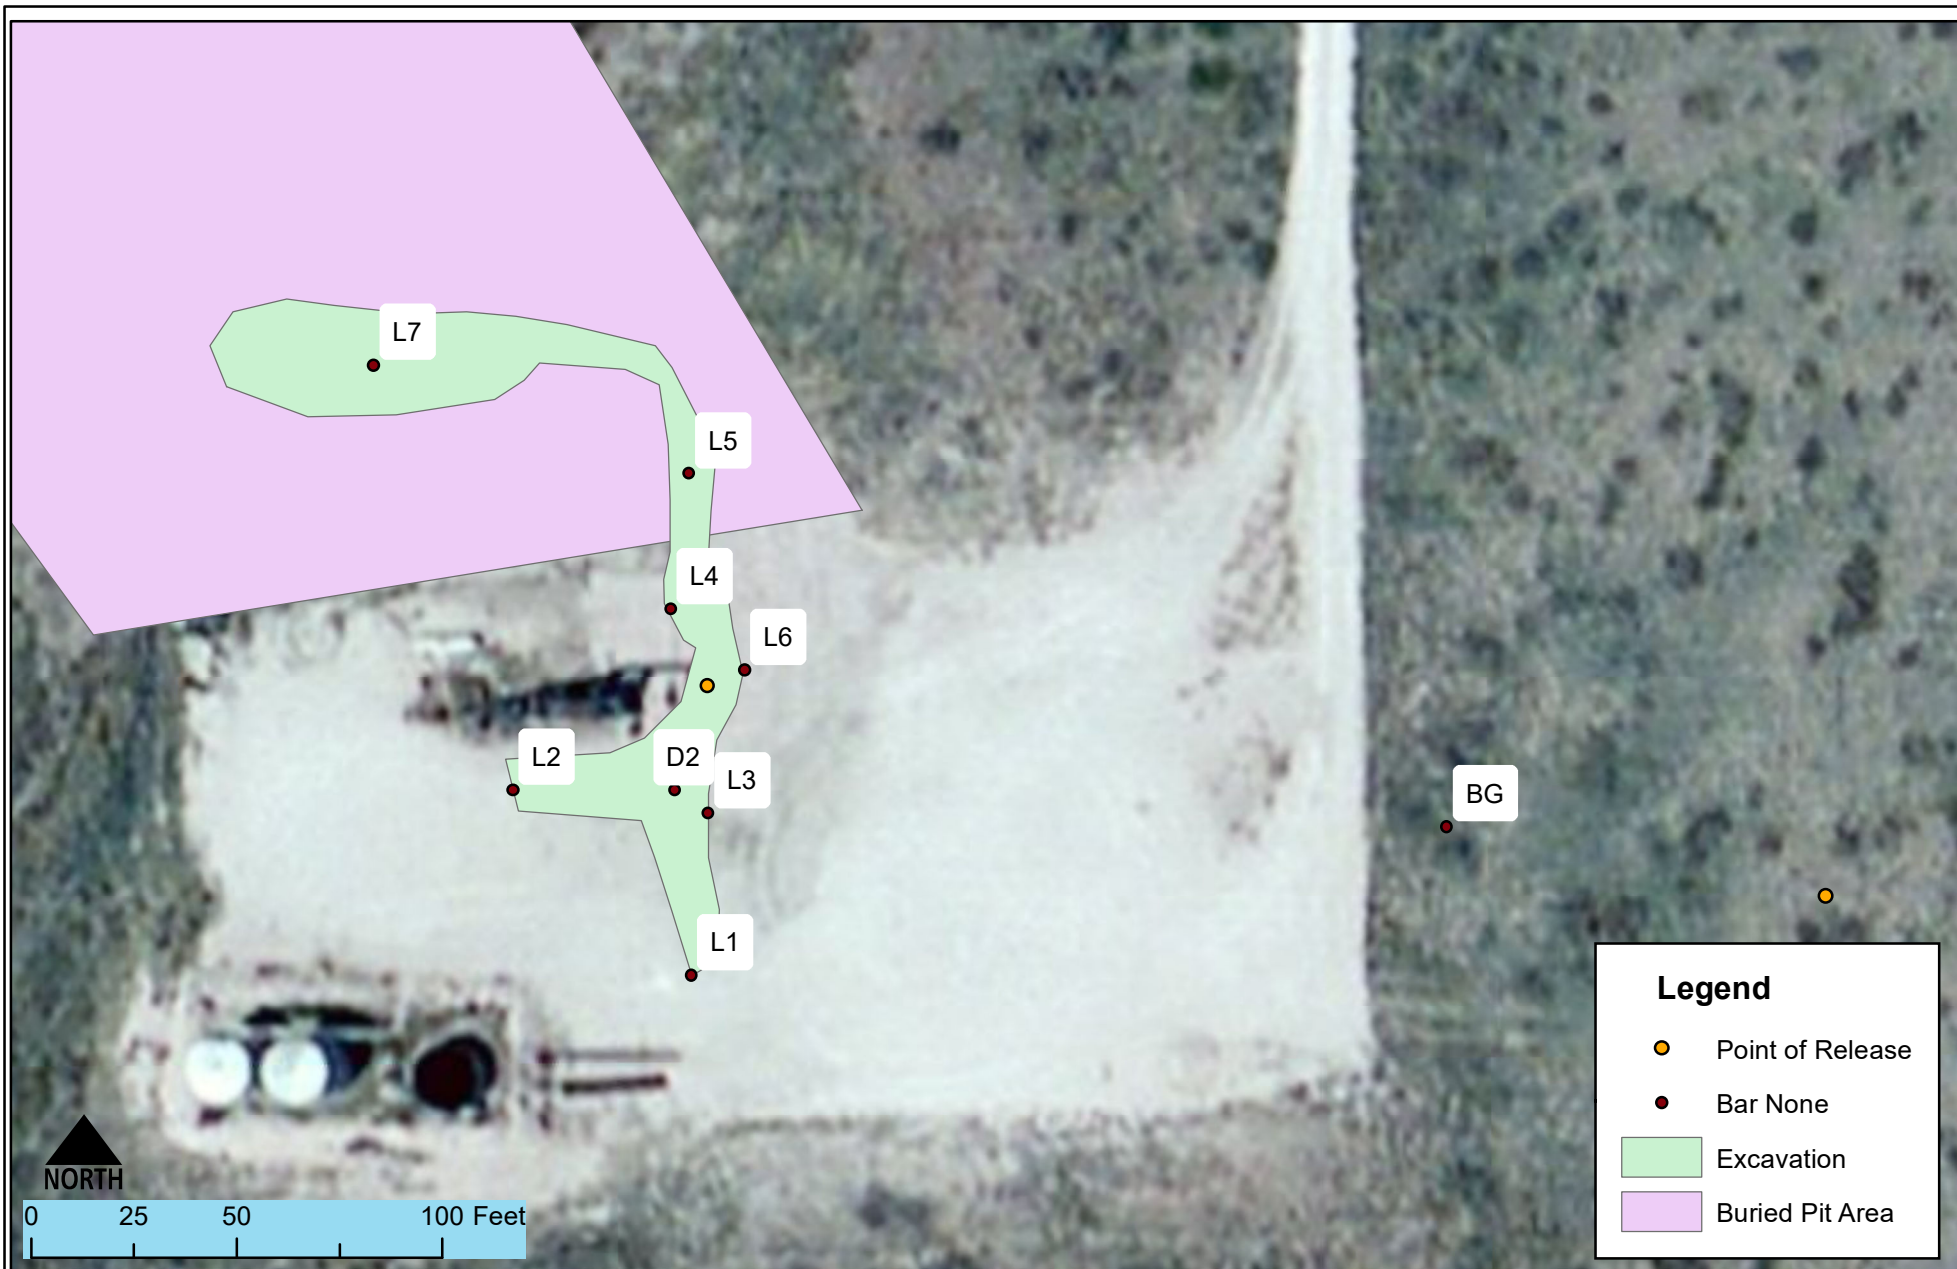
## DETAILED SITE AND SAMPLE MAP

Detailed Site and Sample Map  
Barr None Federal #1- Judah Oil  
Loving, New Mexico

On November 9, 2016 after receiving 811 clearance, SMA field personnel assessed the release area with soil samples collected using a gas powered auger. Samples were screened for hydrocarbons using a calibrated Photo Ionization Detector (PID), and for chlorides using a mobile chlorides titration kit (EPA method 9045D) meter. Field screening results are included in Table 2. The potentially affected area was determined to be approximately 140 feet long and 20 feet wide. The site delineation samples were taken to depths of 1.5 feet bgs. In the north area of the spill over the old pit a plastic liner was found at 8 inches bgs. Samples indicate the impacted soil does not appear to extend past one foot bgs. Specific sample locations for all samples are depicted on Figure 2 (Sample Location Map). All samples were collected and processed according to NMOCD soil sampling procedures. The samples were sent under chain-of-custody protocols to Hall Environmental Analysis Laboratory for analyses of BTEX (EPA Method 8021B), TPH (EPA Method 8015) and/or total chlorides (EPA Method 300.0).

Analytical Report- 1612A79	Sample Number on Figure 1 Map	Sample Date	Depth	BTEX ppm	Benzene mg/Kg	GRO mg/Kg	DRO mg/Kg	Cl- mg/Kg
1612B63-001	L1	12/13/2016	Surface	N/A	N/A	N/A	N/A	170
1612B63-002	L2	12/13/2016	Surface	N/A	N/A	N/A	N/A	210
1612B63-003	L3	12/13/2016	Surface	NA	N/A	N/A	N/A	290
1612B63-004	L5	12/13/2016	Surface	N/A	N/A	N/A	N/A	72
1612B63-005	L7	12/13/2016	Surface	N/A	N/A	N/A	N/A	4,500
1612B63-006	D2-3	12/13/2016	3 Feet	<0.055	<0.024	<4.9	<9.2	420
1612B63-007	D2-2	12/13/2016	2 Feet	N/A	N/A	N/A	N/A	230
1612B63-008	L4	12/13/2016	Surface	N/A	N/A	N/A	N/A	35
1612B63-009	L6	12/13/2016	Surface	N/A	N/A	N/A	N/A	600
