**Re: Chevron Vacuum Grayburg San Andres Unit 148
2017 Site Assessment Report
Case No. 1RP-3688
Lea County, New Mexico**

Site Assessment Report

VGSAU 148 (1RP-3688)
Produced Water Release
Lea County, New Mexico

Chevron Environmental
Management Company

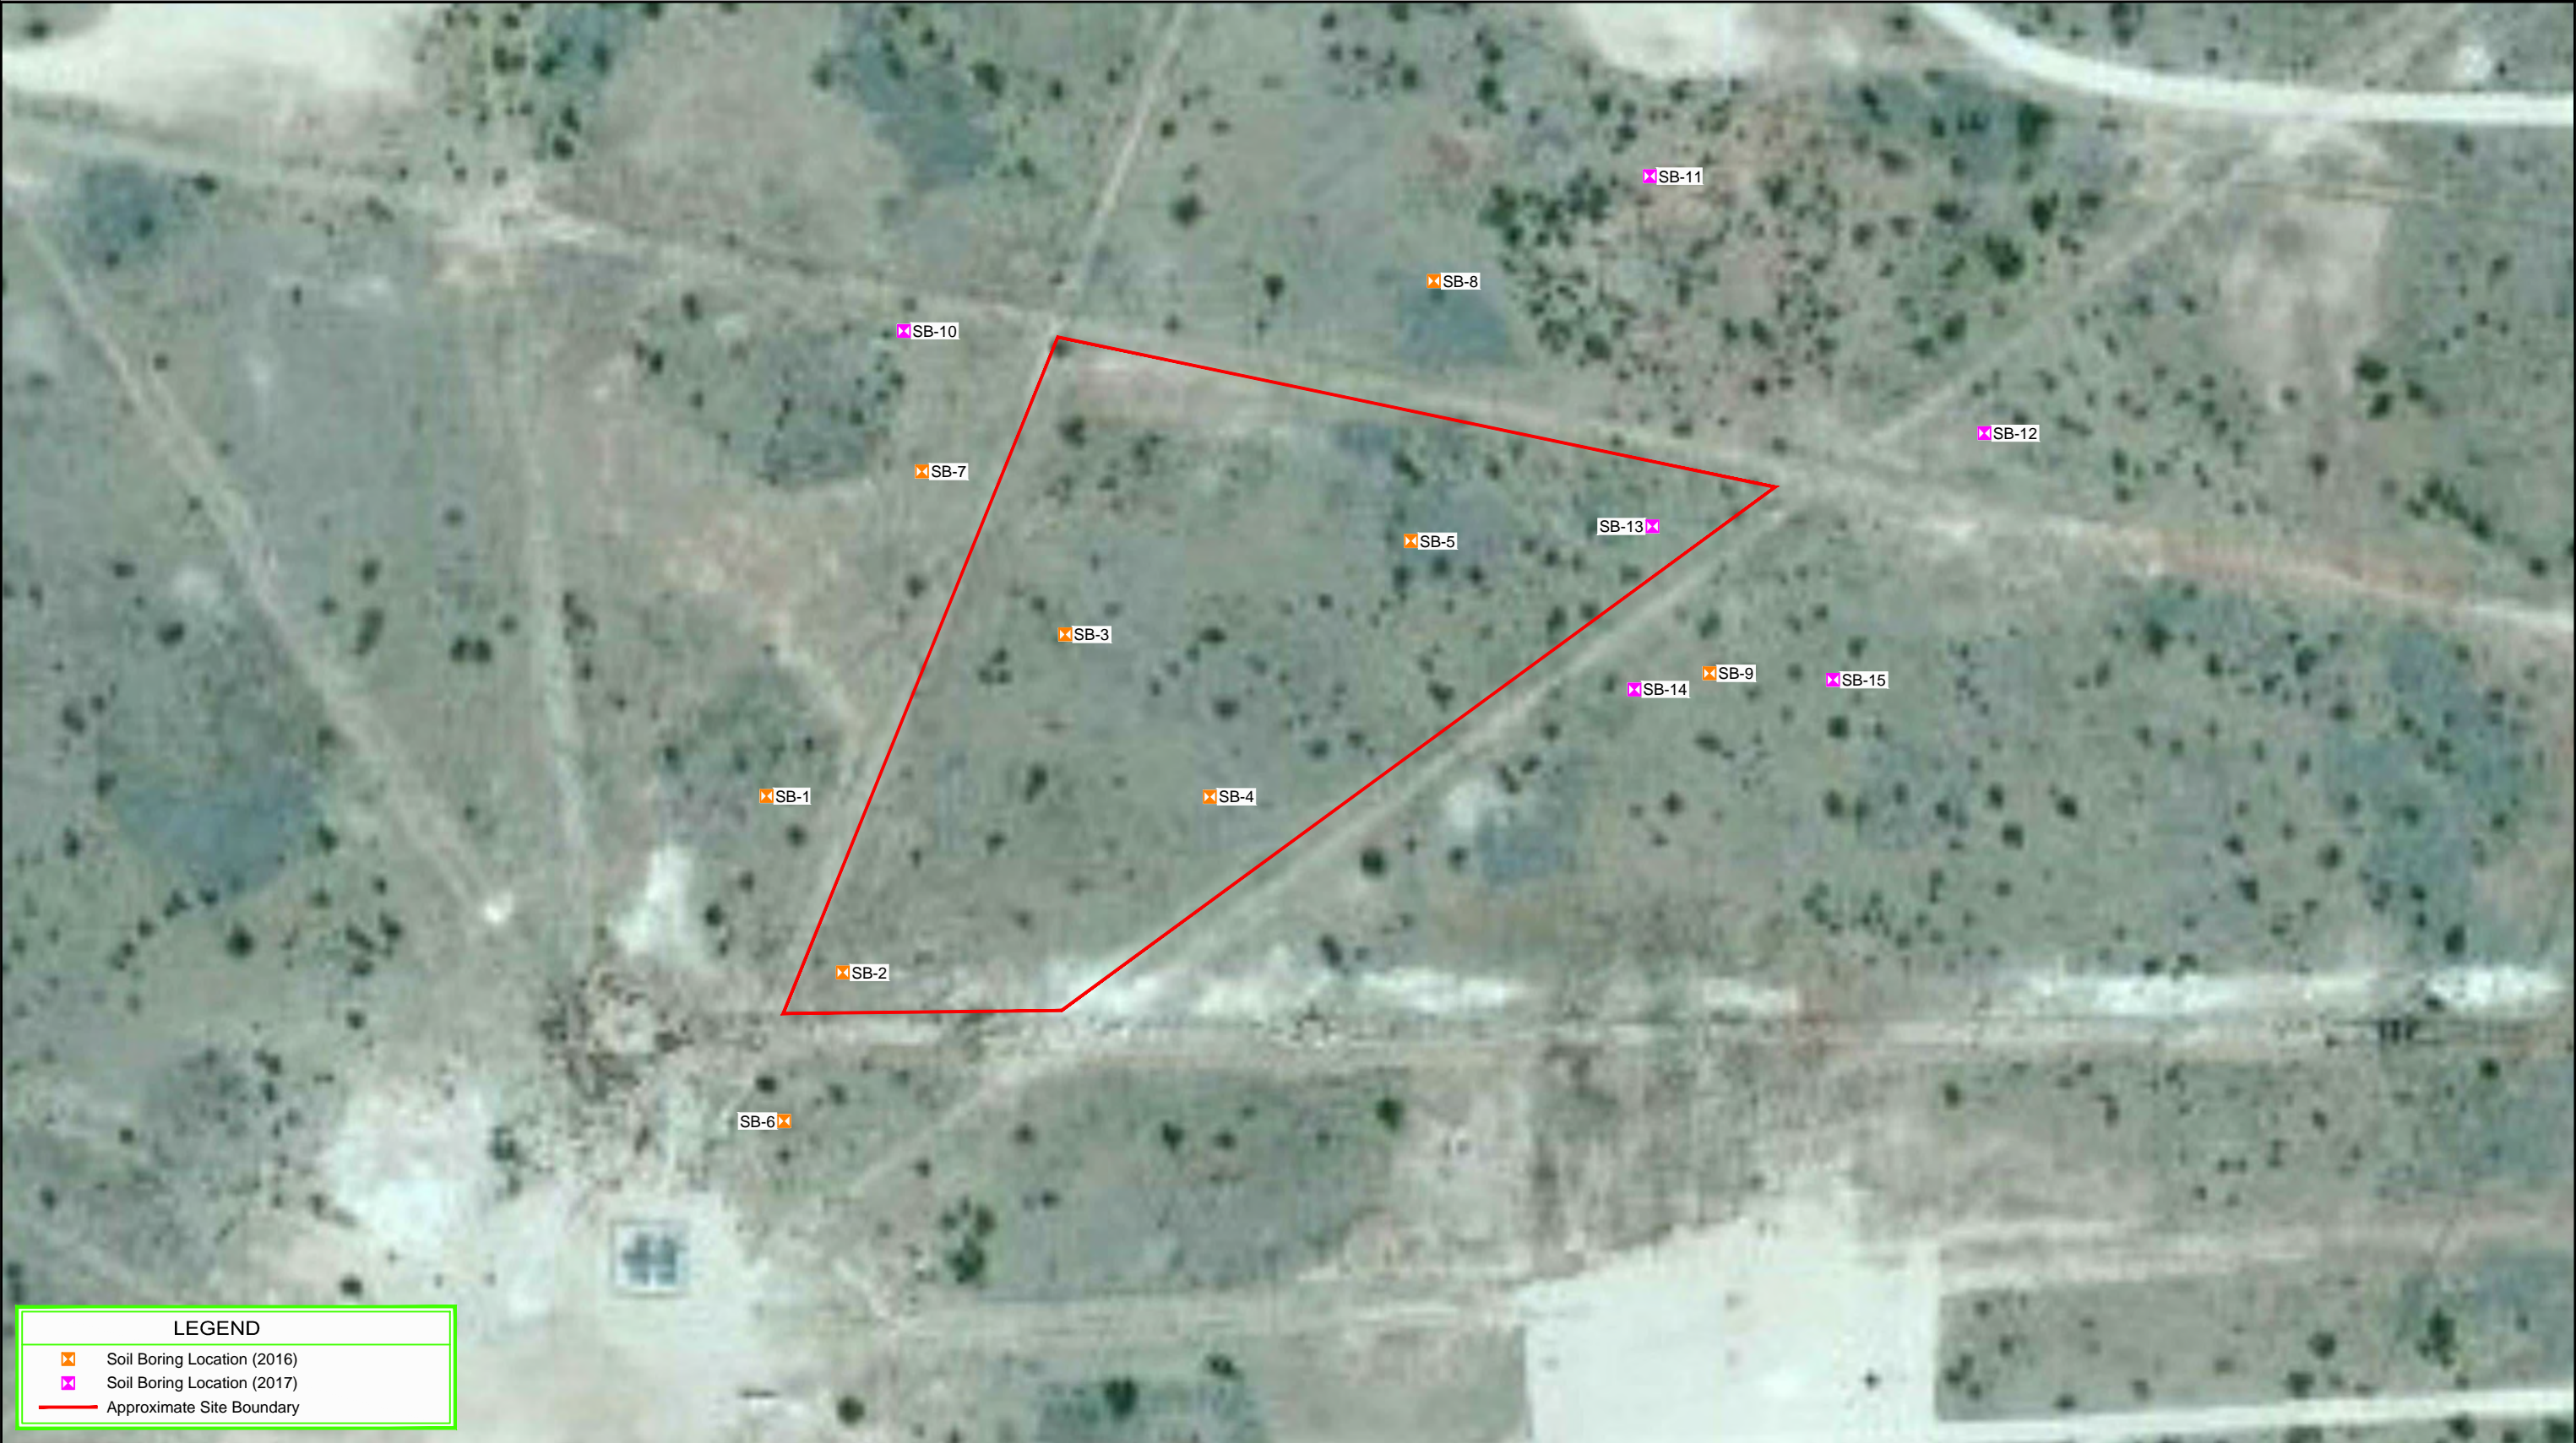
FIGURE 3

geophysical investigation are provided herein. Figure 3 depicts the soil boring locations installed between 2014 through 2017.

In order to further define the horizontal extent of chloride impact at the Site, six (6) additional soils borings (SB-10 through SB-15) were installed using an air rotary drilling rig. GHD's contracted service provider HCI (a New Mexico-licensed water well driller) and GHD mobilized to the Site to begin drilling activities on October 17, 2017. Each boring location was cleared for underground utilities with the use of an air knife up to a depth of 5.0 feet bgs or refusal. SB-10 through SB-15 were advanced to 50 feet bgs. Site details and boring locations are shown on Figure 3.

SITE DETAILS

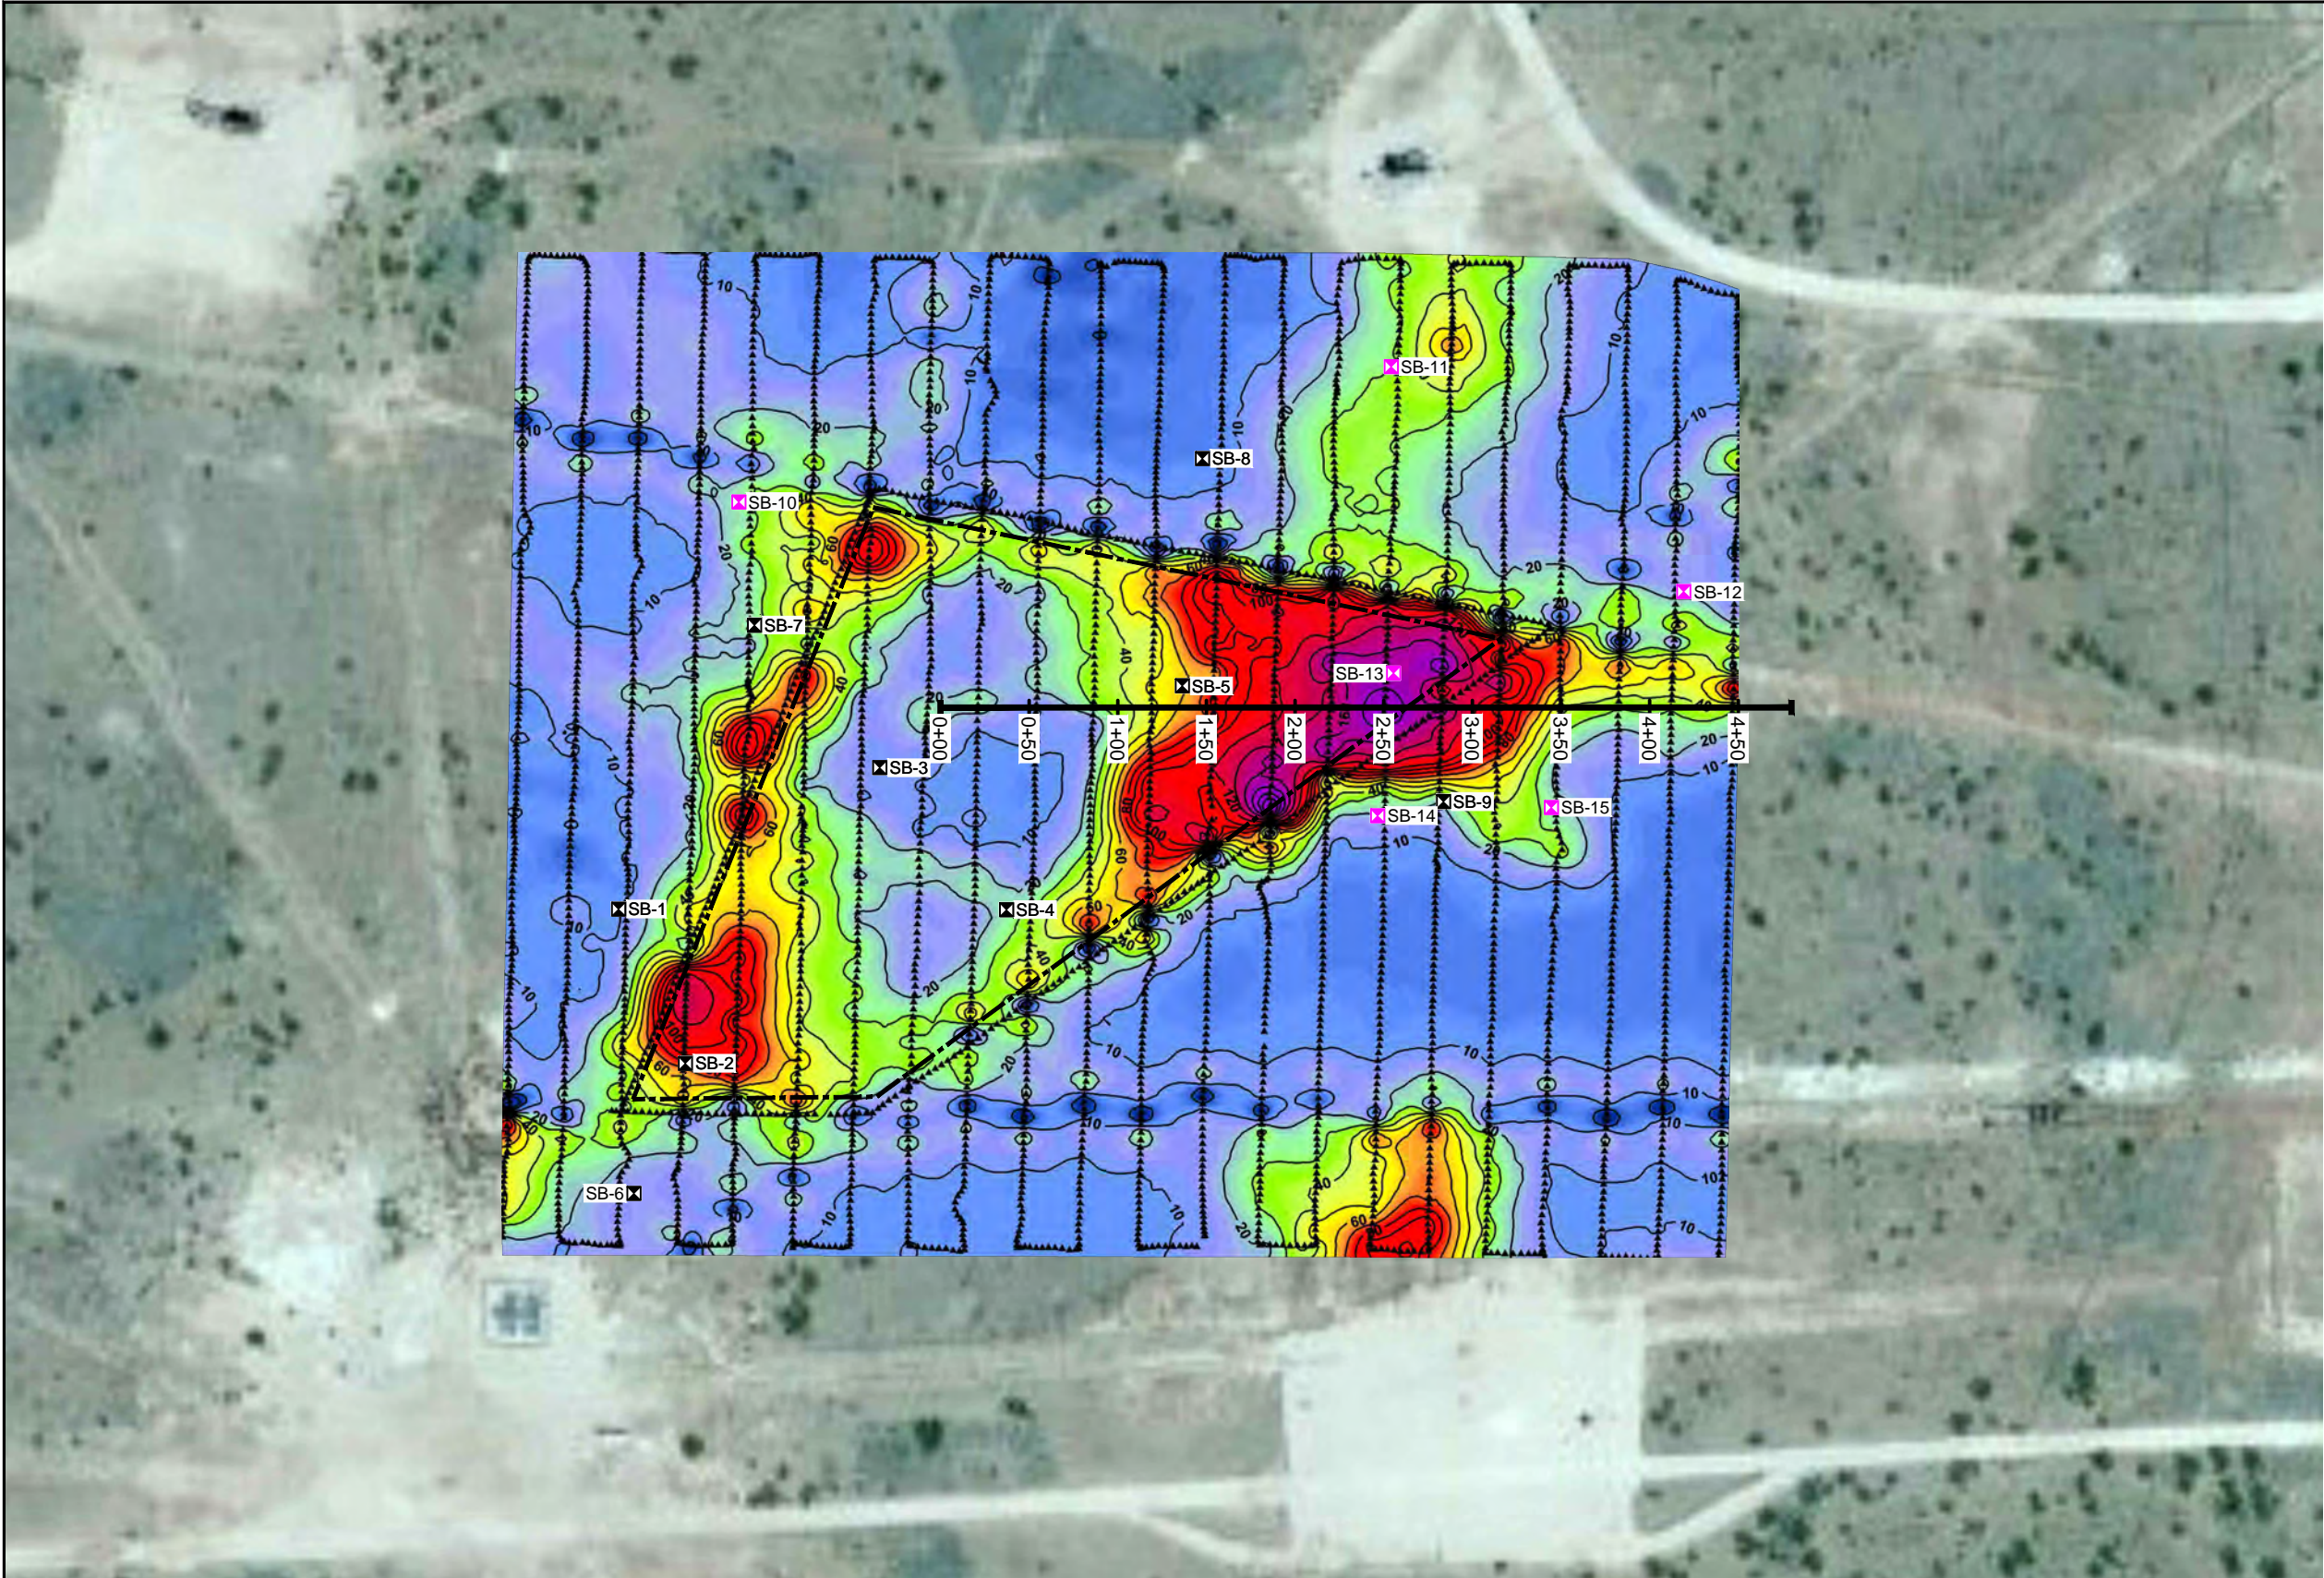
FIGURE 4

The EM31 survey was completed to determine the horizontal extent or limits of chloride impacts in the shallow subsurface soils at the Site. The EM31 consists of transmitter and receiver coils located at opposite ends of a rigid boom. The coil separation for the EM31 is approximately 13 feet, which yields an approximate depth of penetration of 18 feet bgs in vertical dipole mode. Measurements of terrain conductivity from the EM31 were used to assess the extent of chloride impacts at the Site. The data for the EM31 survey were then processed as a colored contour plot. The plot was superimposed on an aerial image of the Site plan, and is used to locate elevated conductivity responses indicative of chloride-impacted areas relative to the Site features. Figure 4 depicts the EM31 survey results.

The colored contour conductivity plot presented on Figure 4 reveals that the highest intensity conductivity responses are colored red to purple, while areas of low response are colored blue. All remaining intermediate responses correspond to the color scale presented on the figure. Results from non-impacted areas within the survey coverage indicate that background conductivity responses were approximately 20 milliSiemens/meter (mS/m). Anomalous responses relative to background were generally 1.5 to 10 times higher, and ranged from approximately 30 to 200 mS/m. The EM31 survey results delineated three main areas of suspected brine-impacted soils (on the northeast, southeast, and west side of the Site).

The response areas on the western portion of the Site are comprised of numerous smaller conductive zones that run parallel to a high pressure gas line. The area on the northwest portion of the Site is located between two additional high pressure gas lines. Several of the smaller conductive zones with higher responses are believed associated with conductive metal piping. An area was identified southeast of the Site boundary and is believed to be a former pit not associated with the VGSAU 148 release.

EM31 GEOPHYSICAL INVESTIGATION

- The geophysical investigation successfully delineated the horizontal and vertical extents of suspected brine-impacted areas in the shallow subsurface within the Site boundaries.
- The EM31 survey delineated two areas of suspected brine-impacted soils within the Site boundaries.

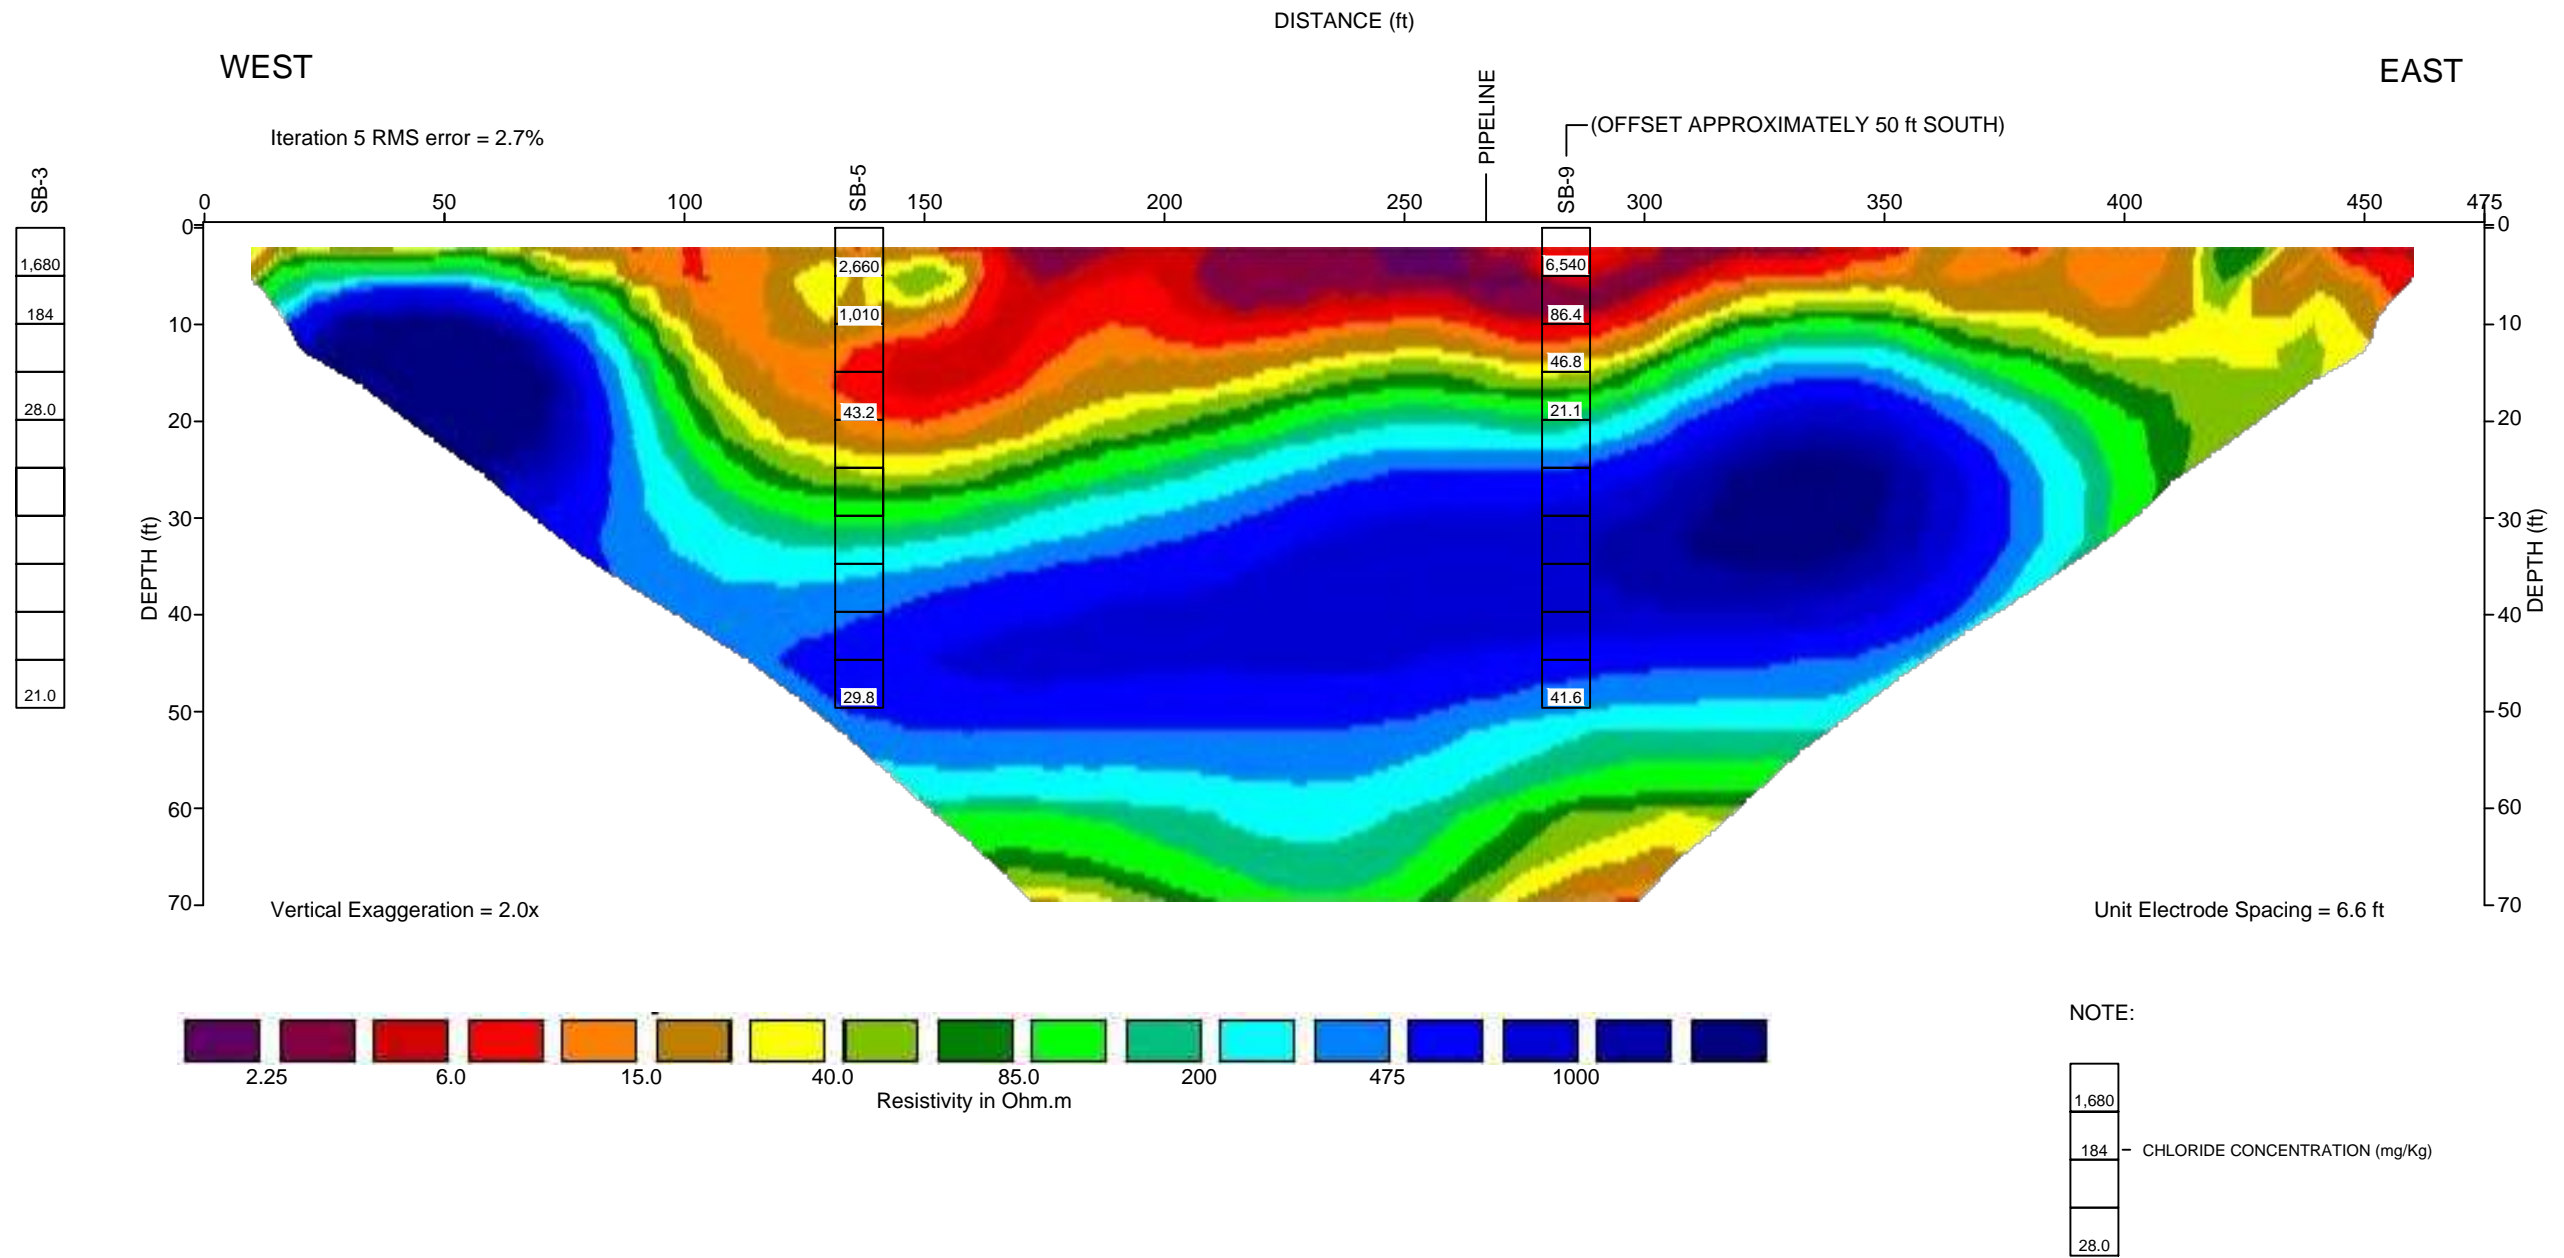
FIGURE 5

The electrical resistivity results for the survey line are presented on Figure 5. These results are based on the measured apparent resistivity values for various depths along the survey line. Calculations of measured apparent resistivity values include the type of ER array (Wenner), the electrode spacing, and raw field data (i.e., applied current and measured voltage for each data point).

The measured apparent resistivity data were processed with the inversion program RES2DINV, to yield the modeled resistivity section presented on Figure 5. The modeled section represents the resistance of earth materials in the shallow subsurface, and thus provides an interpretation of the overburden sequences and areas of suspected brine impacts along the survey line. The highest resistivity values are colored dark blue, while areas of low resistivity (or conversely, high conductivity) are colored yellow to red. All remaining intermediate responses correspond to the color scale presented on the bottom of each section.

The colored plot reveals that the contour intervals ranged from 2.25 to 1,000 Ohm.meters (Ohm.m). The intermediate contour intervals were determined by applying a normalized distribution curve to the data such that the entire range of responses could be identified by discrete colors. The interpreted colored contoured plot suggests that suspected brine-impacted soils can likely be characterized by modeled responses of approximately 2.25 to 40 Ohm.m.

VGSAU 148 - LINE 1 INVERSE MODEL RESISTIVITY SECTION

CEMC
BUCKEYE FMT, LEA COUNTY, NEW MEXICO
VGSAU 148 PRODUCED WATER RELEASE ASSESSMENT
ELECTRICAL RESISTIVITY CROSS-SECTION SURVEY RESULTS
AND HISTORICAL SOIL ANALYTICAL DATA

- In general, the ER survey results indicate the zone of suspected brine impact is a surficial zone, affecting soils at surface down to approximately 30-40 feet bgs.
- The suspected brine impacts appear confined to near surface areas that correlate well with soil sample analytical results for chlorides from the 2016 and 2017 assessment activities.

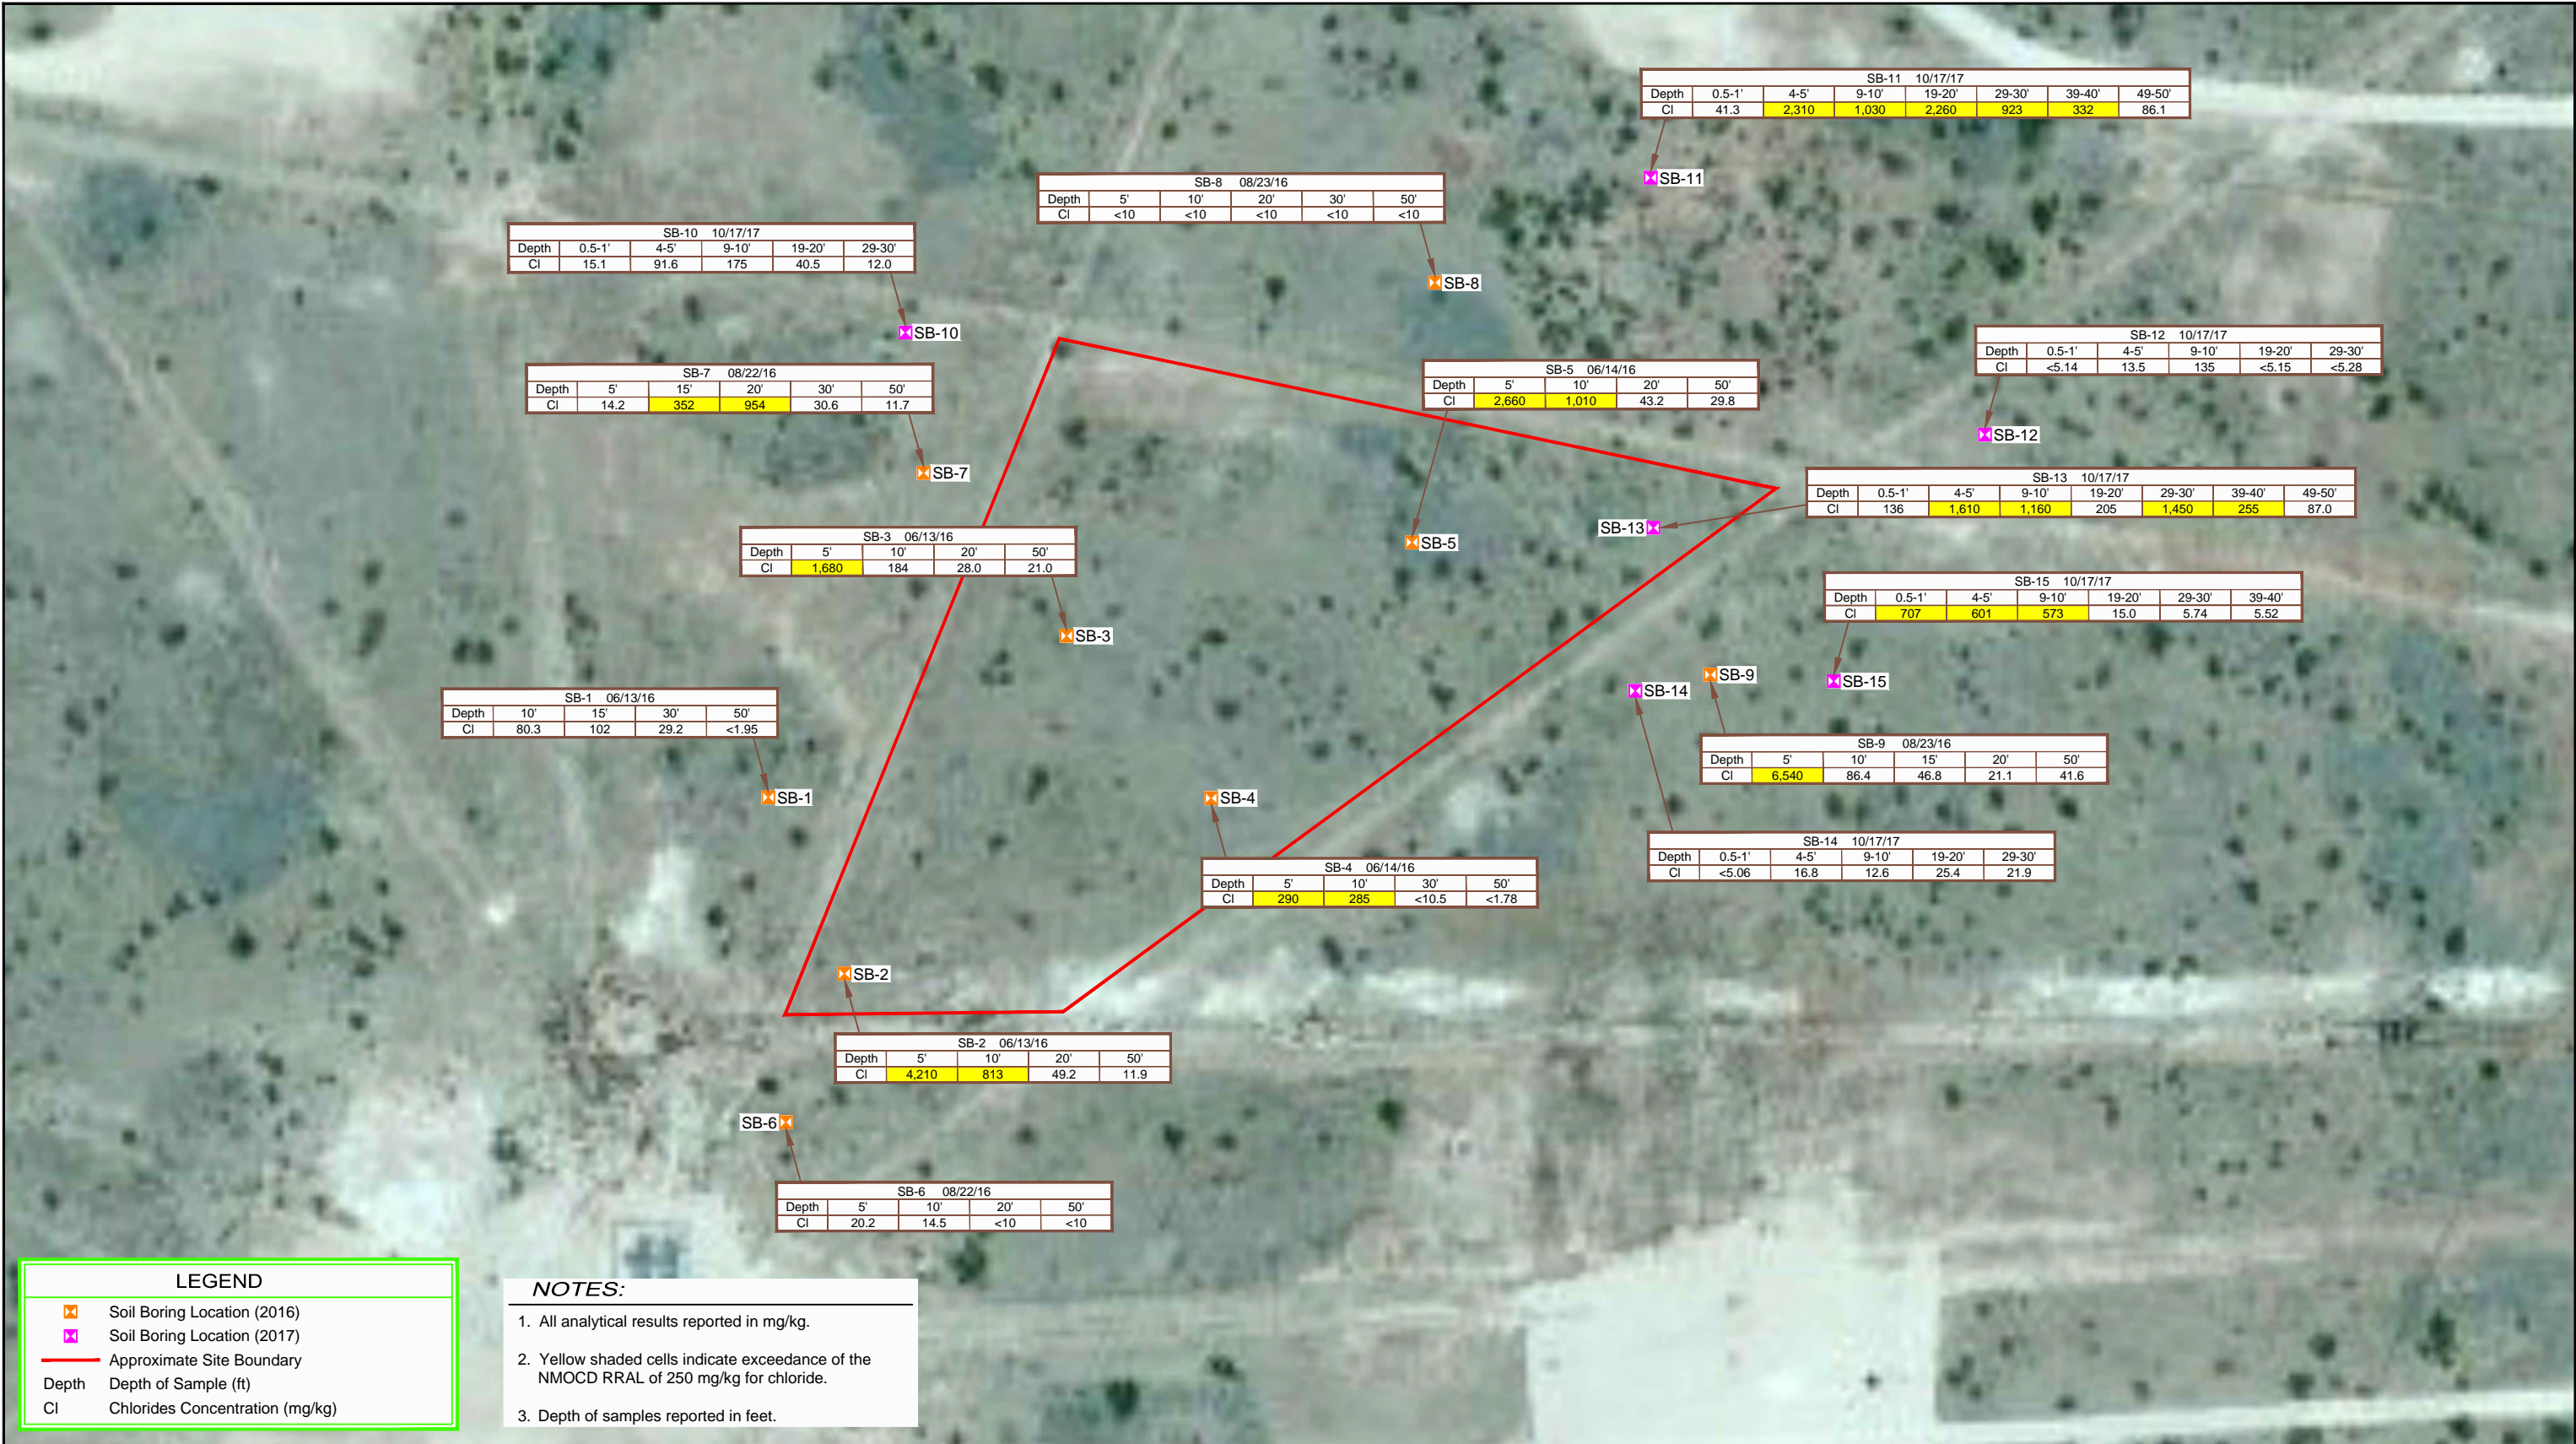
FIGURE 6

Analytical results associated with the soil boring installation activities performed in October 2017 are discussed in the following section. Some of the deeper soil samples were held by the laboratory pending results of shallower soil samples, and were subsequently not analyzed at the direction of GHD. Analytical results are presented in Table 1 and the laboratory reports are provided in Appendix B. These results are shown in map view on Figure 6, and are summarized below:

- Soil samples collected from SB-10, SB-12, and SB-14 demonstrated chloride concentrations below the site-specific RRAL of 250 mg/kg in samples from 0.5-30 feet intervals. As such, deeper soil sample intervals (30-50 feet) were not analyzed.

- Soil samples from SB-11 exhibited chloride concentrations exceeding the RRAL in five sample intervals (4-40 ft ranging from 332 to 2,310 mg/kg). The chloride concentrations decreased through the deeper intervals with the highest concentrations from the 4-5 feet bgs interval (2,310 mg/kg). The soil boring terminal depth (50 feet bgs) sample reported chloride below the RRAL at 86.1 mg/kg.

- Soil samples from SB-13 exhibited chloride concentrations exceeding the RRAL in four sample intervals (4-5 feet bgs, 9-10 feet bgs, 29-30 feet bgs, and 39-40 feet bgs ranging from 255 to 1,610 mg/kg). The soil boring terminal depth (50 feet bgs) sample reported chloride below the RRAL at 87.0 mg/kg.

- Soil samples from SB-15 exhibited chloride concentrations exceeding the RRAL in the three shallowest sample intervals (707 mg/kg, 601 mg/kg, and 573 mg/kg at 0.5-1 feet bgs, 4-5 feet bgs, and 9-10 feet bgs, respectively). The chloride concentrations decreased throughout the

SITE DETAILS AND ANALYTICAL RESULTS MAP

Analytical results associated with assessment activities conducted in 2016 and 2017 indicate the horizontal extents of the chloride impact in soil have not been fully delineated. The vertical extent of chloride impact appears delineated and confined to shallow soils less than 40 feet bgs, therefore the risk of impact to groundwater is believed minimal.

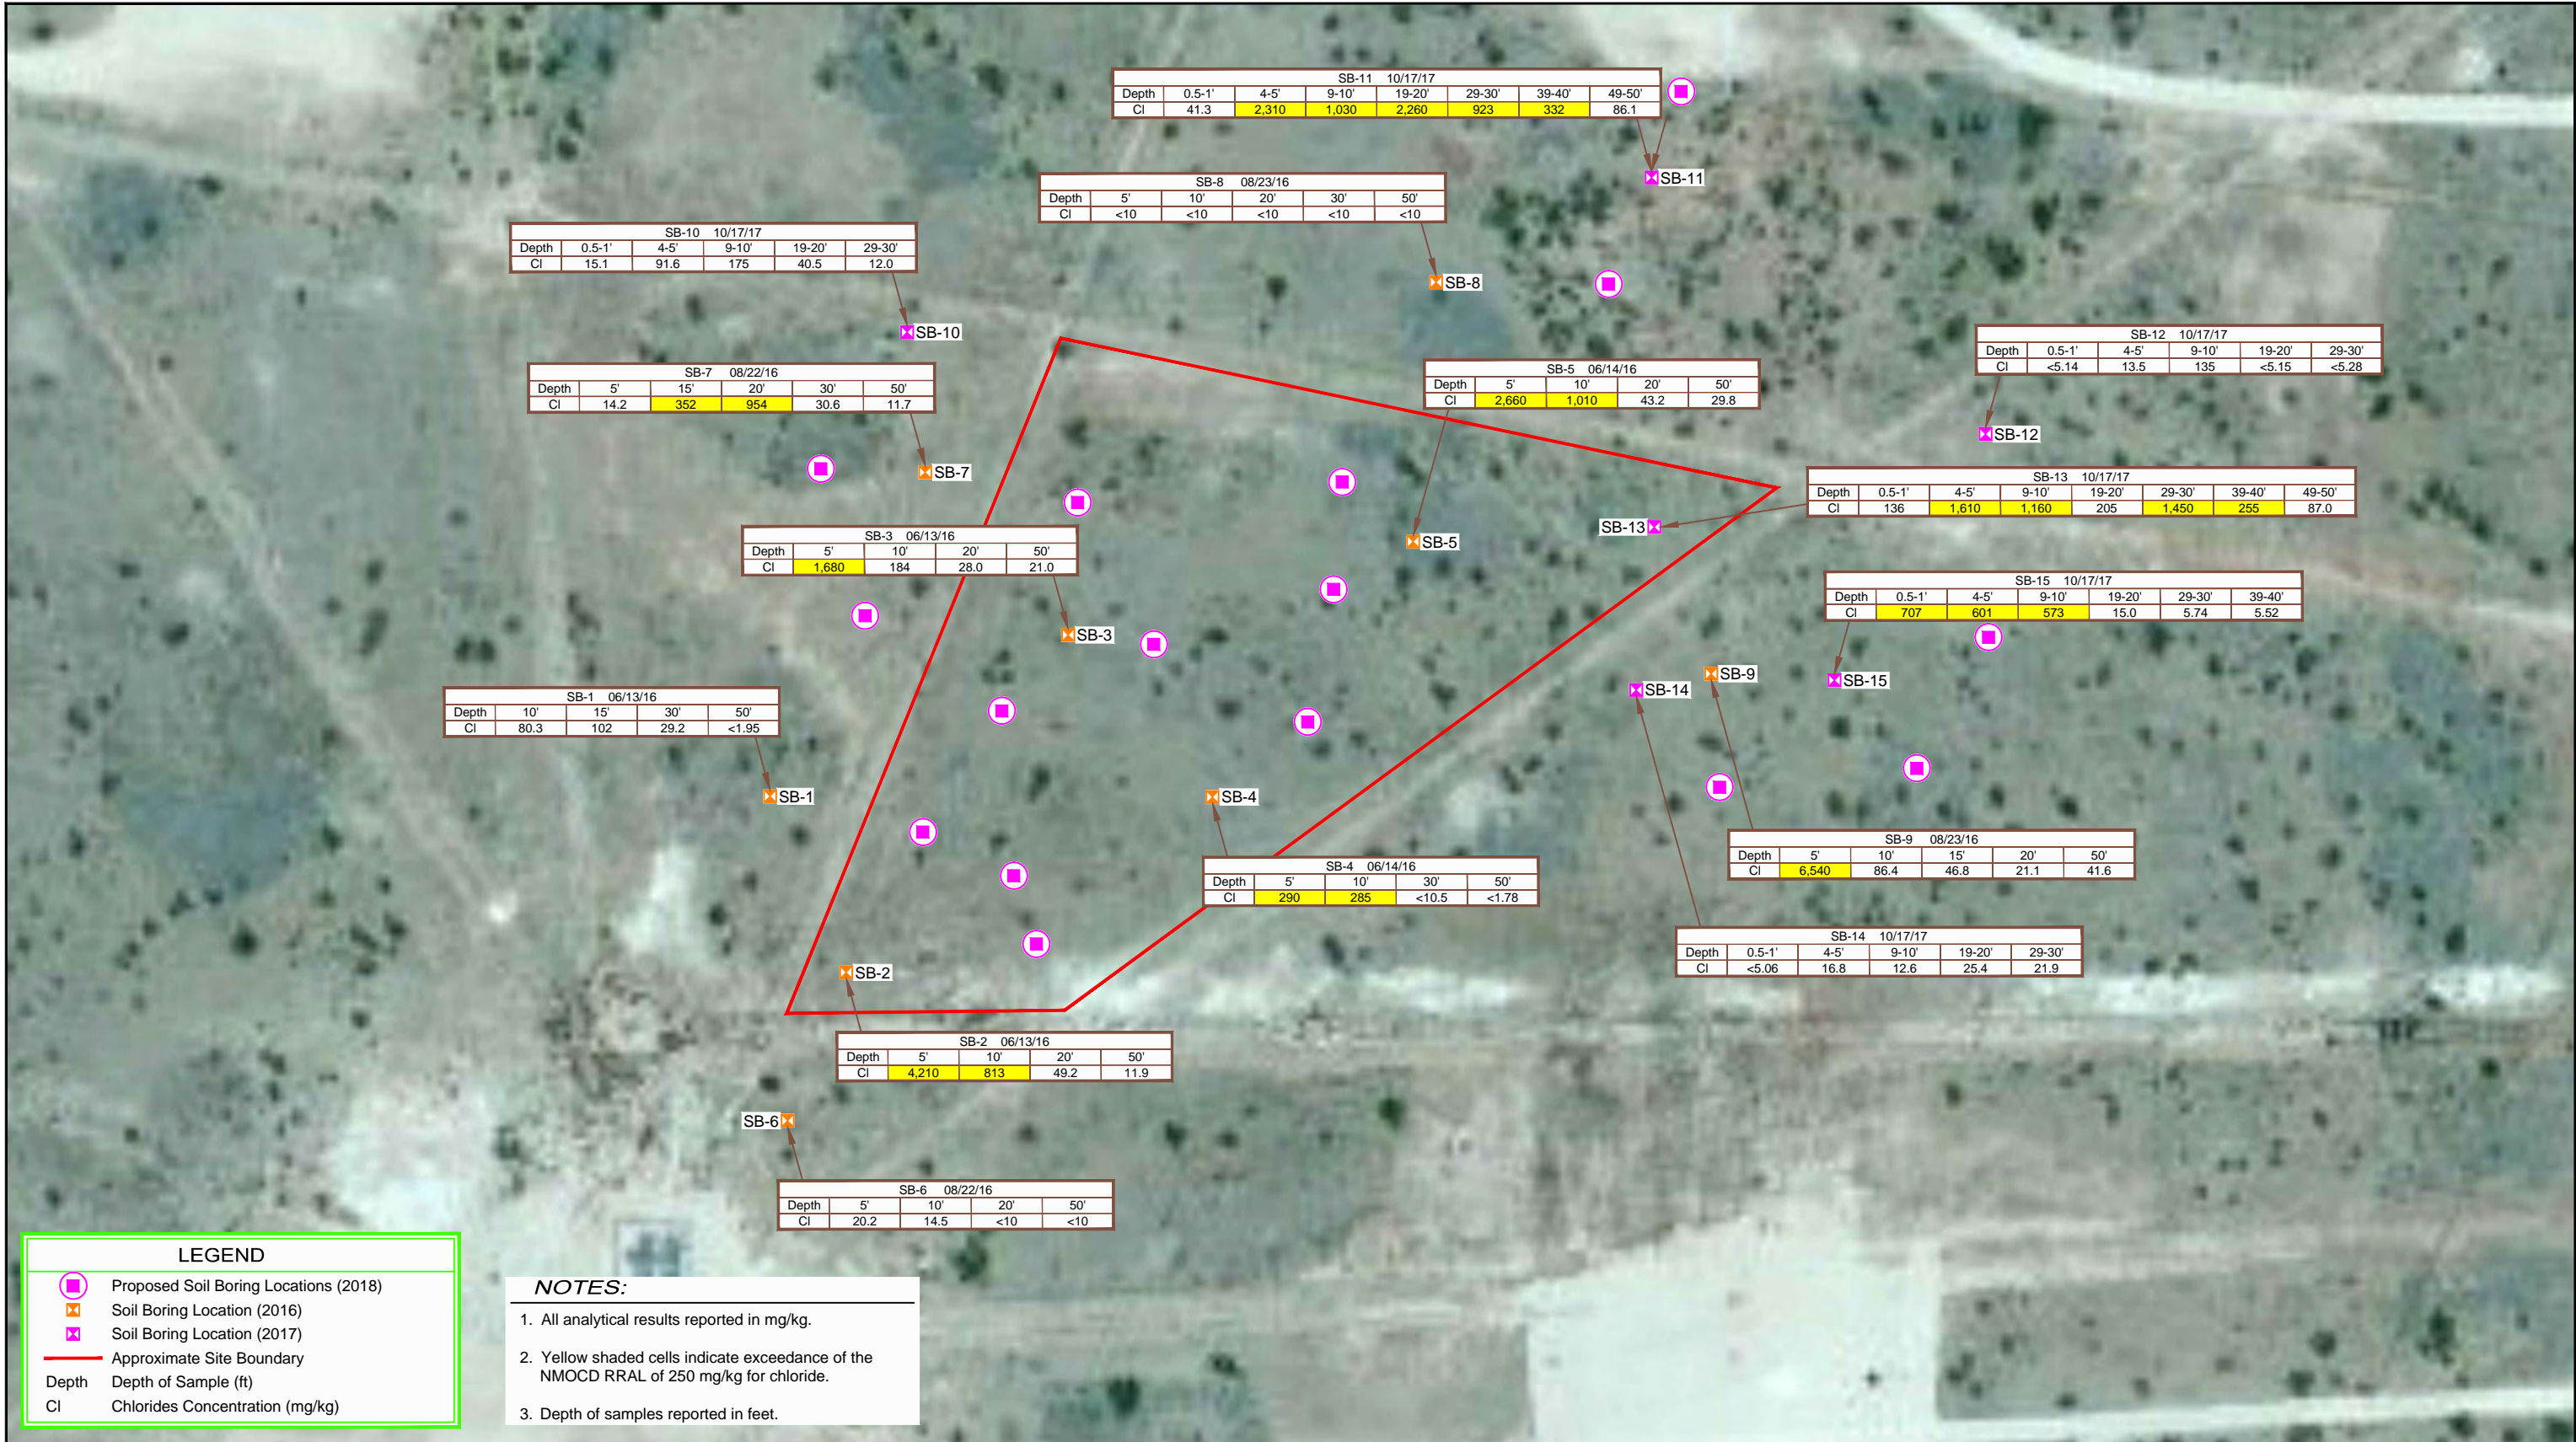
Attachment: Figure 1 – Proposed Soil Boring Location Map

On February 13, 2018, GHD and Chevron representatives met with NMOCD and the New Mexico State Land Office (NMSLO) regarding further delineation activities and future remedial actions addressing the presence of chloride concentrations at the Site. Further delineation activities recommended include the advancement of sixteen soil borings to 40 feet bgs (see Figure 1). The specific locations of the soil borings have been determined based on the geophysical survey and previous soil sample analytical results.

- Prior to mobilizing the drilling equipment to the Site, a site visit will be performed by GHD. GHD will mark the proposed boring locations for New Mexico 811 notification. A One Call ticket will be initiated by the driller to identify subsurface hazards within the proposed drilling areas. Chevron will spot locate any underground utilities and/or pipelines within the assessment area;
