Re: Work Plan
Marshall & Winston – Slick Mesa State 27-1H
NMOCD Reference #'s: 1RP-5047, 1RP-5065, 1RP-5066

RXSoil, Inc. is pleased to submit the work plan summarizing the on-site remediation of produced water impacted soil at the Slick Mesa State 27-1H site located in Lea County, New Mexico. Remediation work plan follows in the attached report.

On behalf of Marshall & Winston, Inc., RXSoil, Inc. ("RXSoil") has prepared this work plan that describes the assessment and action plan for remediation of the releases of 1RP-5047, 1RP-5065, 1RP-5066 at the Slick Mesa State 27-1H site with API #30-025-30587.

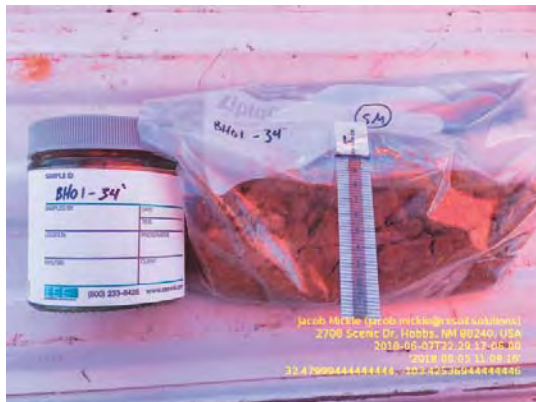
BH01-34'
DRILL RIG
34'
FIELD TEST: CHLORIDES (1:4)
LOW: 1.6 = 176 PPM
HIGH: -

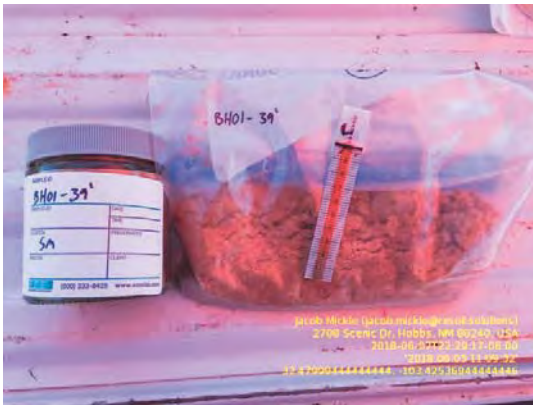
Soil
Sample to Lab
BH01-39'
DRILL RIG
39'
FIELD TEST: CHLORIDES (1:4)
LOW: 2.0 = 228 PPM
HIGH: -

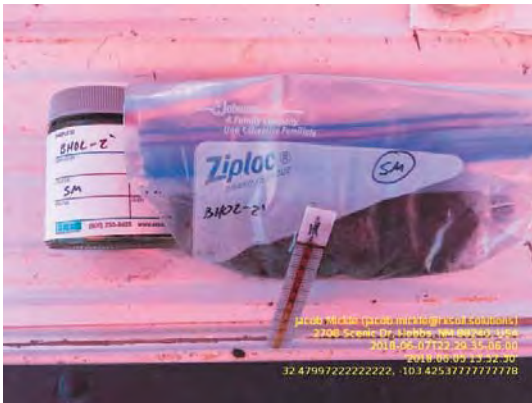
Type of Field Test	Soil
Method of Testing	Sample to Lab
Name of Sample Point	BH02-2'
Method of Sample Collecting	DRILL RIG
Depth (inches)	24"
Comments	FIELD TEST: CHLORIDES (1:4) LOW: - HIGH: 5.0 = 4,064 PPM

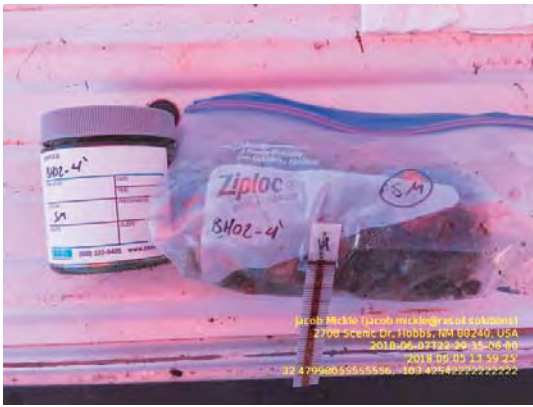
Soil
Sample to Lab
BH02-4'
DRILL RIG
48"
FIELD TEST: CHLORIDES (1:4)
LOW: -
HIGH: 4.6 = 3,460 PPM

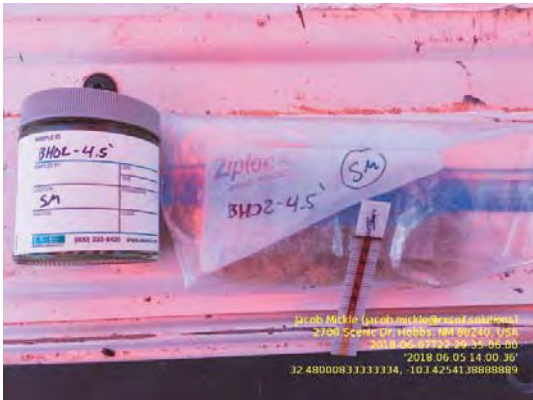
Type of Field Test	Soil
Method of Testing	Sample to Lab
Name of Sample Point	BH02-4.5'
Method of Sample Collecting	DRILL RIG
Depth (inches)	4.5'
Comments	FIELD TEST: CHLORIDES (1:4) LOW: - HIGH: 4.6 = 3,460 PPM

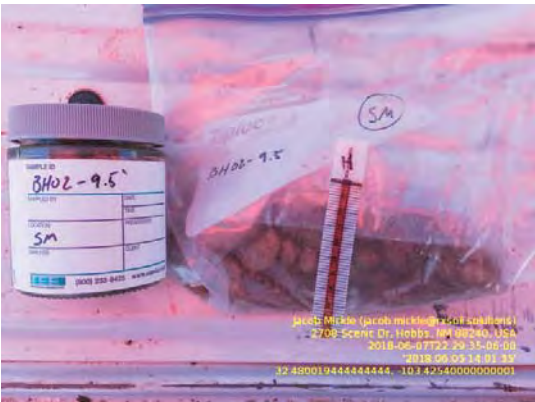
Soil
Sample to Lab
BH02-9.5'
DRILL RIG
9.5'
FIELD TEST: CHLORIDES (1:4)
LOW: -
HIGH: 3.0 = 1,732 PPM

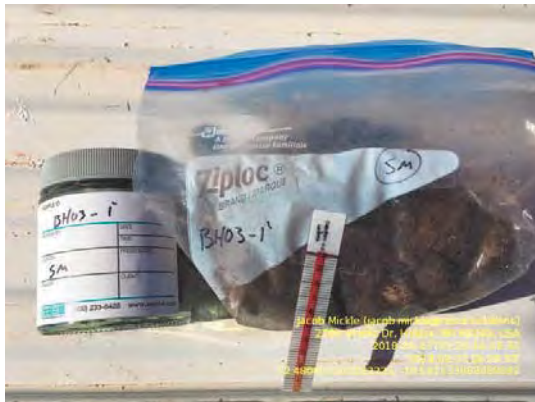
Type of Field Test: Soil
Method of Testing: Sample to Lab
Name of Sample Point: BH03-1'
Method of Sample Collecting: DRILL RIG
Depth (inches): 12"
Comments: FIELD TEST: CHLORIDES (1:4)
LOW: -
HIGH: 3.2 = 1,904 PPM

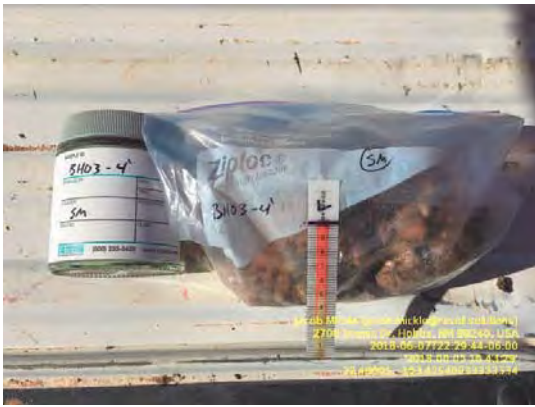
Soil
Sample to Lab
BH03-4'
DRILL RIG
48"
FIELD TEST: CHLORIDES (1:4)
LOW: 5.4 = 1,056 PPM
HIGH: -

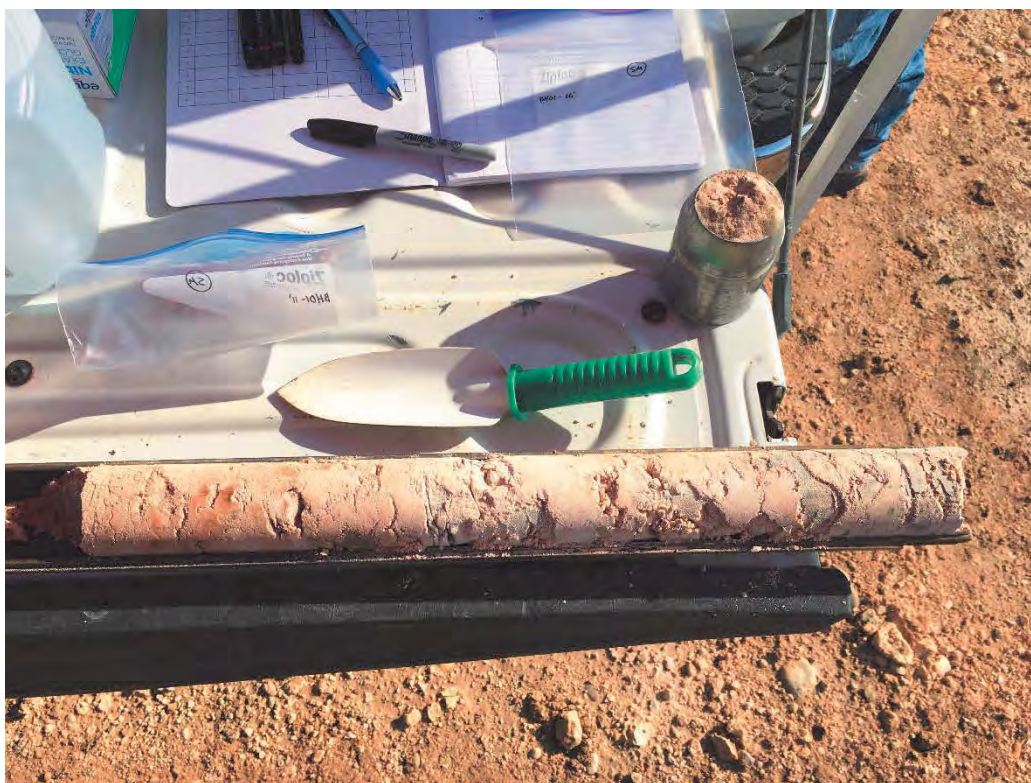
Figure 3: The spoon used for vertical delineation is shown (06/05/18).
