Re: Chevron Lovington Paddock Unit 59 2017 Soil Assessment Report Case No. 1RP-915 Lea County, New Mexico

Site Assessment Report

Lovington Paddock Unit 59 1RP-915 Produced Water Release Lea County, New Mexico

Chevron Environmental Management Company

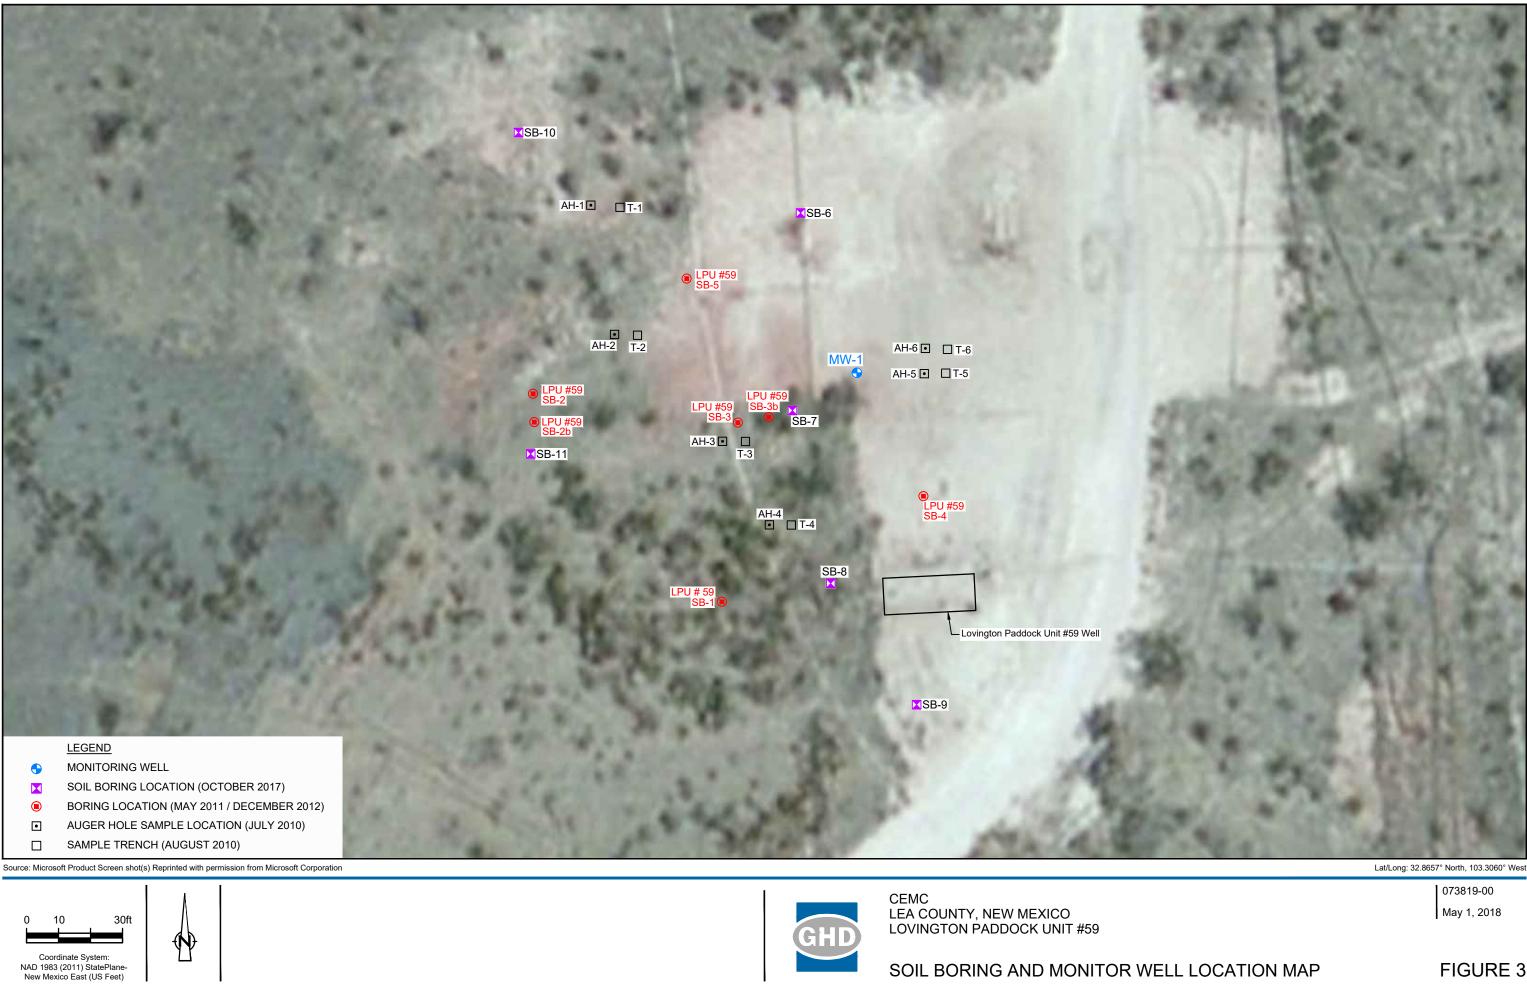
FIGURE 3

SOIL BORING AND MONITOR WELL LOCATION MAP
