REMEDIATION SUMMARY & SITE CLOSURE REQUEST

**Black Mountain Operating, LLC
MADERA 19 FEDERAL #4
Lea County, New Mexico
Unit Letter "N", Section 19, Township 26 South, Range 35 East
Latitude 32.022315° North, Longitude -103.409676° West
NMOCD Reference #: 1RP-4472**

March 2017

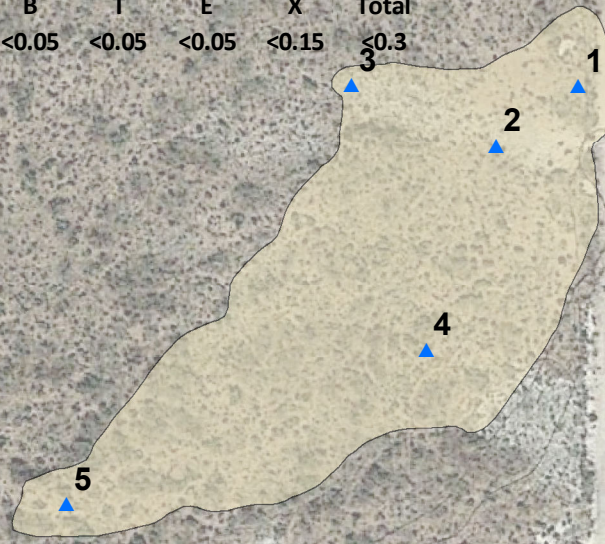
Figure 2 – Site & Sample Location Map

Initial Sampling

Sample Point 1

Depth	Cl-	GRO	DRO	B	T	E	X	Total
Surface	32	<10	754	<0.05	<0.05	<0.05	<0.15	<0.3
1'	272	<10	<10					
2'	160

Sample Point 2

Depth	Cl-	GRO	DRO
Surface	16	<10	43.9
1'	64	<10	10.1
2'	400		
3'	256		
4'	64

Sample Point 3

Depth	Cl-	GRO	DRO	B	T	E	X	Total
Surface	32	<10	12.5	<0.05	<0.05	<0.05	<0.15	<0.3
1'	<16	<10	12.6					
2'	<16

Sample Point 4

Depth	Cl-	GRO	DRO
Surface	<16	<10	<10
1'	<16	<10	<10
2'	<16

Sample Point 5

Depth	Cl-	GRO	DRO
Surface	<16	<10	<10
1'	<16	<10	<10

- ▲ SAMPLE POINT
- STAIN - 28,929 SQ FT

Basin personnel were on site beginning January 24, 2017 to begin sampling and delineation activities. Initial samples taken with depth were retrieved and submitted to a certified NMOCD approved commercial laboratory for initial analysis of chloride concentration utilizing method SM4500Cl-B. Gasoline range organics (GRO) and diesel range organics (DRO) were analyzed utilizing method TPH 8015M. Benzene, toluene, ethylbenzene and xylenes (BTEX) were analyzed utilizing method BTEX 8021B. An “Initial Sample Location Map” is provided as Figure 2. Laboratory analytical reports are provided as Appendix C.

The impacted area was not actionable in that all discrete samples obtained did not exhibit a concentration above the recommended remediation action level (RRAL). Laboratory results confirm that delineation was achieved.

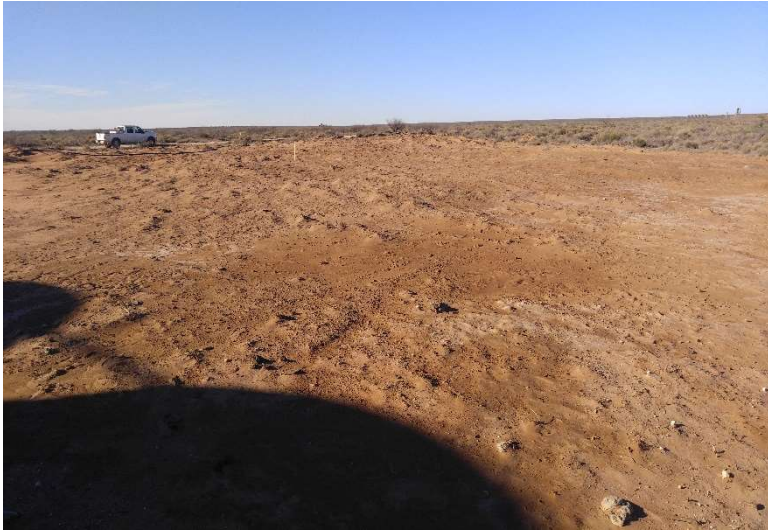
Final overspray removal, facing southwest 1/24/17

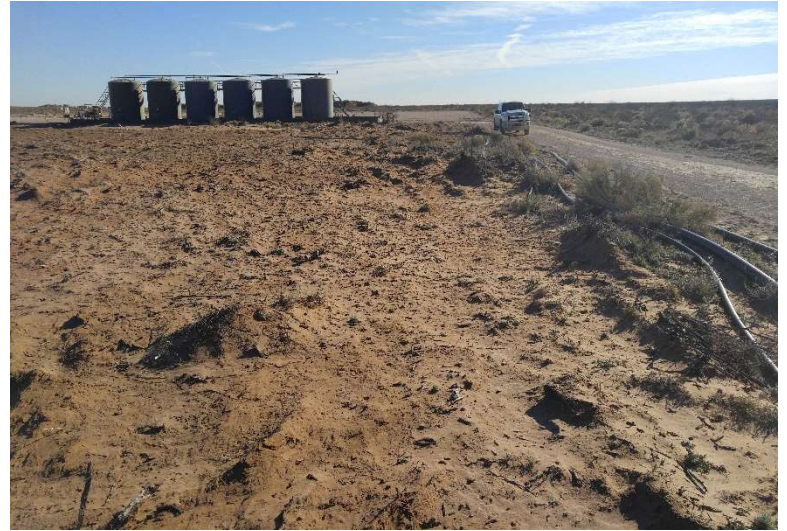
Final overspray removal, facing east 1/24/17

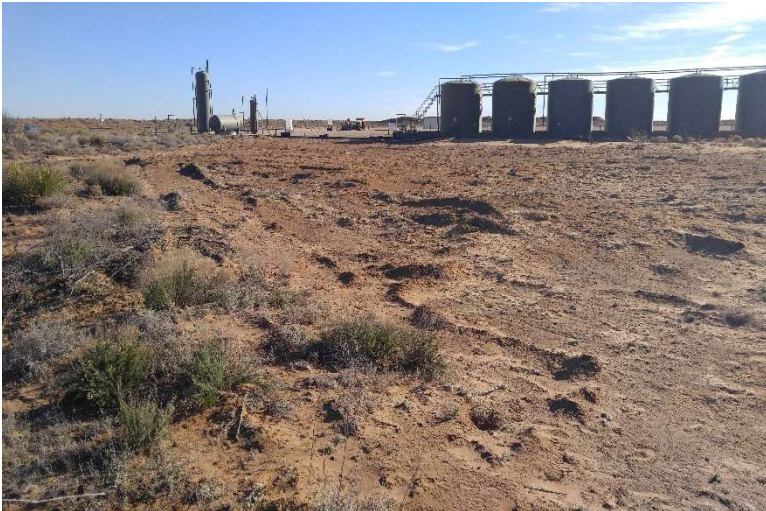
Final overspray removal, facing northeast 1/24/17

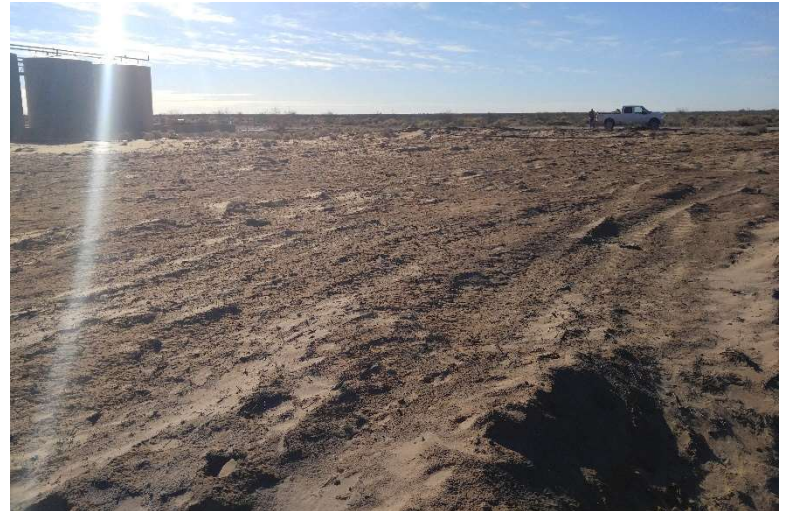
Final overspray removal, facing southeast 1/24/17
