Subject: Memo of observations during staking 1RP-4953 - Produced Water Releases; 1RP-4778 Tomahawk SWD; 1RP-

Memo

Re: 1RP-4953 – Produced Water Releases; 1RP-4778 Tomahawk SWD;

1RP-4821 – Coop 6 State Com Battery (1H)

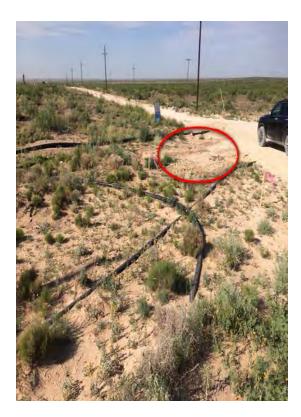
Furthermore, Figures M1 & M2 shows the area is undergoing natural revegetation with the exception of the areas outlined by a red circle, which is suitable for one borehole for vertical delineation. Figure M3 shows the powerlines and flowlines that restrict drilling access at East of Battle 34.

Figure M 1: Photograph viewing south along access road. The red circle is a potential location for one borehole for vertical delineation that is within the spill release area. The remaining spill area is undergoing natural revegetation. Numerous on-surface flowlines cross the area.

At the Battle 34 location, one borehole for vertical delineation can be drilled at the southern extent of the 4-foot excavation depth that is within the release area. At the East of Battle 34 location, drilling E. of Battle 34 Pooling may be possible if the drill rig can access the location which is on top of a sandhill.

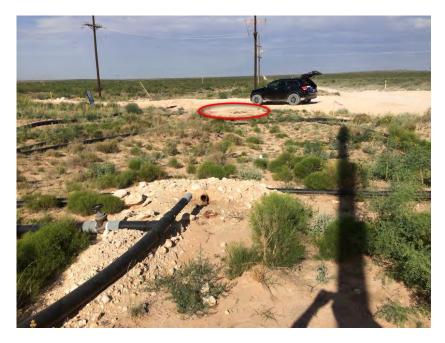
Figure M 2: Photograph viewing west-southwest along the east-west extent of spill area. The red circle is the same area as shown in Figure M1.

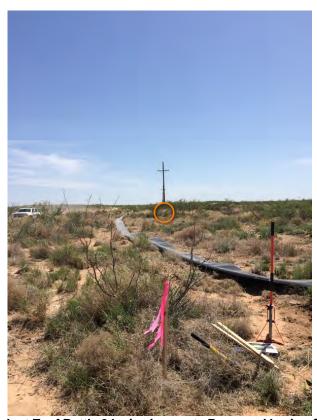
Figure M 3: Photograph at E. of Battle 34, viewing east. Proposed boring Southwest (foreground) and Southeast (background, orange circle) are identified by pink flagging. Powerlines are directly overhead. Drill rig requires 20-feet of clearance from powerlines.

Exhibit M1 shows the "Battle 34" and "East of Battle 34" relative to overhead powerlines and surface flowlines. Boreholes Battle 34 North, Battle 34 Pooling, Southwest, Southeast, and East of Battle 34 Pooling cannot be drilled as requested by NMOCD. These boreholes are either directly below an overhead powerline or within 20-feet of a powerline. Therefore, vertical delineation is not possible in these areas. Surface restoration will occur on the upper four feet or to the extent practical, whichever is less – with a liner placed at total-depth.

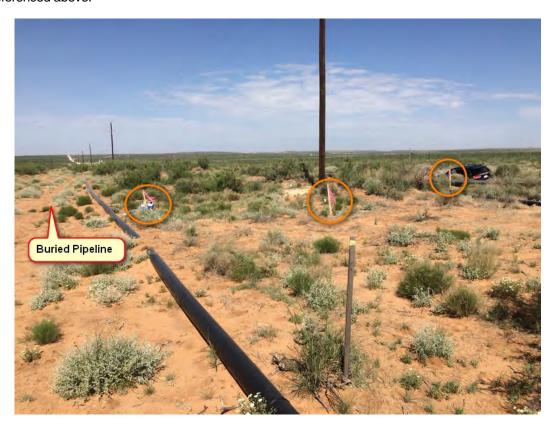
Figure M4 shows the powerlines and flowlines that restrict drilling access for the three boreholes referenced above.

Figure M 4: Photograph viewing west along powerline/pipelines. Powerlines and flowlines restrict access to drill rig. Proposed boreholes are identified with pink flagging (see orange circles). From left to right: 32 26 50 South, 32 26 50 East, and 32 26 50 Pooling.

Exhibit M2 shows the Latitude location relative to overhead powerlines and surface flowlines. Boreholes 32 26 50 Pooling, 32 26 50 East, and 32 26 50 South cannot be drilled as requested by NMOCD. These boreholes are either directly below an overhead powerline or within 20-feet of a powerline. Therefore, vertical delineation is not possible in these areas. Surface restoration will occur on the upper four feet or to the extent practical, whichever is less – with a liner placed at total-depth.

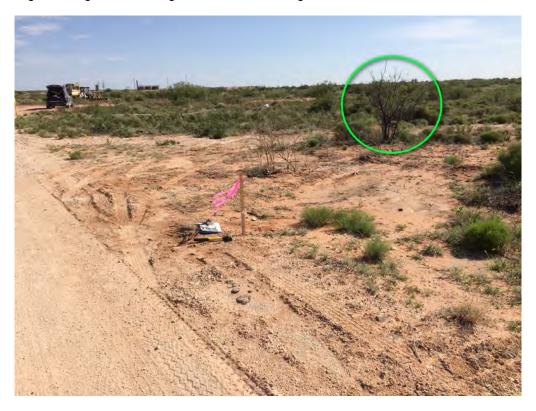
Exhibit M3 shows the W. of Merchant location relative to the release extent. No obstructions exist at this location. Figure M5 shows the southern proposed excavation area during our July 2018 staking. Figure M6 shows the southern release extent from the March 2018 sampling. The green circle identifies a mesquite bush present in both figures for perspective. The southern release extent is beginning to undergo natural revegetation as shown in Figure M5.

Figure M 5: Photograph of the southern release extent viewing north-northeast. The release extent shows signs of natural revegetation. The green circled mesquite bush is the same bush show in Figure M 6.

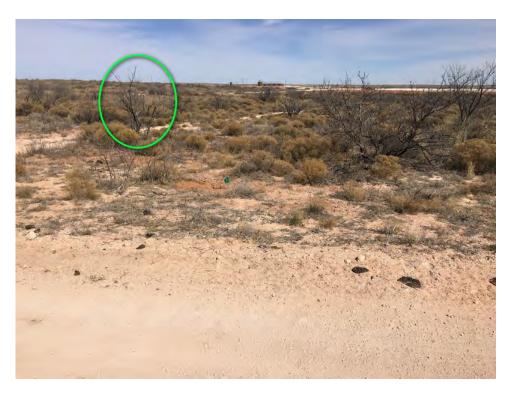
Figure M 6: Photograph of the southern release extent viewing east-northeast. The dark green pin flag (photo center) is the location of a March 2018 sample point. The green circled mesquite bush is the same bush in Figure M 5.

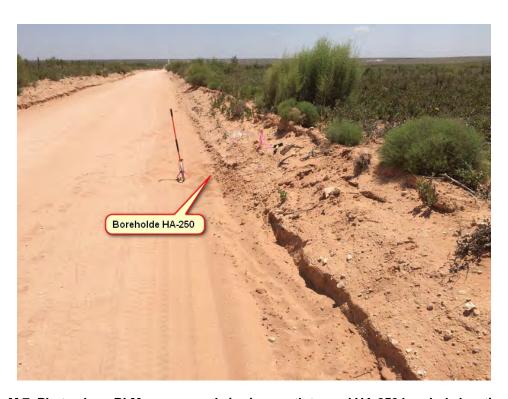
Exhibit M4 shows the Tomahawk SWD location relative to the tank battery and well pad. Sample HA-250 along the roadside ditch may not be accessible without grading an area along the west side of the road (Figure M7), which is on BLM surface. Figure M8 shows the area around HA-4 (Trench 4). This area is undergoing natural revegetation and does not need to be restored. Furthermore, it lies within a drainage.

Figure M 7: Photo along BLM access road viewing south toward HA-250 borehole location. To drill at this location will involve grading the bar ditch and destroying vegetation. An arch clearance may be required prior to any grading activities.

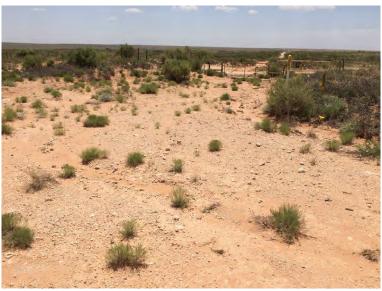
Figure M 8: Photograph of the HA-4 (Trench 4) area viewing west-southwest toward a caliche road along BLM surface. The area is undergoing natural revegetation and does not need to be restored.

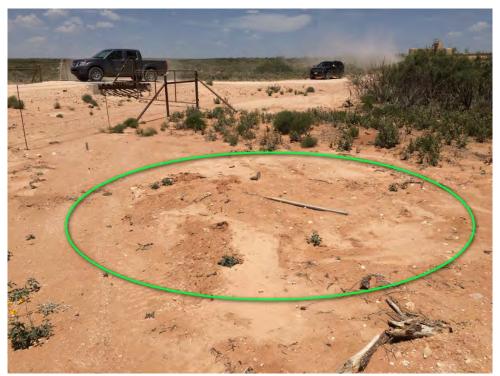
Figure M 9: Excavated material, in the area of Trench 5, from the March 2018 sampling event to be removed during restoration activities.

Figure M9 shows excavated material from the March 2018 sampling event from the area within Trench 5. The excavated material will be removed and the area restored.

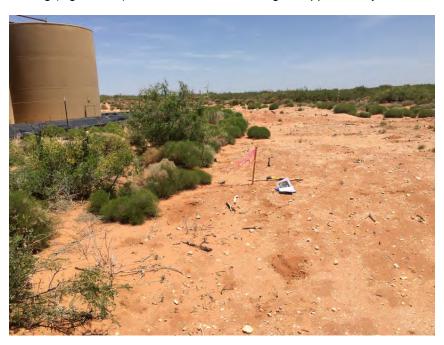
Exhibit M6 shows the location relative to the release extent and nearby infrastructure. As shown in Exhibit M6, three locations are identified for vertical delineation. All three locations are not suitable for drilling. Borehole SP-16 is located near a buried pipeline (Figure M10). Moving the location to the north will place the borehole out of the release area. Location 21 & 26 lies within an area that has vegetation growth. Accessing these two areas with a drill rig will cause unnecessary damage to the vegetation (Figures M11 and M12). Location 21 exhibits evidence of the release as indicated by hydrocarbon staining (Figure M13). We recommend restoring the upper soil layer in this area.

Figure M 10: Photo of proposed location of borehole SP-16. The location is within a pipeline easement. The COOP6 State 1H tank battery is visible photo left.

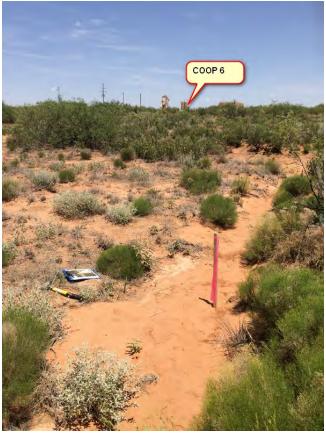
Figure M 11: Photograph of SP-26 viewing east toward the COOP 6 State 1H location. The release is within a small undefined drainage. The surround area supports vegetation.

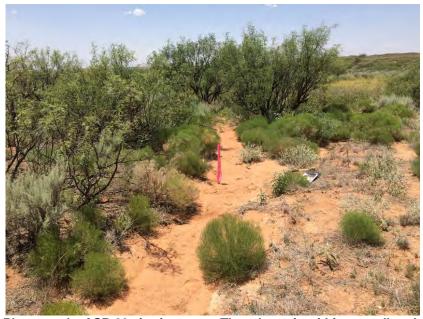
Figure M 12: Photograph of SP-26 viewing west. The release is within a small undefined drainage. The surround area supports vegetation.

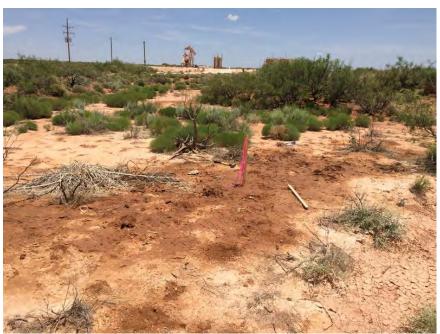
Figure M 13: Photograph of the hydrocarbon surface staining at SP-21.

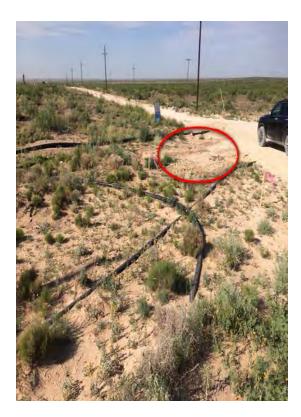
Furthermore, Figures M1 & M2 shows the area is undergoing natural revegetation with the exception of the areas outlined by a red circle, which is suitable for one borehole for vertical delineation. Figure M3 shows the powerlines and flowlines that restrict drilling access at East of Battle 34.

Figure M 1: Photograph viewing south along access road. The red circle is a potential location for one borehole for vertical delineation that is within the spill release area. The remaining spill area is undergoing natural revegetation. Numerous on-surface flowlines cross the area.

At the Battle 34 location, one borehole for vertical delineation can be drilled at the southern extent of the 4-foot excavation depth that is within the release area. At the East of Battle 34 location, drilling E. of Battle 34 Pooling may be possible if the drill rig can access the location which is on top of a sandhill.

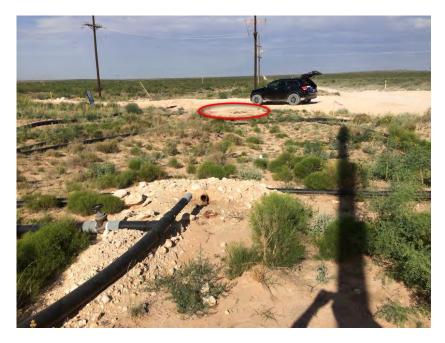
Figure M 2: Photograph viewing west-southwest along the east-west extent of spill area. The red circle is the same area as shown in Figure M1.

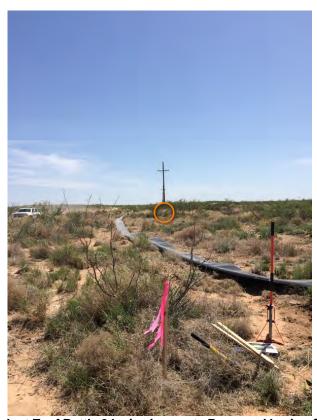
Figure M 3: Photograph at E. of Battle 34, viewing east. Proposed boring Southwest (foreground) and Southeast (background, orange circle) are identified by pink flagging. Powerlines are directly overhead. Drill rig requires 20-feet of clearance from powerlines.

Exhibit M1 shows the "Battle 34" and "East of Battle 34" relative to overhead powerlines and surface flowlines. Boreholes Battle 34 North, Battle 34 Pooling, Southwest, Southeast, and East of Battle 34 Pooling cannot be drilled as requested by NMOCD. These boreholes are either directly below an overhead powerline or within 20-feet of a powerline. Therefore, vertical delineation is not possible in these areas. Surface restoration will occur on the upper four feet or to the extent practical, whichever is less – with a liner placed at total-depth.

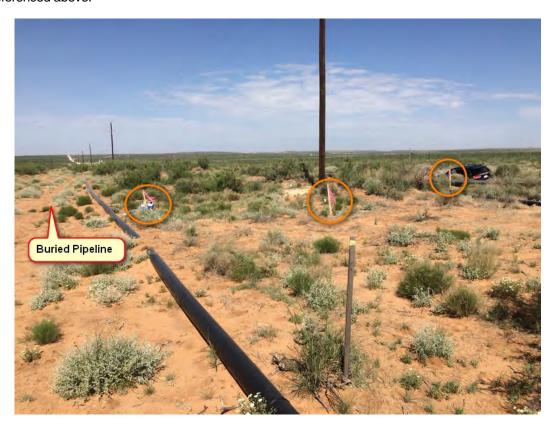
Figure M4 shows the powerlines and flowlines that restrict drilling access for the three boreholes referenced above.

Figure M 4: Photograph viewing west along powerline/pipelines. Powerlines and flowlines restrict access to drill rig. Proposed boreholes are identified with pink flagging (see orange circles). From left to right: 32 26 50 South, 32 26 50 East, and 32 26 50 Pooling.

Exhibit M2 shows the Latitude location relative to overhead powerlines and surface flowlines. Boreholes 32 26 50 Pooling, 32 26 50 East, and 32 26 50 South cannot be drilled as requested by NMOCD. These boreholes are either directly below an overhead powerline or within 20-feet of a powerline. Therefore, vertical delineation is not possible in these areas. Surface restoration will occur on the upper four feet or to the extent practical, whichever is less – with a liner placed at total-depth.

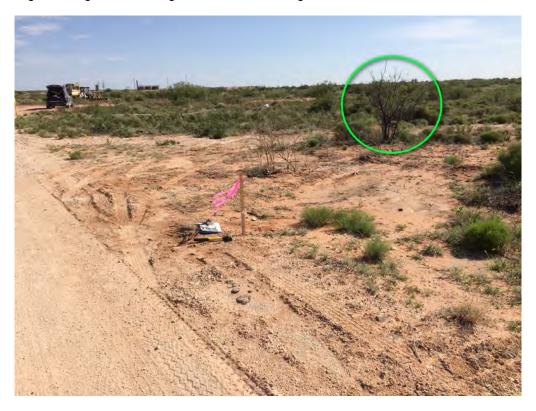
Exhibit M3 shows the W. of Merchant location relative to the release extent. No obstructions exist at this location. Figure M5 shows the southern proposed excavation area during our July 2018 staking. Figure M6 shows the southern release extent from the March 2018 sampling. The green circle identifies a mesquite bush present in both figures for perspective. The southern release extent is beginning to undergo natural revegetation as shown in Figure M5.

Figure M 5: Photograph of the southern release extent viewing north-northeast. The release extent shows signs of natural revegetation. The green circled mesquite bush is the same bush show in Figure M 6.

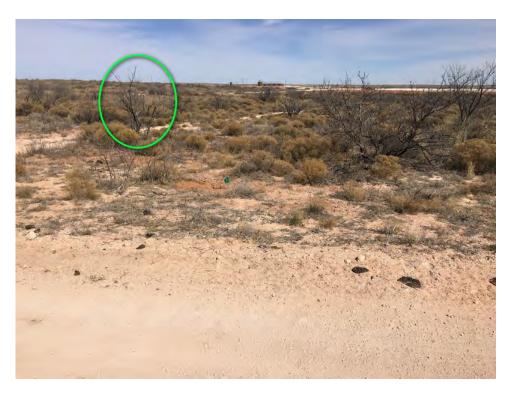
Figure M 6: Photograph of the southern release extent viewing east-northeast. The dark green pin flag (photo center) is the location of a March 2018 sample point. The green circled mesquite bush is the same bush in Figure M 5.

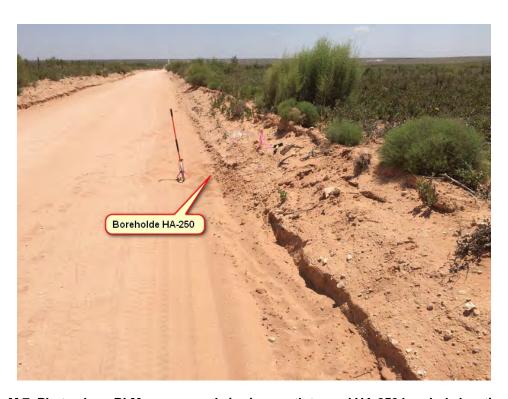
Exhibit M4 shows the Tomahawk SWD location relative to the tank battery and well pad. Sample HA-250 along the roadside ditch may not be accessible without grading an area along the west side of the road (Figure M7), which is on BLM surface. Figure M8 shows the area around HA-4 (Trench 4). This area is undergoing natural revegetation and does not need to be restored. Furthermore, it lies within a drainage.

Figure M 7: Photo along BLM access road viewing south toward HA-250 borehole location. To drill at this location will involve grading the bar ditch and destroying vegetation. An arch clearance may be required prior to any grading activities.

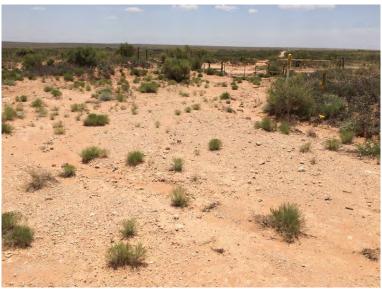
Figure M 8: Photograph of the HA-4 (Trench 4) area viewing west-southwest toward a caliche road along BLM surface. The area is undergoing natural revegetation and does not need to be restored.

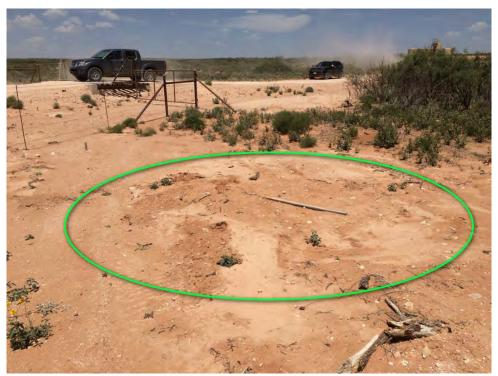
Figure M 9: Excavated material, in the area of Trench 5, from the March 2018 sampling event to be removed during restoration activities.

Figure M9 shows excavated material from the March 2018 sampling event from the area within Trench 5. The excavated material will be removed and the area restored.

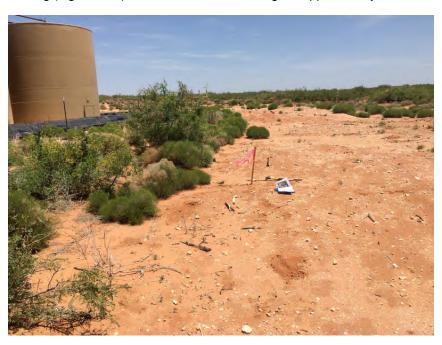
Exhibit M6 shows the location relative to the release extent and nearby infrastructure. As shown in Exhibit M6, three locations are identified for vertical delineation. All three locations are not suitable for drilling. Borehole SP-16 is located near a buried pipeline (Figure M10). Moving the location to the north will place the borehole out of the release area. Location 21 & 26 lies within an area that has vegetation growth. Accessing these two areas with a drill rig will cause unnecessary damage to the vegetation (Figures M11 and M12). Location 21 exhibits evidence of the release as indicated by hydrocarbon staining (Figure M13). We recommend restoring the upper soil layer in this area.

Figure M 10: Photo of proposed location of borehole SP-16. The location is within a pipeline easement. The COOP6 State 1H tank battery is visible photo left.

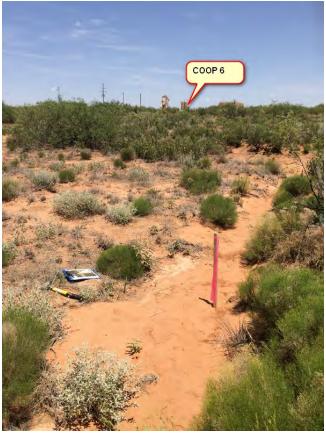
Figure M 11: Photograph of SP-26 viewing east toward the COOP 6 State 1H location. The release is within a small undefined drainage. The surround area supports vegetation.

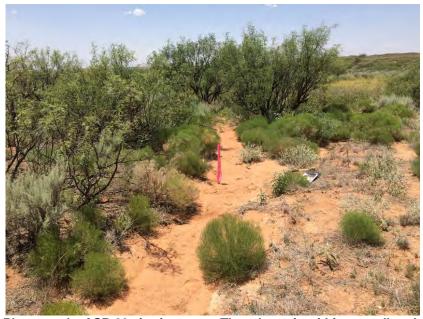
Figure M 12: Photograph of SP-26 viewing west. The release is within a small undefined drainage. The surround area supports vegetation.

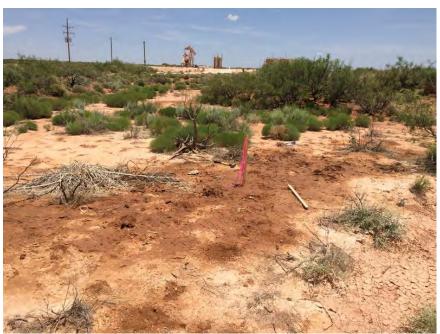
Figure M 13: Photograph of the hydrocarbon surface staining at SP-21.
