Release Notification

Responsible Party	XTO Energy, Inc.	OGRID	5380
Contact Name	Shelby Pennington, Environmental Supervisor	Contact Telephone	(281) 723-9353
Contact email	shelby_pennington@xtoenergy.com	Incident #	NCH1828535092 EUNICE
Contact mailing address	6401 Holiday Hill Road, Midland, TX 79707		MONUMENT SOUTH UNIT B #857 (EMSU B #857) @ 30-025-04220

Site Name	Eunice Monument South Unit B #857 (EMSU B #857)	Site Type	Wellhead location
Date Release Discovered	September 22, 2018 (0645 Hrs MDT)	API# (if applicable)	30-025-04220

XTO Energy, Inc. - EMSU B #857 Release

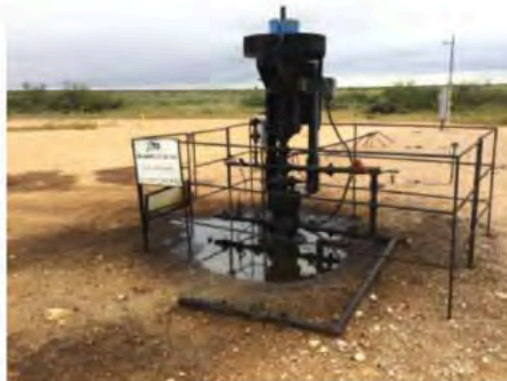
EMSU B #857 Wellhead

EMSU B #857 Wellhead. Leak has been repaired.
Worker was present on-site at time of Sport
Environmental's site visit to perform further checks on
repair work. Facing North

Lease operator found 1" nipple on EMSU B 857 wellhead with a pin hole in it due to corrosion.

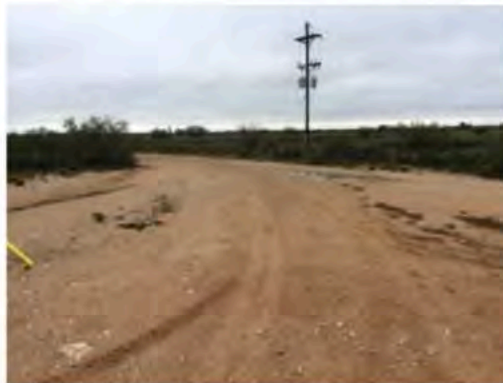
EMSU B #857 Release Path (View 1)

EMSU B #857 Release Path. Free liquids have been removed. Some pooled rainwater is present - no visible sheen observed. Facing South/Southeast

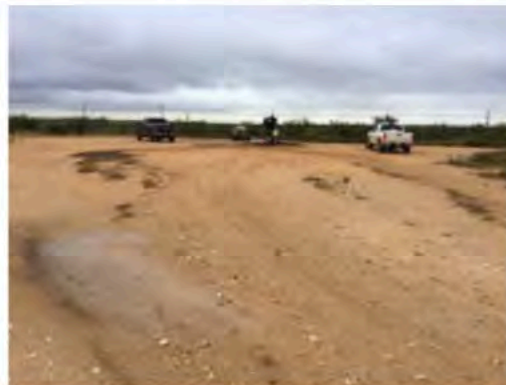
EMSU B #857 Release Path (View 2)

EMSU B #857 Release Path. Free liquids have been removed. Minor staining is present. Facing South/Southwest

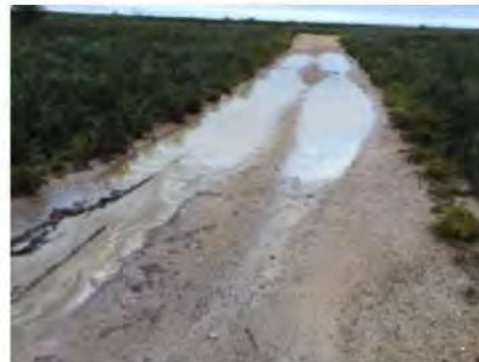
EMSU B #857 (Pooled Rainwater)

EMSU B #857 — Pooled Rainwater is present on the lease road.
