Site Characterization and Work Plan

Apache Corp. NEDU 503W Lea County, New Mexico Unit Letter "K", Section 10, Township 21 South, Range 37 East Latitude 32.4918556 North, Longitude 103.1526871 West NMOCD Reference #1RP-4371

March 2017

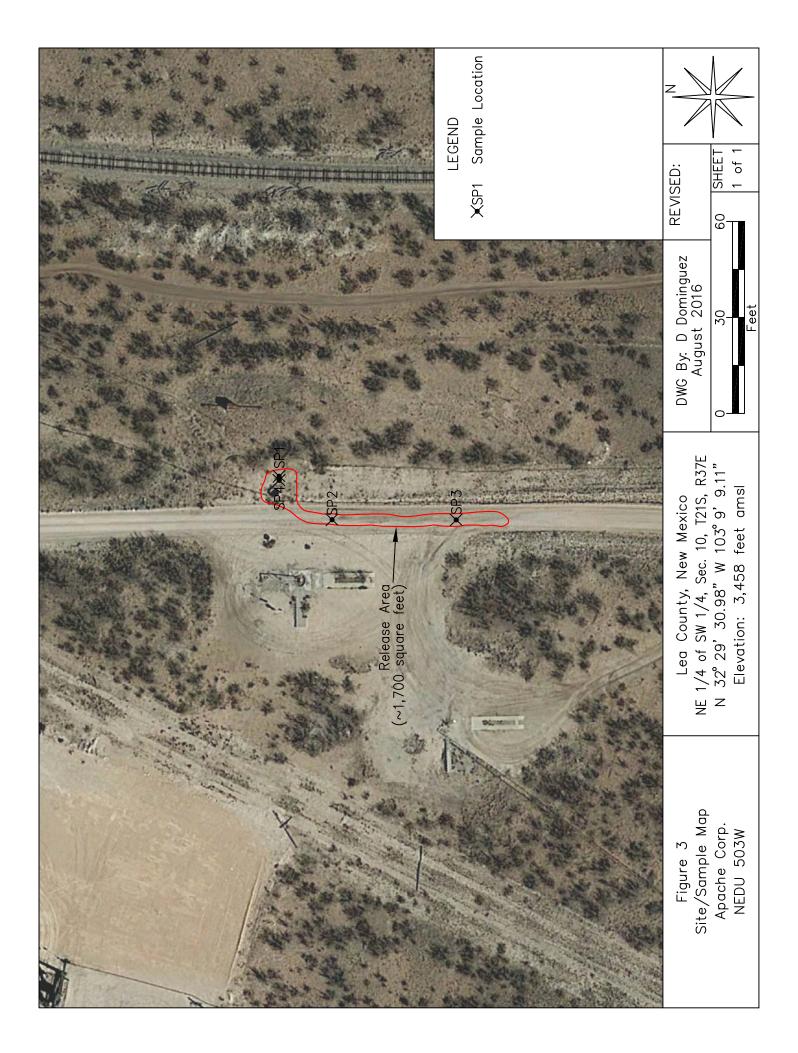
On July 1, July 7, and August 3, 2016, EPI personnel mobilized on site collect soil samples to determine the vertical extent of contamination. A total of eighteen soil samples were collected from four sample locations; SP1 – SP4. All samples were placed on ice and transported to Cardinal Labs in Hobbs, New Mexico for testing. Laboratory results indicate the release area to be void of Benzene, BTEX, and TPH concentrations in excess of NMOCD Recommended Remedial Action Levels (RRALs) of 10 mg/Kg, 50 mg/Kg, and 1,000 mg/Kg, respectively, in all samples. Chloride concentrations exceed NMOD RRALs of 500 mg/Kg at each sample location to varying depths (reference *Figure 3* and *Table 2*).

As per the March 8, 2017 Apache Corp. discussion with NMOCD personnel, EPI proposes to excavate the release area around SP1 and SP4 to a depth of two feet bgs. The area around SP2 and SP3 will be excavated to a depth of one foot bgs. No further sampling of the area will be required. As the release area is located on an active lease road, once excavation activities are complete, EPI proposes to backfill the excavation with clean soil. The road excavation will be backfilled with caliche; the pasture excavation will be backfilled with select topsoil. All soil will be free of rocks, clumps or deleterious material.

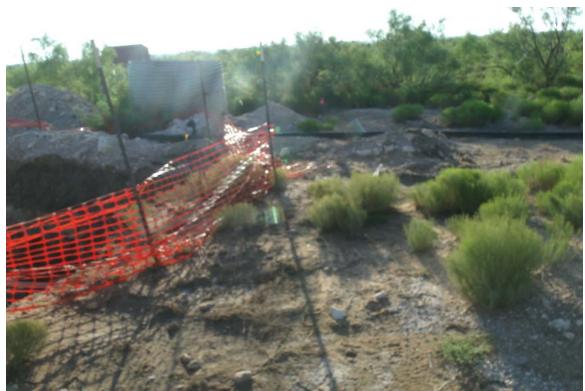
At the point of release the produced water covered an area about 20' x 30'. This area is loamy clay topsoil. The produced water traveled down a lease road approximately 140'. This area is highly compacted caliche.

Photograph #1- Point of release

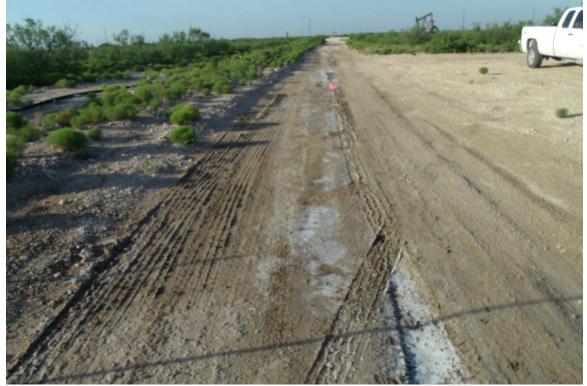
Photograph #2- Looking across release area.
