**Re: Site Assessment Report and Proposed Remediation Plan**

**Site Name: Lea Unit South Battery**

**NMOCD Ref. No. 1RP-5167**

Lowry Environmental & Associates, LLC (LEA), on behalf of Legacy Reserves Operating, LP, has prepared this Site Assessment Report and Proposed Remediation Plan for the Release Site known as the Lea Unit South Battery. Details of the release are summarized on the table below:

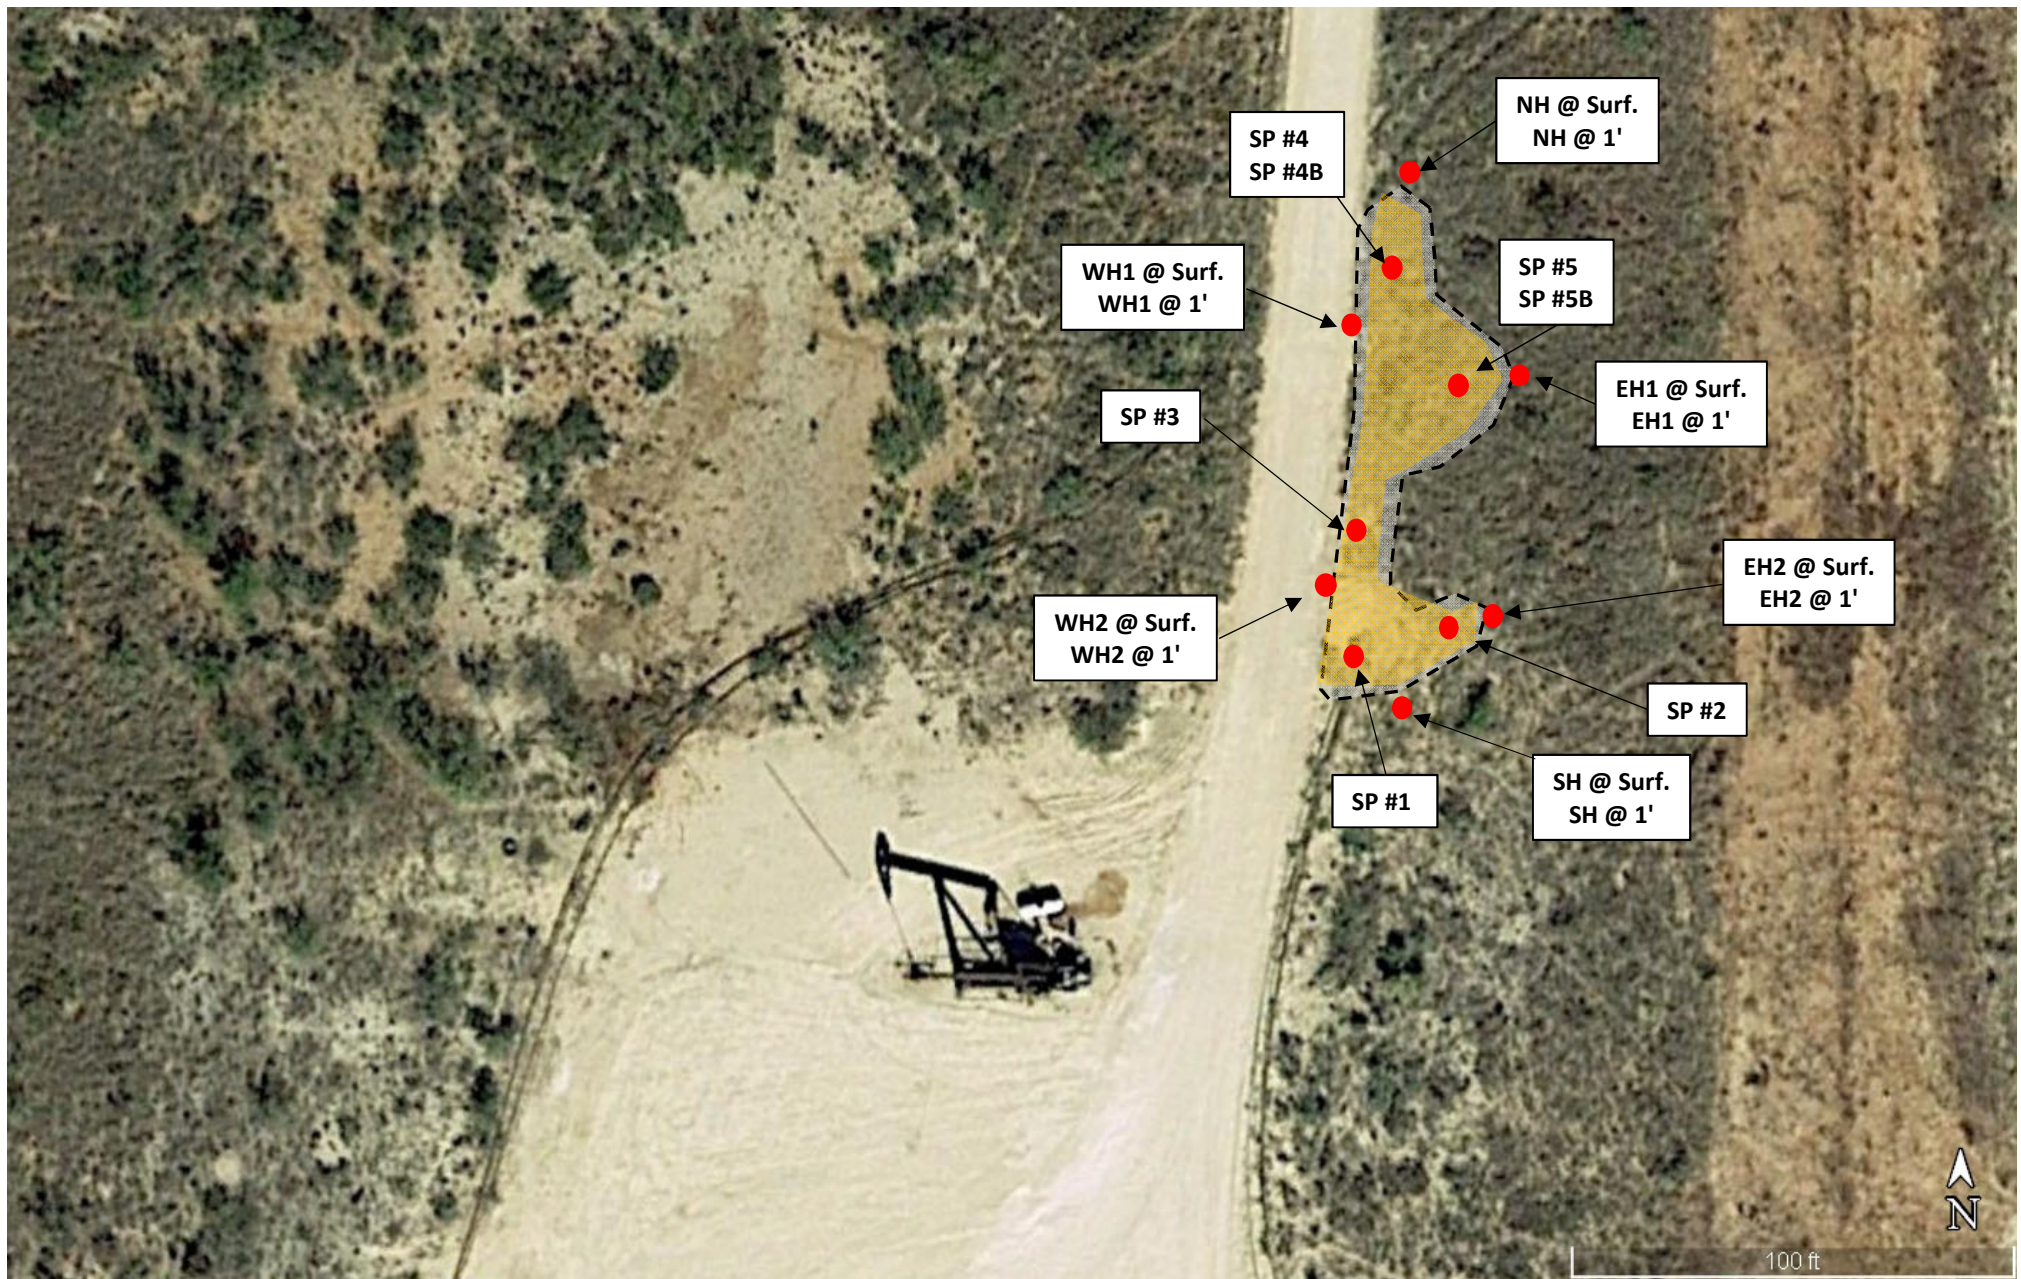
**Figure 3**

- Sample Location
- Affected Area
- Excavated Area

Site & Sample Location Map  
 Legacy Reserves Operating, LP  
 Lea Unit South Battery  
 GPS: 32.55722, -103.50805  
 Lea County, New Mexico

A "Site & Sample Location Map" is provided as Attachment #3. Field Data, if applicable, is provided as Attachment #9. Soil profile observations are provided on Attachment #5. Laboratory analytical reports are provided as Attachment #6.

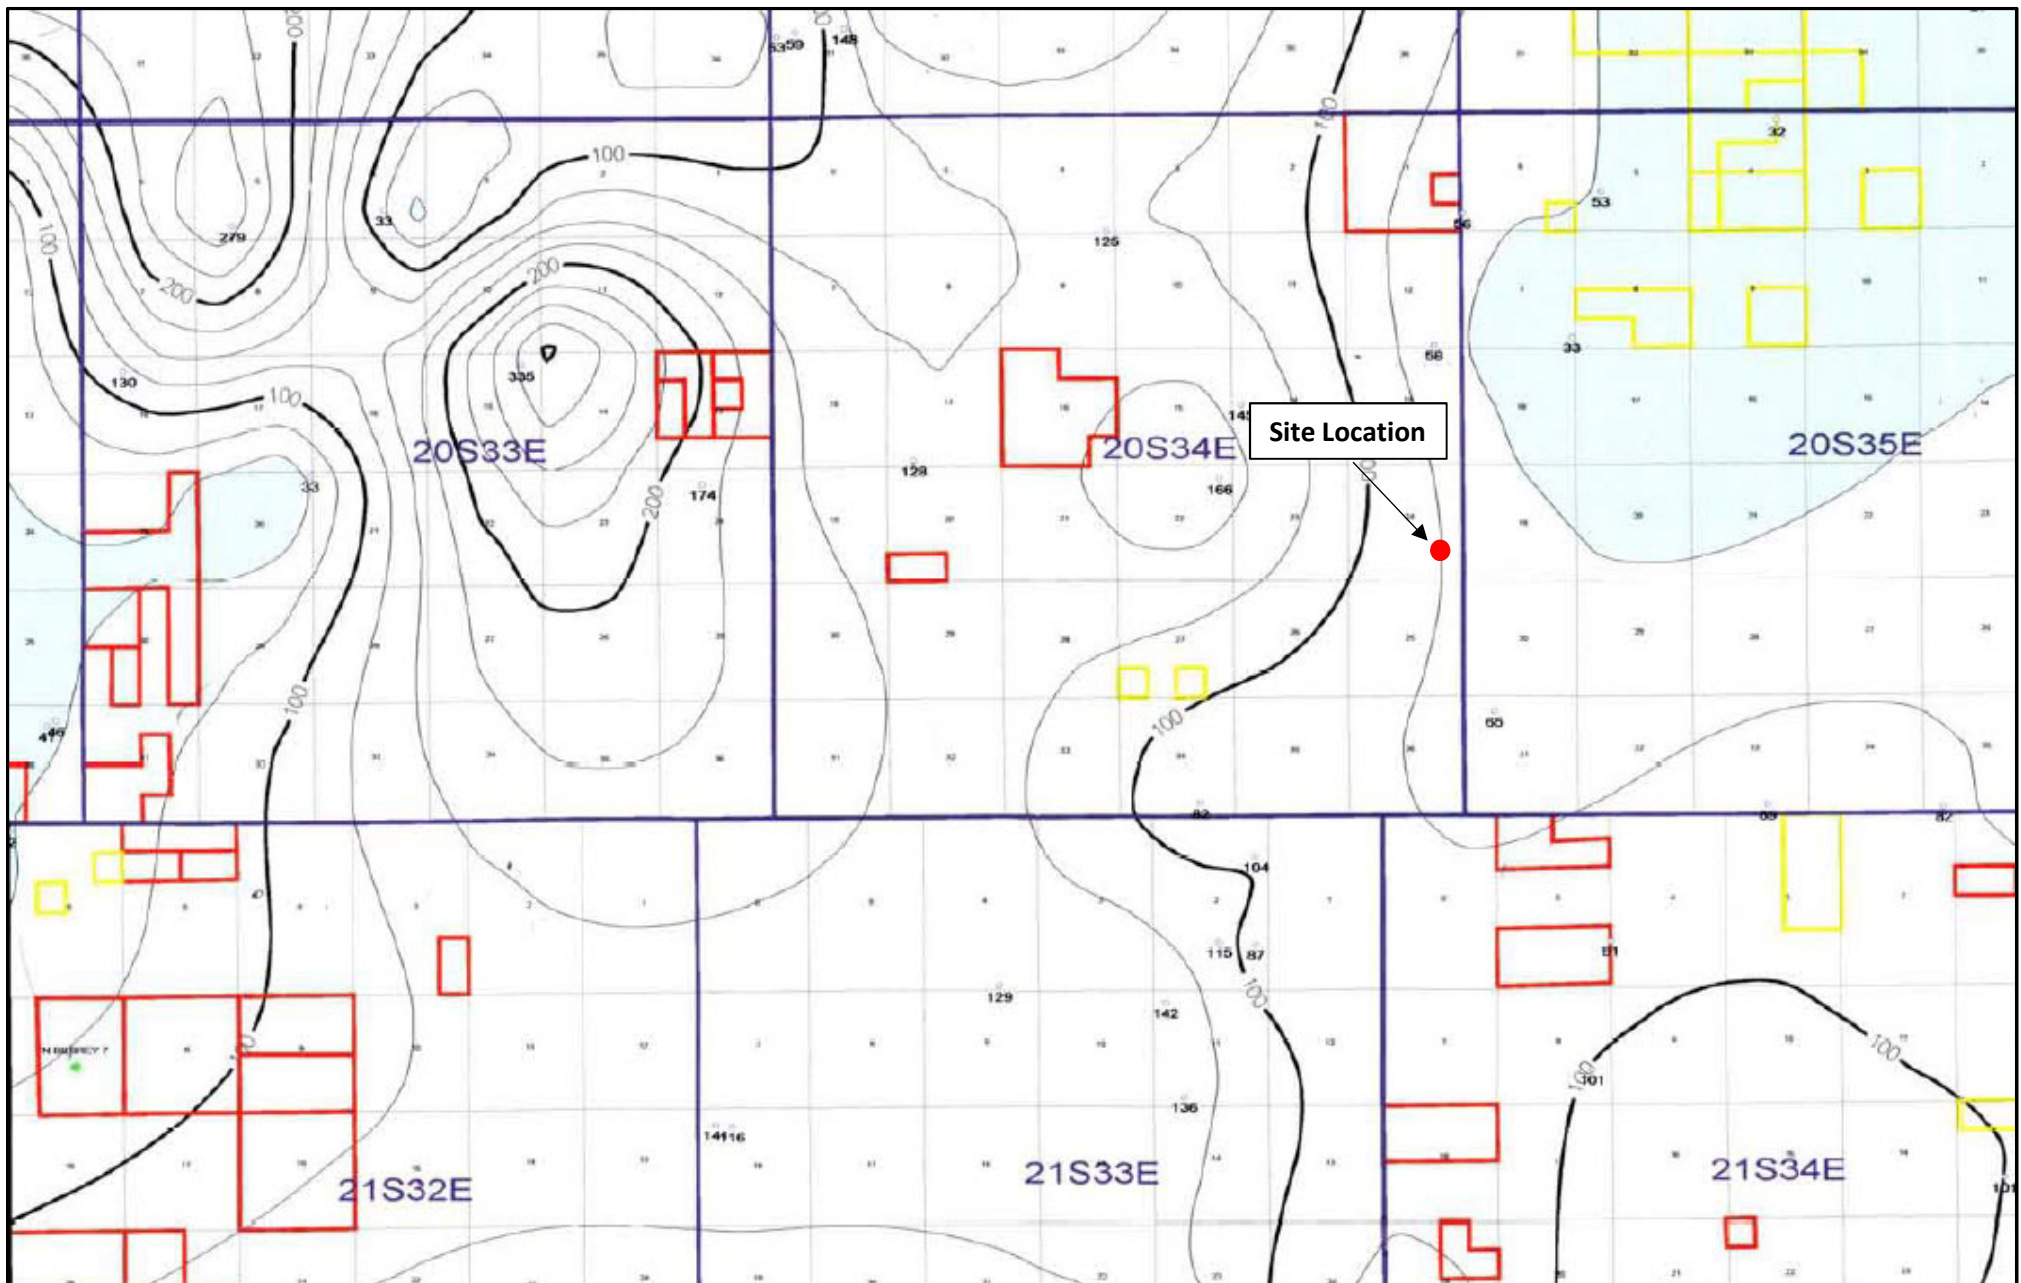
**Figure 4**

Inferred Depth to Groundwater Trend Map  
 Legacy Reserves Operating, LP  
 Lea Unit South Battery  
 GPS: 32.55722, -103.50805  
 Lea County, New Mexico

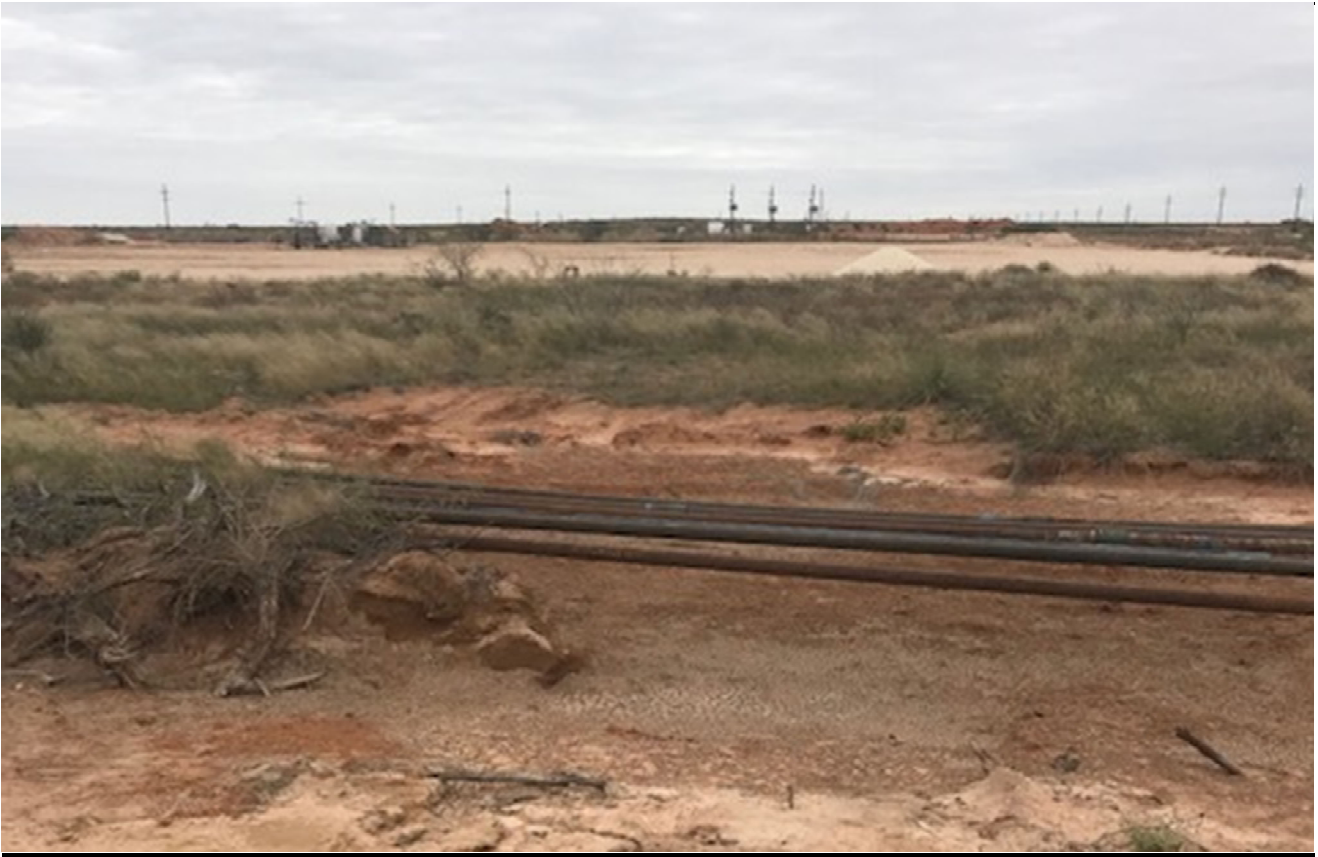
**Figure 1** View of portion of the excavated area, facing East.

- Utilizing mechanical equipment, excavate impacted soil within the release margins in the area characterized by sample points SP#3, SP#4 and SP#5 to a depth beyond 1 ft. bgs, until laboratory analytical results from confirmation soil samples indicate concentrations of BTEX, TPH and chloride are below the NMOCD Closure Criteria.

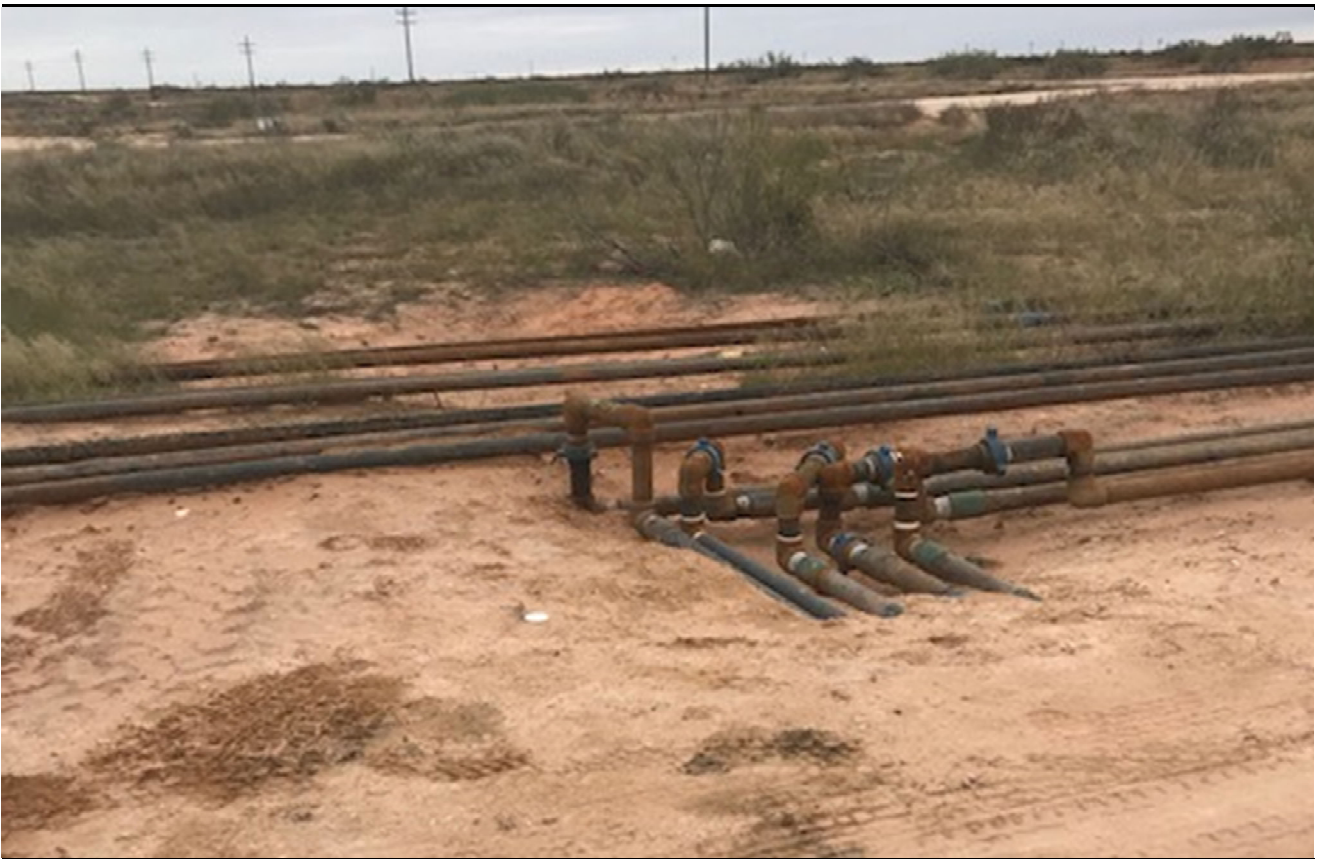
**Figure 2** View of portion of the excavated area, facing East.

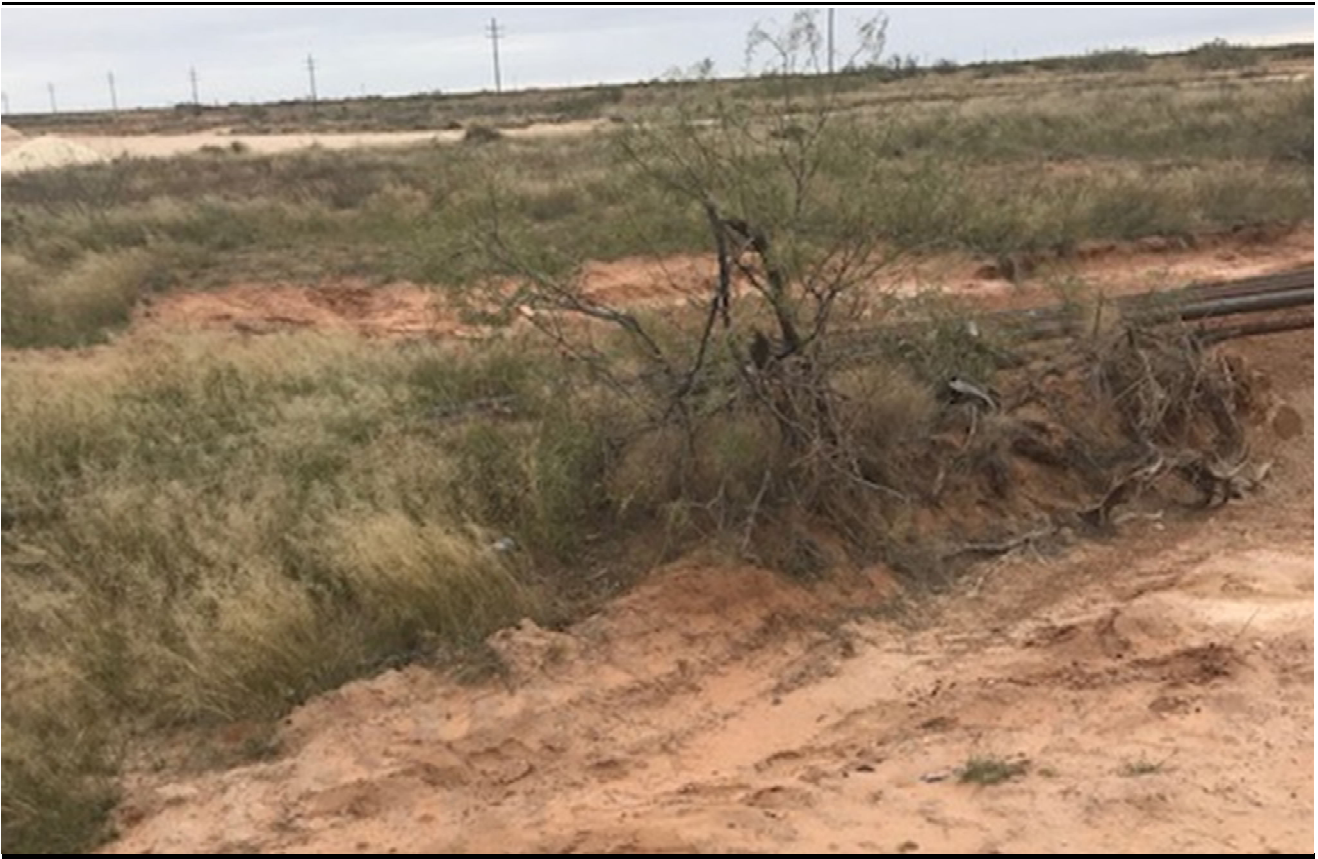
**Figure 3** View of portion of the excavated area, facing East.

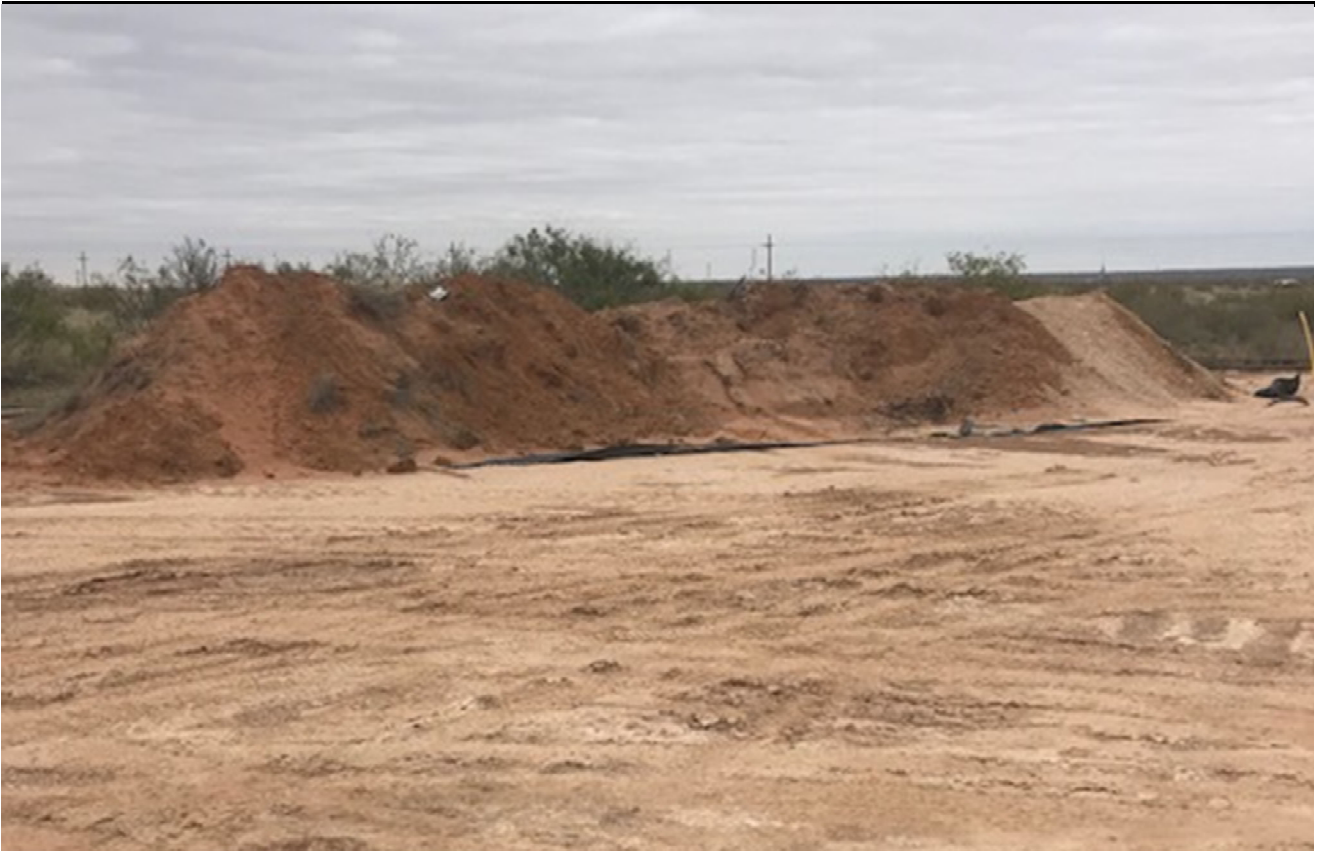
**Figure 4** View of soil excavated during initial remediation activities.

- Excavated soil will be temporarily stockpiled on-site, pending transportation under manifest to an NMOCD-approved disposal facility.
- Upon receiving favorable laboratory analytical results from confirmation soil samples (below the NMOCD Closure Criteria) excavated areas will be backfilled with locally sourced, non-impacted "like" material. Excavation backfill will be placed at or near original relative positions. The affected area will be contoured and/or compacted to achieve erosion control, stability and preservation of surface water flow to the extent practicable.

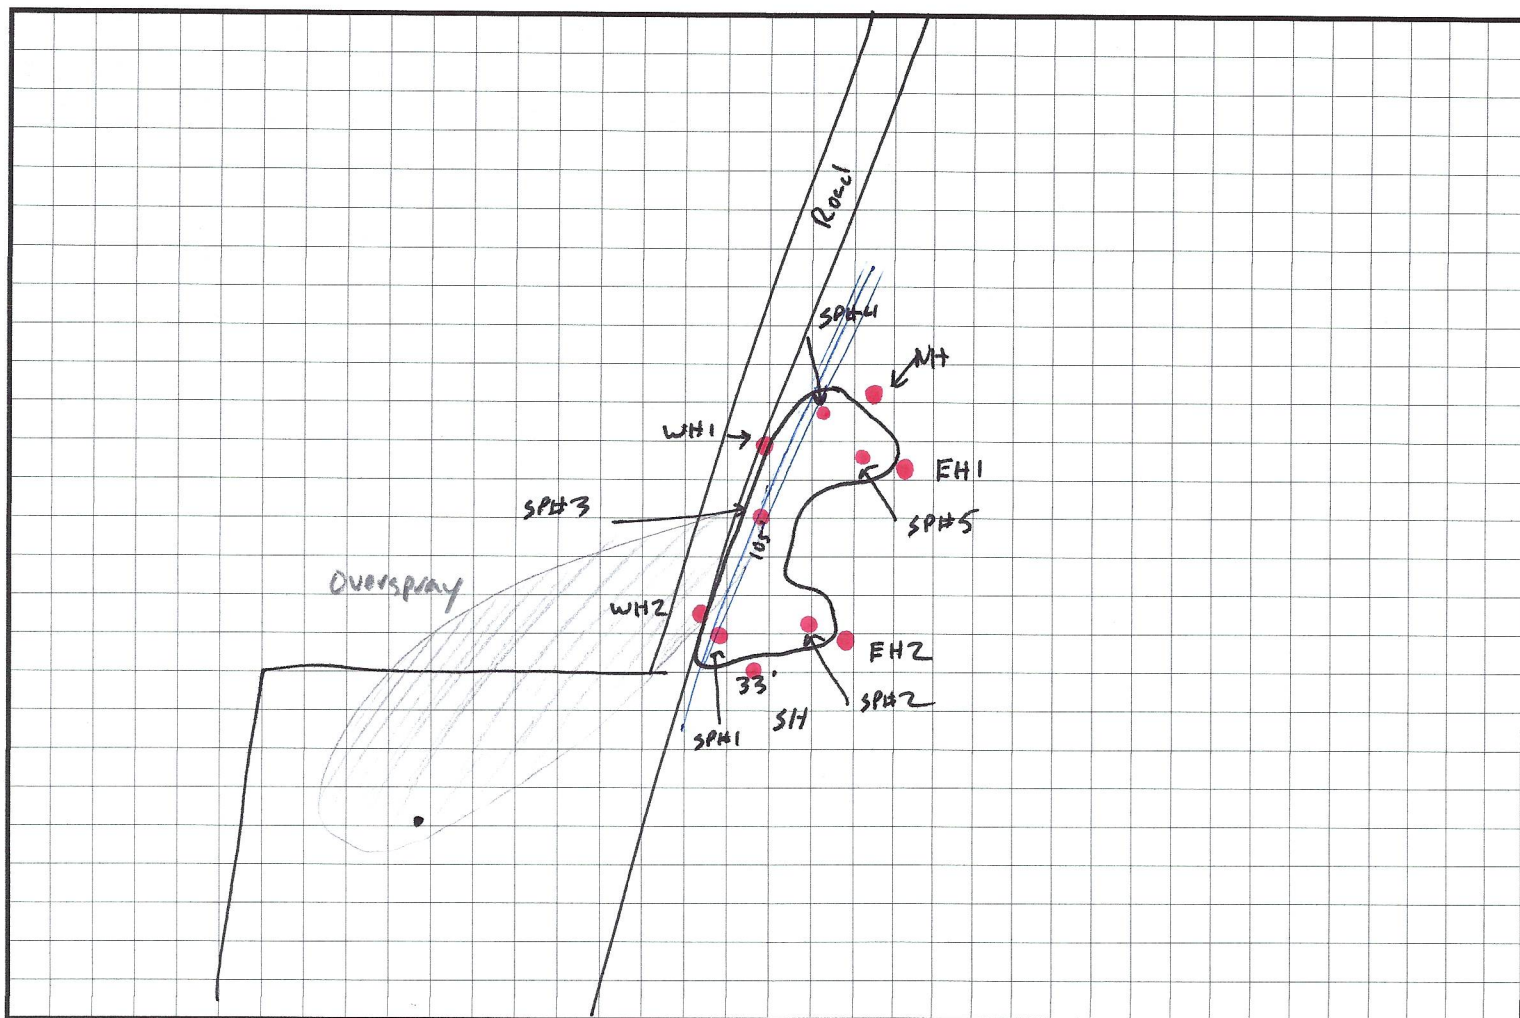
Check Microblate treatment of overspray, will require additional scraping

Collect samples necessary for Workplan
