REMEDIATION PROGRESS REPORT AND CLOSURE PROPOSAL

SKELLY BAKER HISTORICAL RELEASE
NMOCD REF. #1RP-2638

UL-F (SE1/4 OF THE NW1/4) OF SECTION 27, T22S, R37E

EUNICE, LEA COUNTY, NEW MEXICO

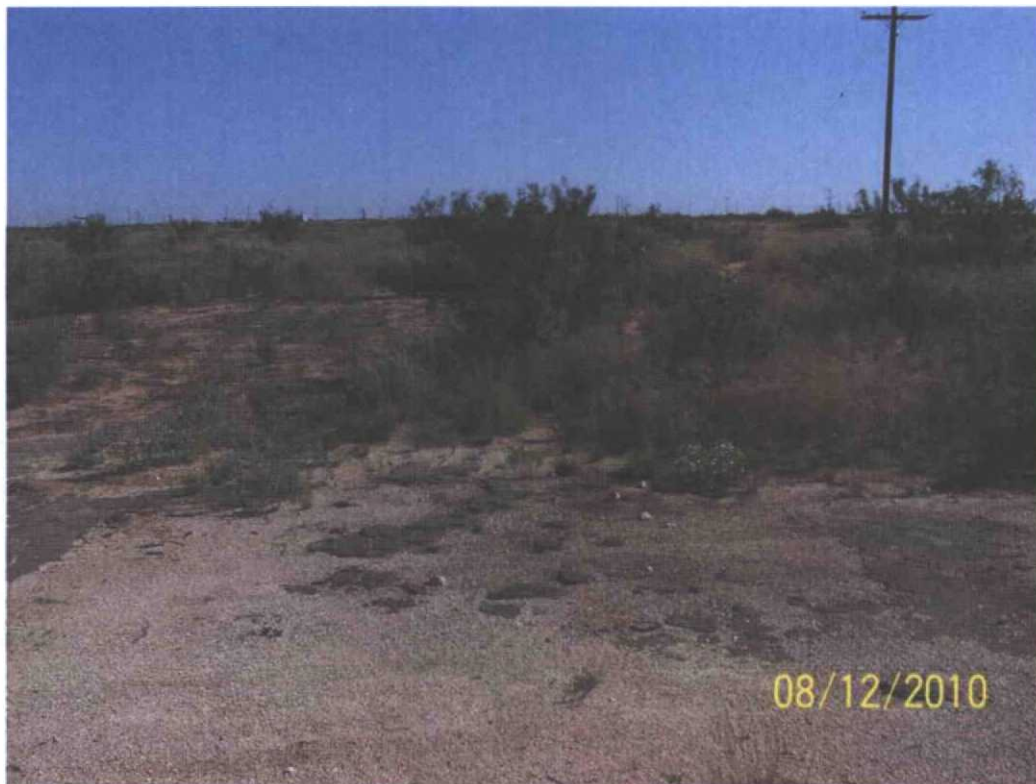
Photograph No. 1 – Looking northerly at asphaltine and historic overflow area

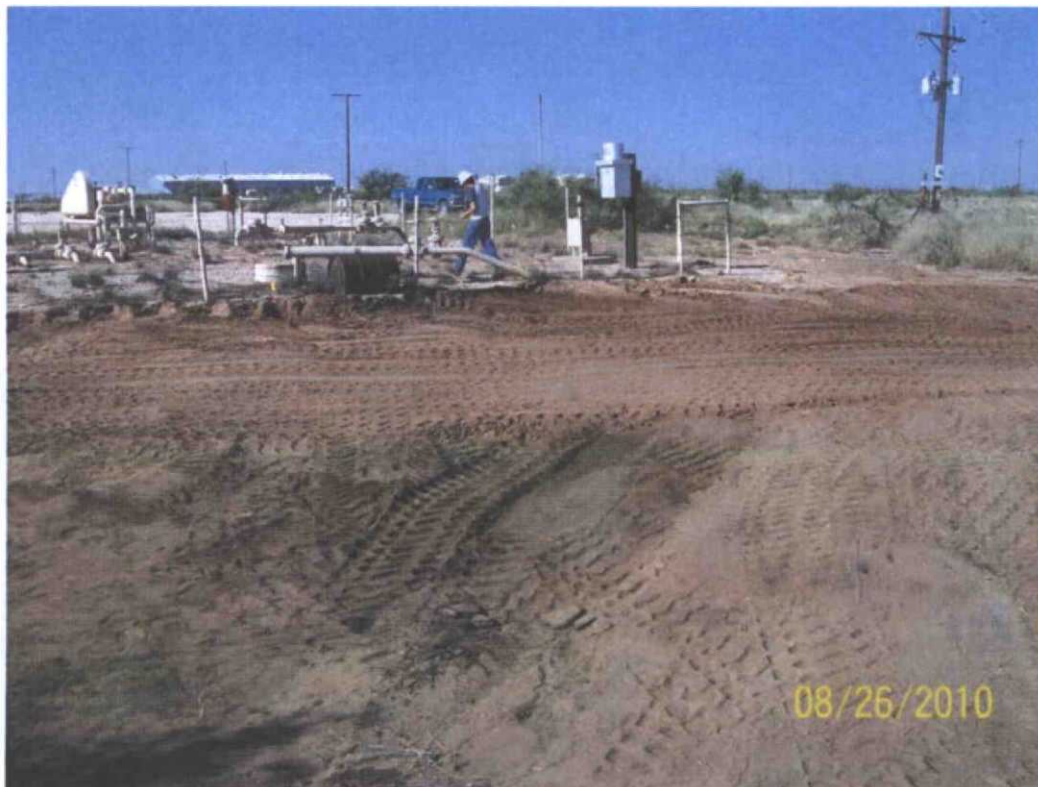
Photograph No. 3 – Looking southerly at Pump Station and partially remediated historic overflow area

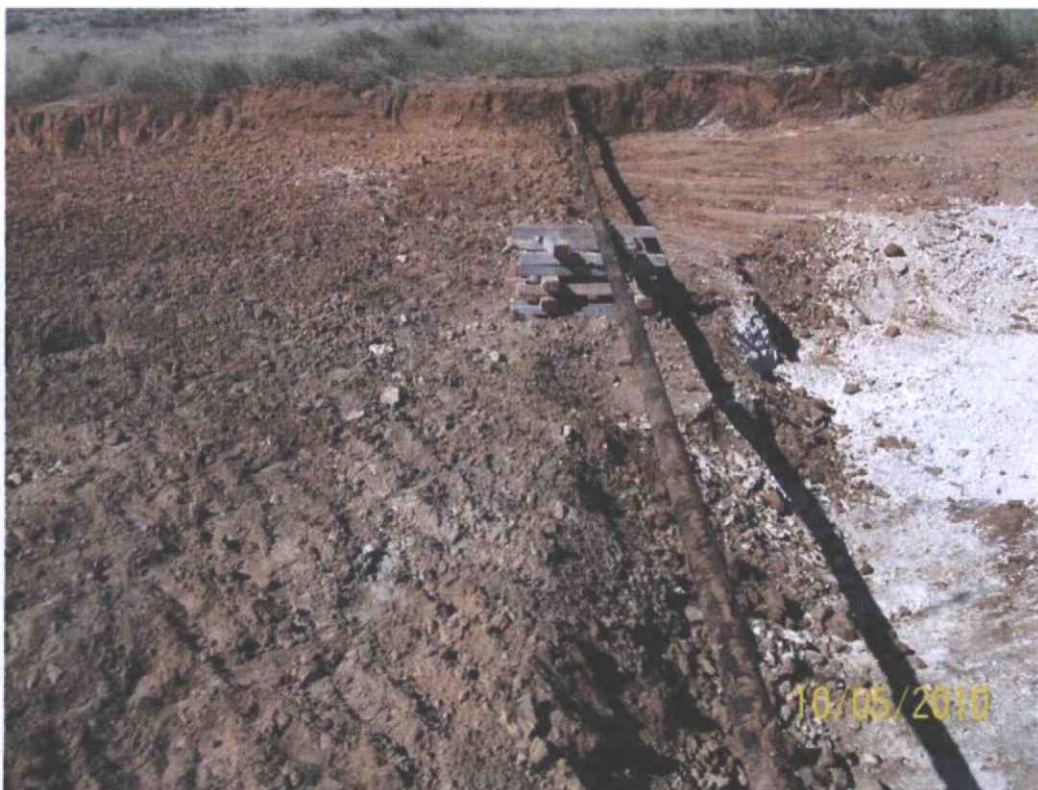
Photograph No. 4 – Looking northerly at initial excavated area and active pipeline supported with wooden brace

Permanent steel pipe support(s) will be constructed to hold the over head steel pipeline and wooden braces removed. The northerly sector of contaminated sidewall will be excavated laterally until soil sample field tests from confirm TPH concentrations are below NMOCD Goals. Soil samples will be collected from the north sidewall and remitted to an independent laboratory for BTEX and TPH concentrations as detailed in the previous paragraph. Upon receipt of laboratory analysis confirming the northerly wall is below NMOCD Goals, backfilling of the excavation will resume.

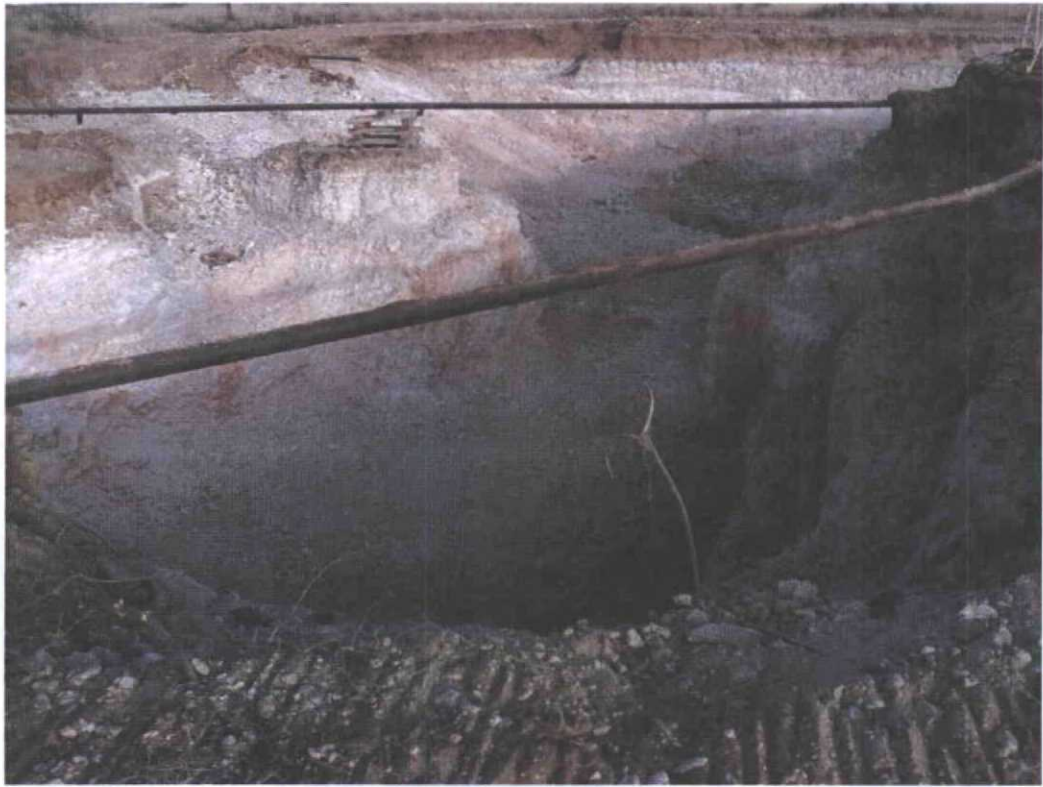
Photograph No. 5 – Looking northeasterly at excavation, active lines and wooden brace

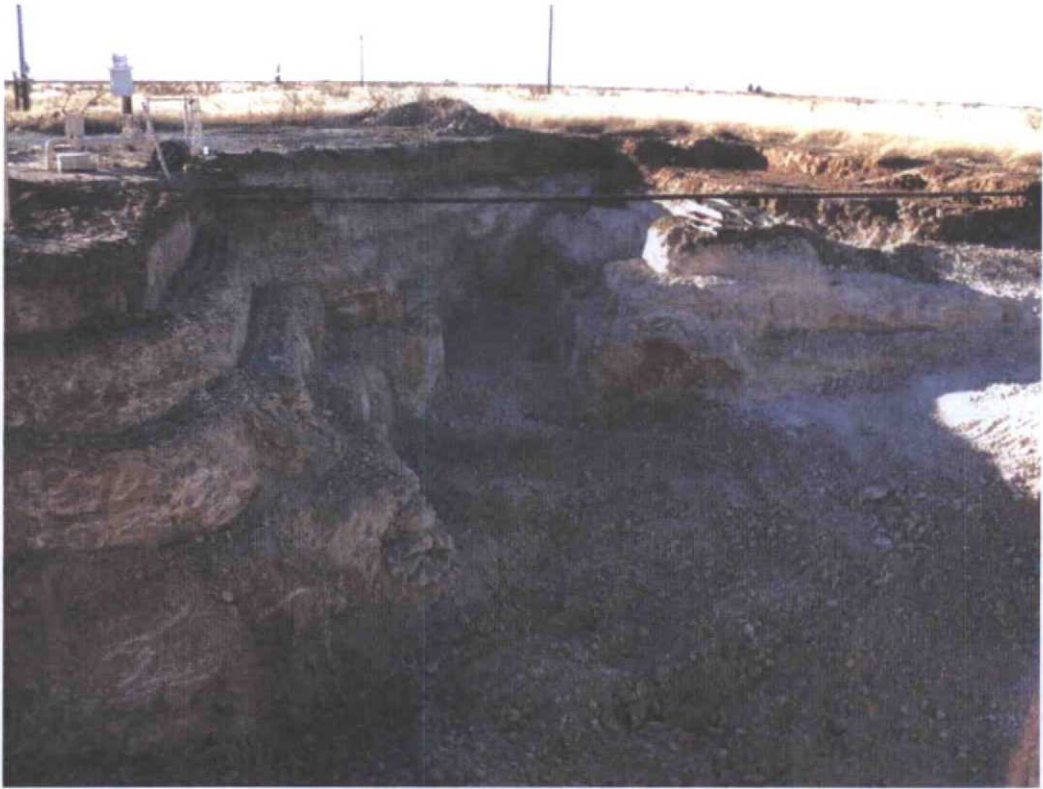
Photograph No. 6 – Looking westerly at excavation, active pipeline supported by wooden brace and southerly wall adjacent to Pump Station
