Pit or Below-Grade Tank Registration or Closure

# ***Bell Lake Federal #27***

## ***Reserve Drilling Pit Closure Report***

***Phoenix Environmental, LLC.***

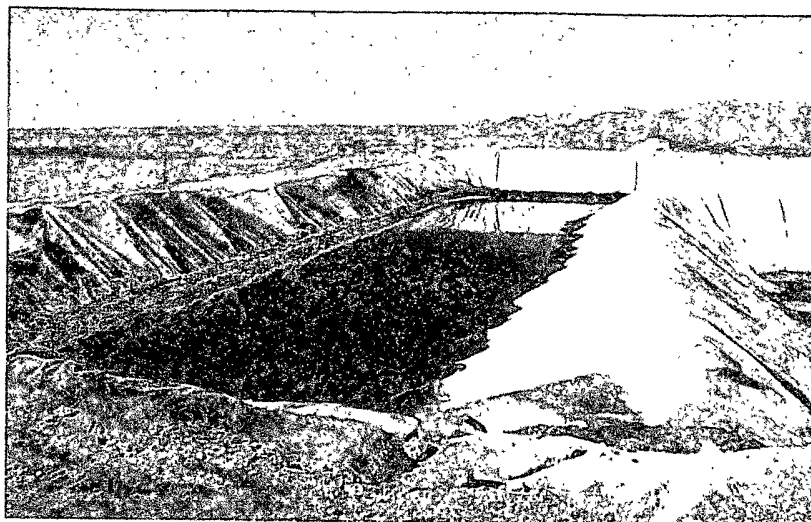
*Photo #1 Beginning View*

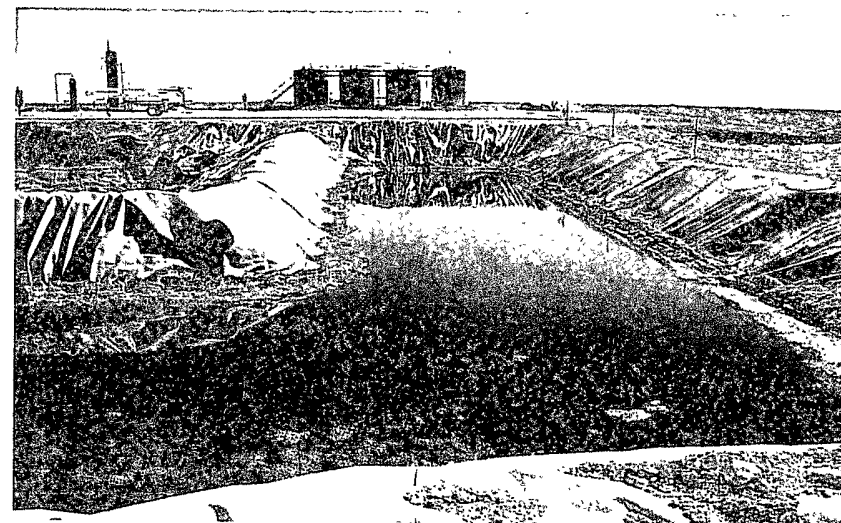
*Photo #2 Beginning View*

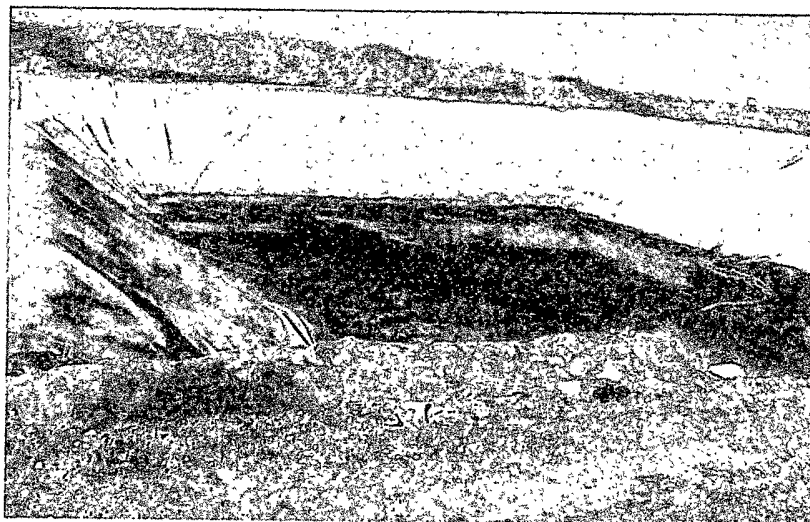
*Photo #3 Beginning View*

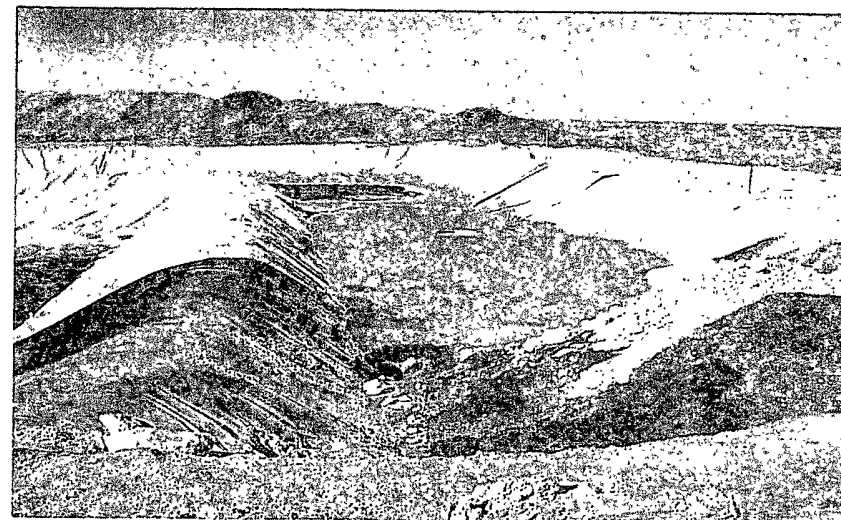
*Photo #4 Beginning View*

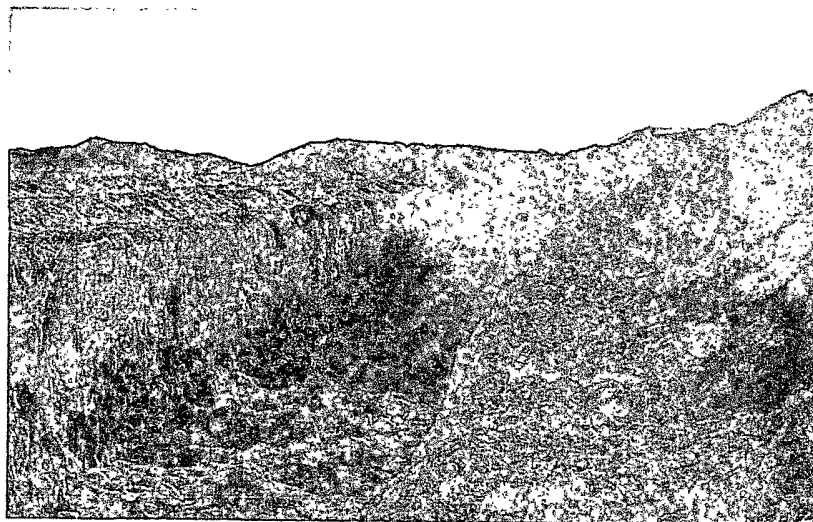
*Photo #5 Excavation of the Deep Bury (entombment) Pit*

2. *February 19, 2008 – The crew started digging the deep bury (entombment) pit.*
3. *February 20 thru 22, 2008 – Crew continued to dig a deep bury (entombment) pit to hold reserve drilling pit contents.*

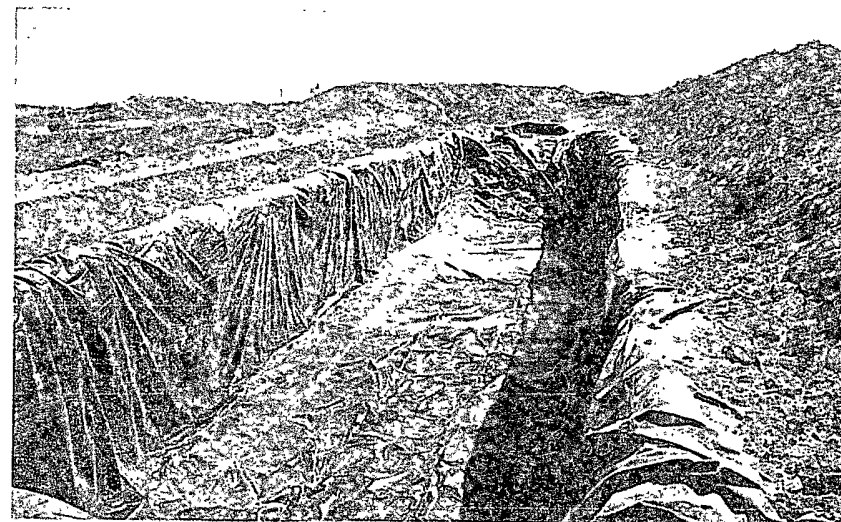
*Photo #8 View of Lined Deep Bury (entombment) Pit*

7. *March 6, 2008 – The deep bury (entombment) pit was lined with 12 mil HDPE bottom. The crew started transferring the contents of the reserve drilling pit to the deep bury (entombment) pit.*

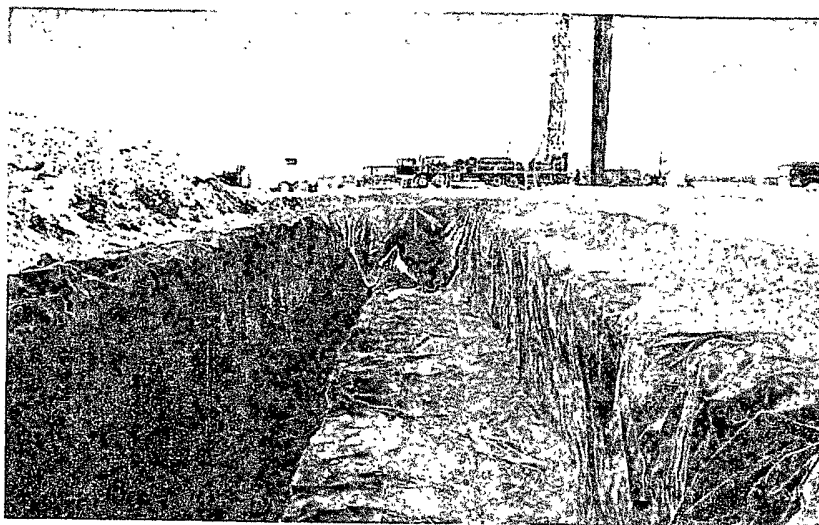
*Photo #9 Lined Deep Bury Pit*

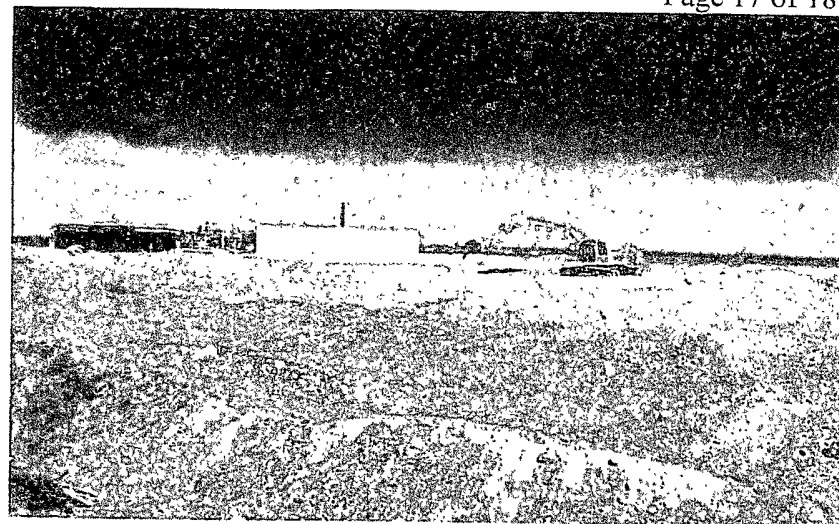
*Photo #10 Transferring Drilling Mud to Deep Bury Pit*

8. *March 7, 2007 – Crew continued transferring drilling mud and cuttings from the reserve-drilling pit to deep bury (entombment) pit.*
9. *March 10, 2008 – The bottom of the reserve drilling pit was cleaned and final samples were taken and sent to a third party laboratory for analysis of Chlorides for final verification of the limits met. (Please refer to attached reports, pages 9 through 12 of this report). The deep bury (entombment) pit was capped with a 20 mil HDPE top.*

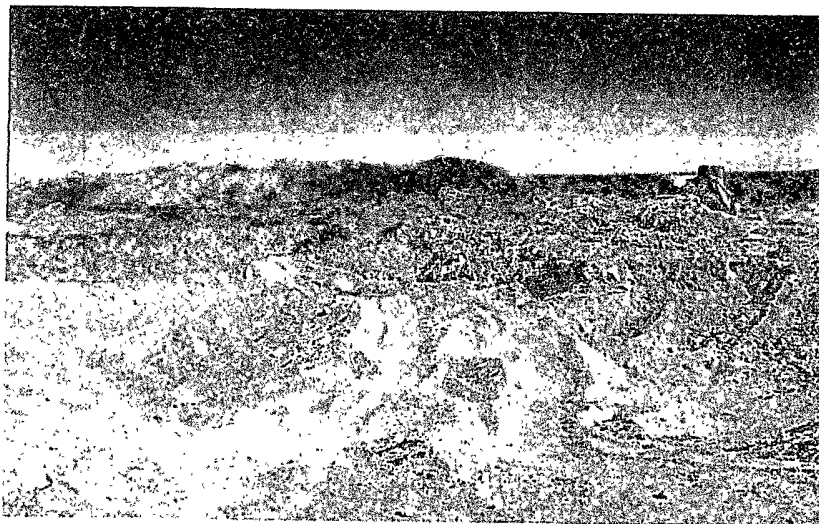
*Photo #11 Transferring Drilling Mud to Deep Bury Pit*

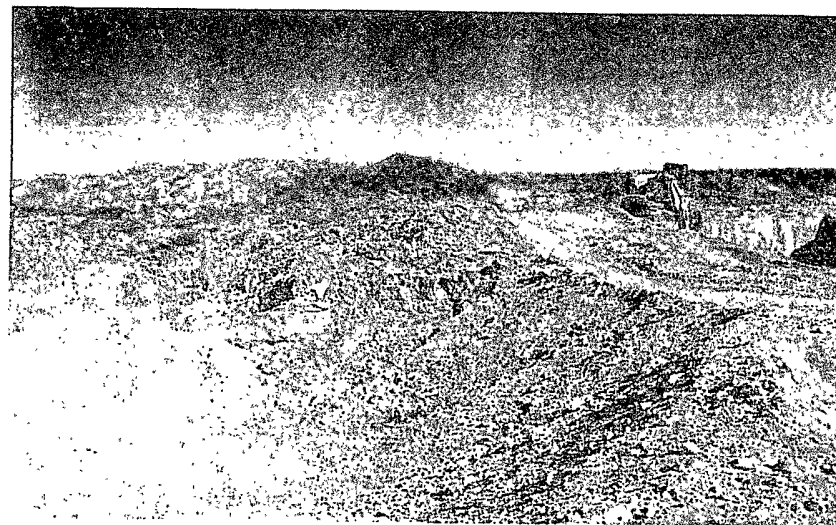
*Photo #12 Transferring Drilling Mud to Deep Bury Pit*

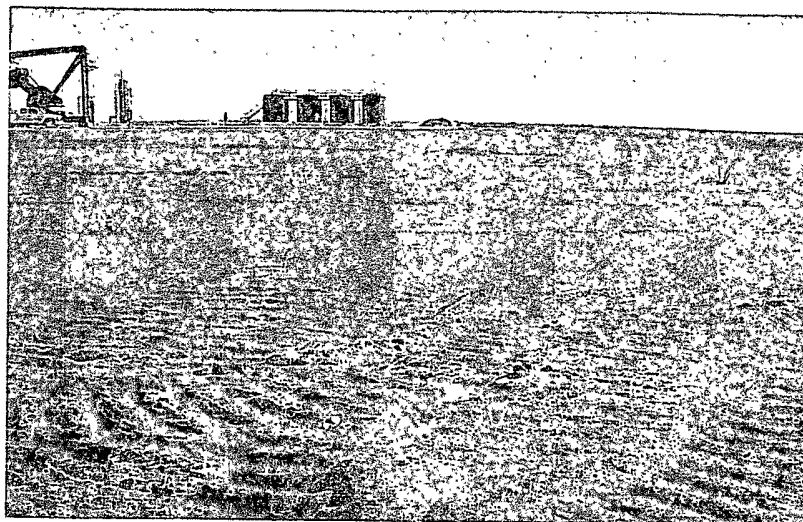
*Photo #13 Final View of Location*

19. *March 27, 2008 - Final contouring and compaction was implemented to return the site back to grade. Contouring was completed with a crown to prevent rainwater ponding.*

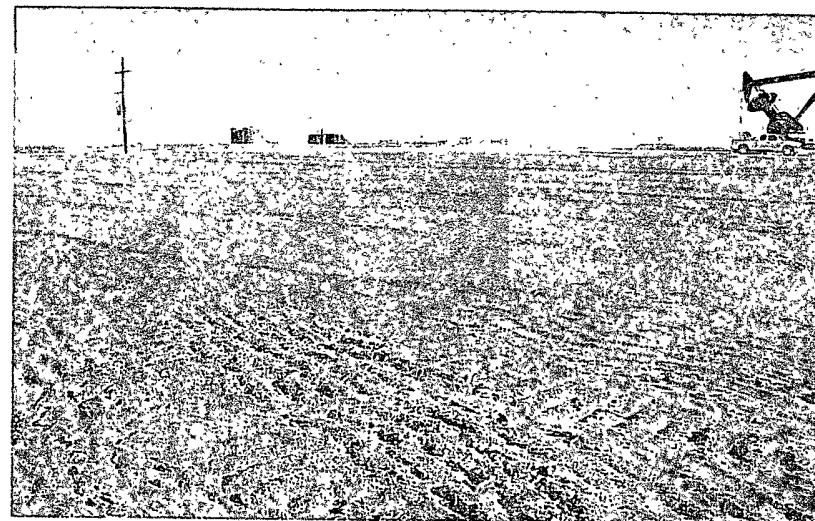
*Photo #14 Final View of Location*

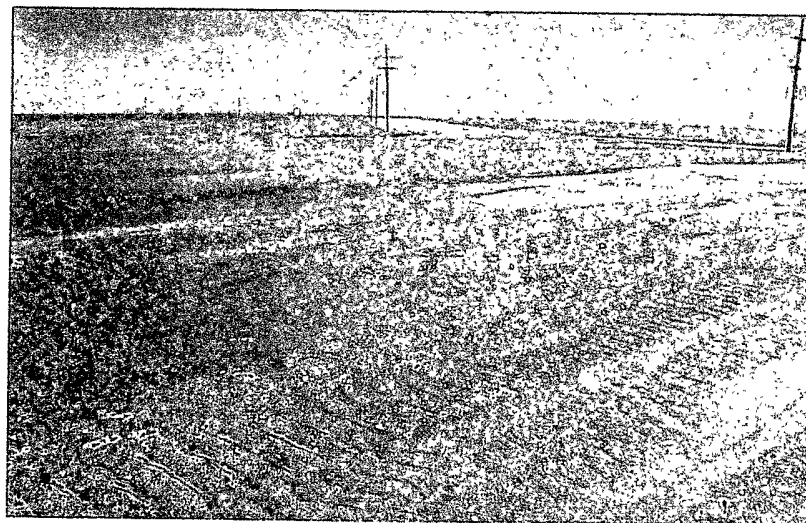
*Photo #15 Final View of Location*

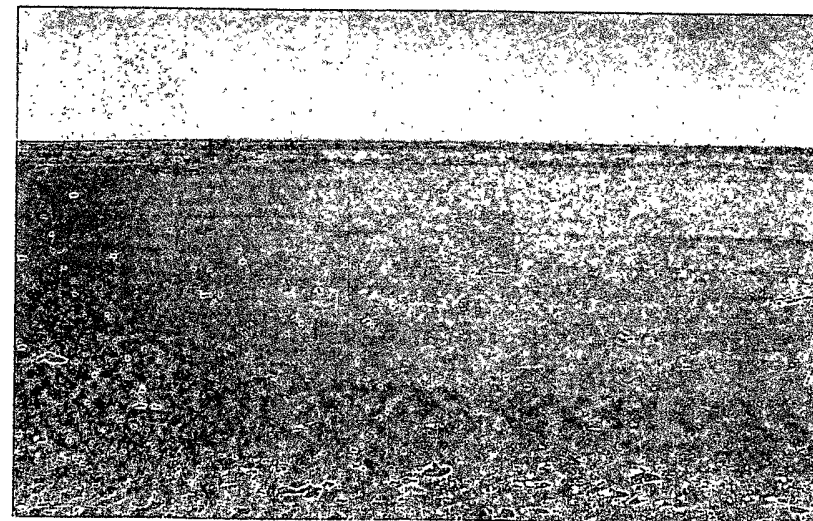
*Photo #16 Final View of Location*

20. *April 23, 2008 - The site was reseeded with native grasses and with the available moisture should vegetate very quickly.*
