**EOG Resources, Inc.**  
Artesia Division Office  
104 S. 4<sup>th</sup> Street  
Artesia, N. M. 88210

Re: Link BKT Federal Com #1HY  
30-015-36399  
Section 18, T16S-R25E  
Eddy County, New Mexico  
2RP-4960

EOG Y Resources, Inc. is submitting the enclosed CLOSURE REPORT and C-141 Final Report for the above captioned location. The report is being submitted in response to the C-141 Initial Report dated 8/23/2018.

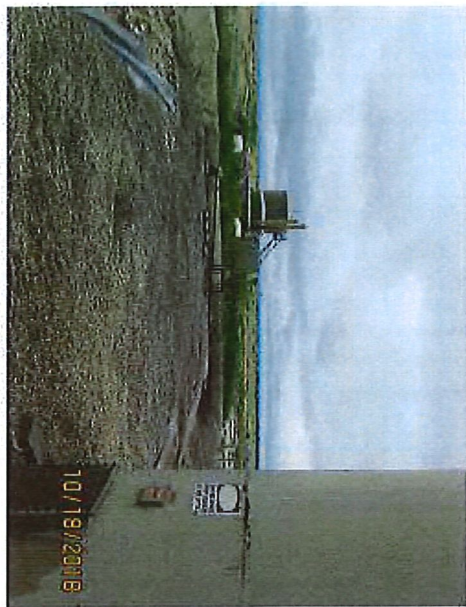
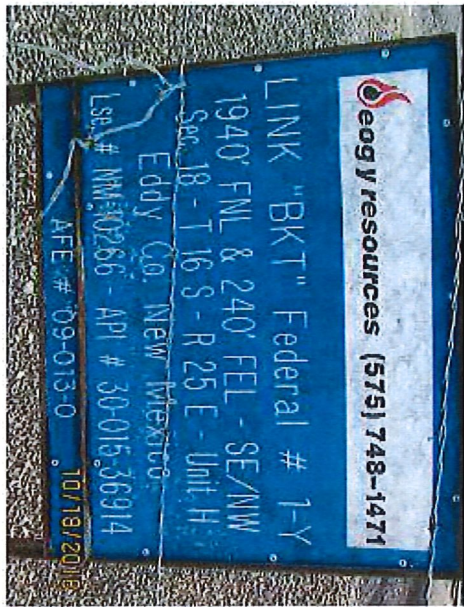
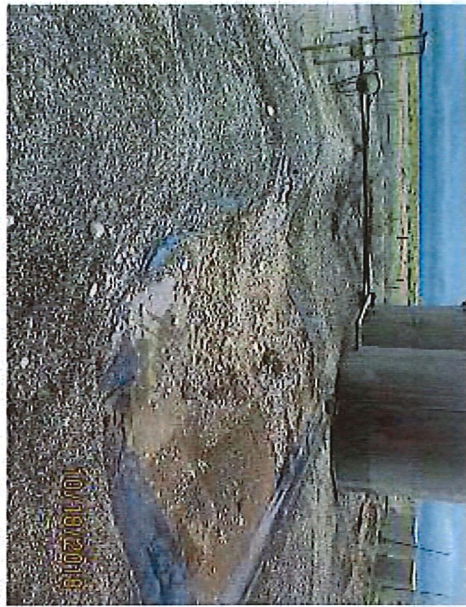
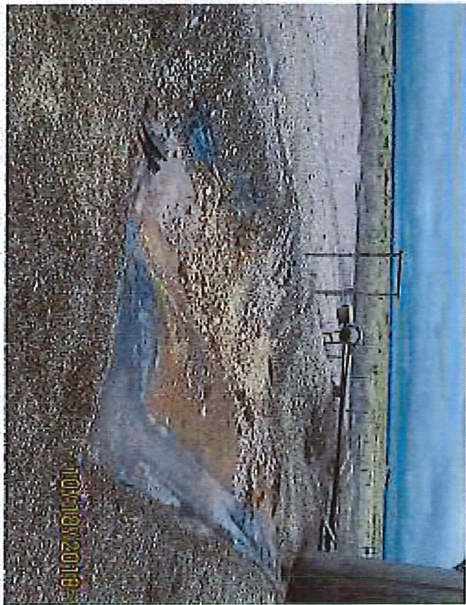
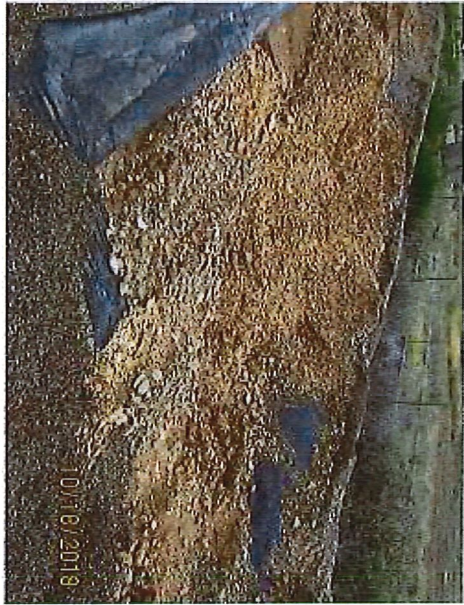
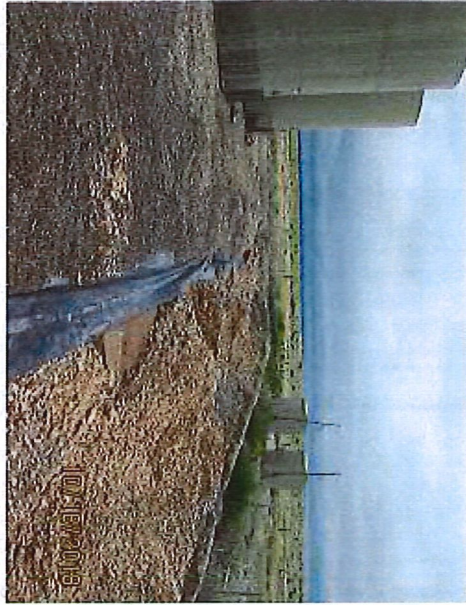
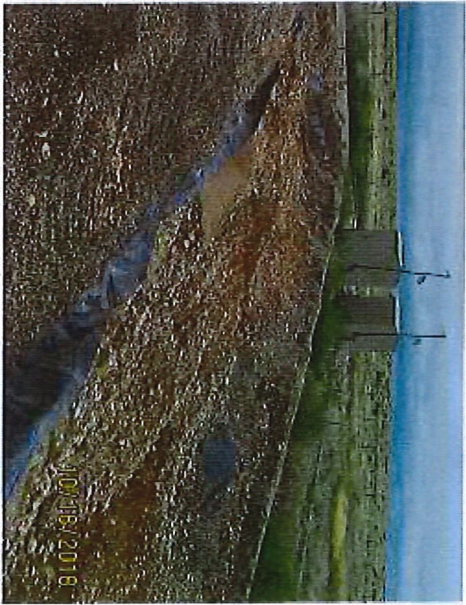
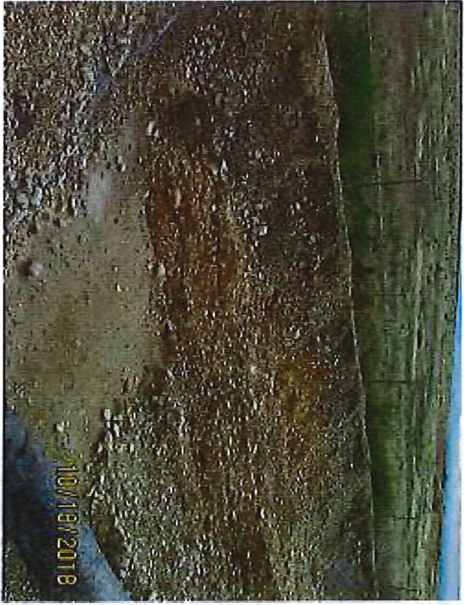
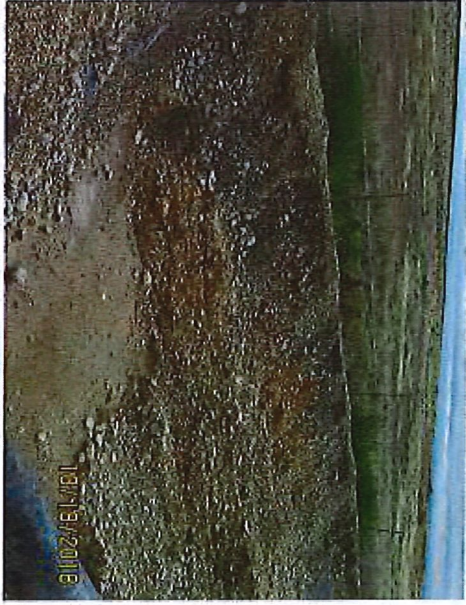
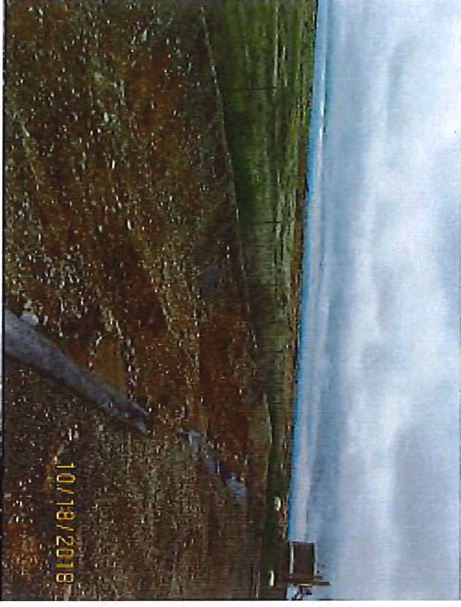
## Figure 2

The battery is bermed and lined with a 20 millimeter liner, but with the fire that started from the lightning strike the synthetic liner inside the battery was compromised.

Vertical and horizontal delineation samples (S 1, S 2, S 3 & S 4) were collected within the area effected from the compromised liner. Samples were collected at 1', 2', 3' below grade surface (bgs). The soil samples will be analyzed for Benzene, BTEX, TPH extended and Chlorides. All samples will be sent to a NMOCD approved laboratory for analysis.

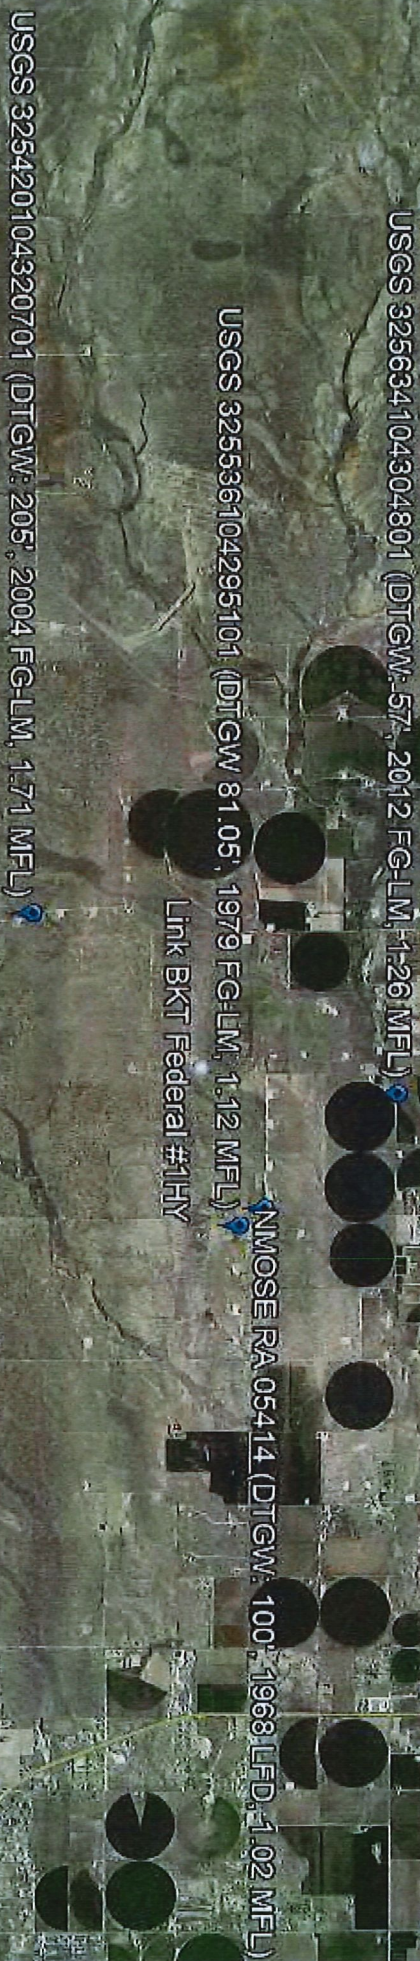
## **Water Well Date Site Map**

Section 18, T16S-R25E; Eddy County, New Mexico  
Water Well Data: Site Ranking is Zero (0). Depth to Ground Water: >100'  
(Approximately 110.75', per NMOSE & USGS Groundwater Levels).  
FG-LM (Field Groundwater-Level Measurement Date)  
LFD (Log File Date)  
MFL (Miles From Location)

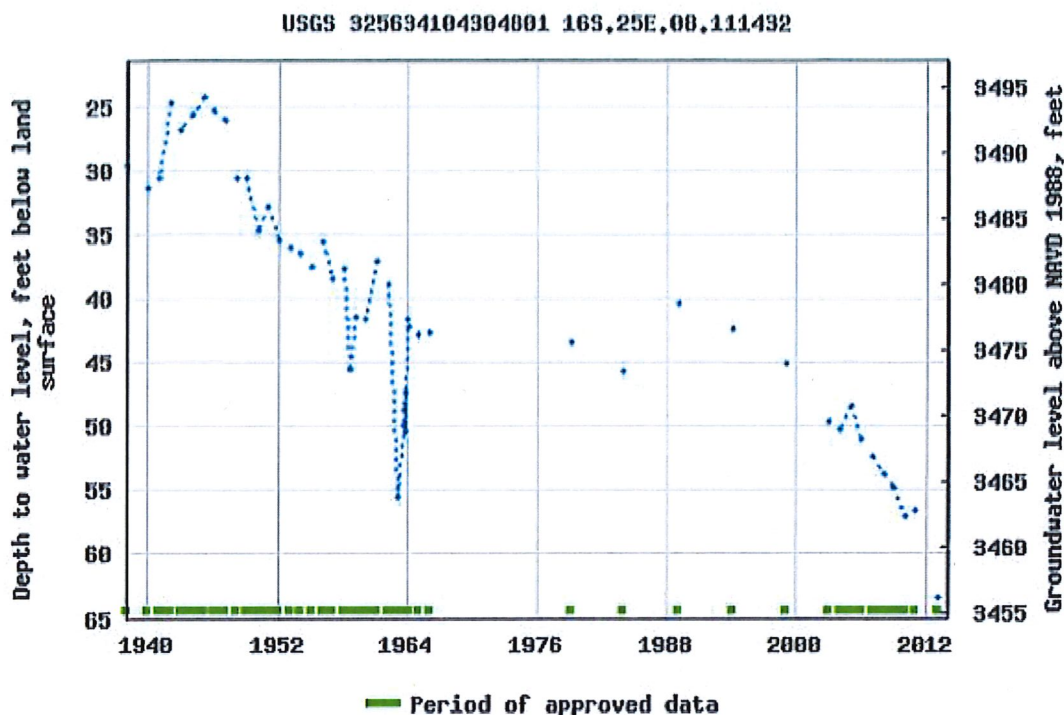
## USGS 325634104304801 16S.25E.08.111432

This well is completed in the Alluvium, Bolson Deposits and Other Surface Deposits (110AVMB) local aquifer.

Breaks in the plot represent a gap of at least one year between field measurements.

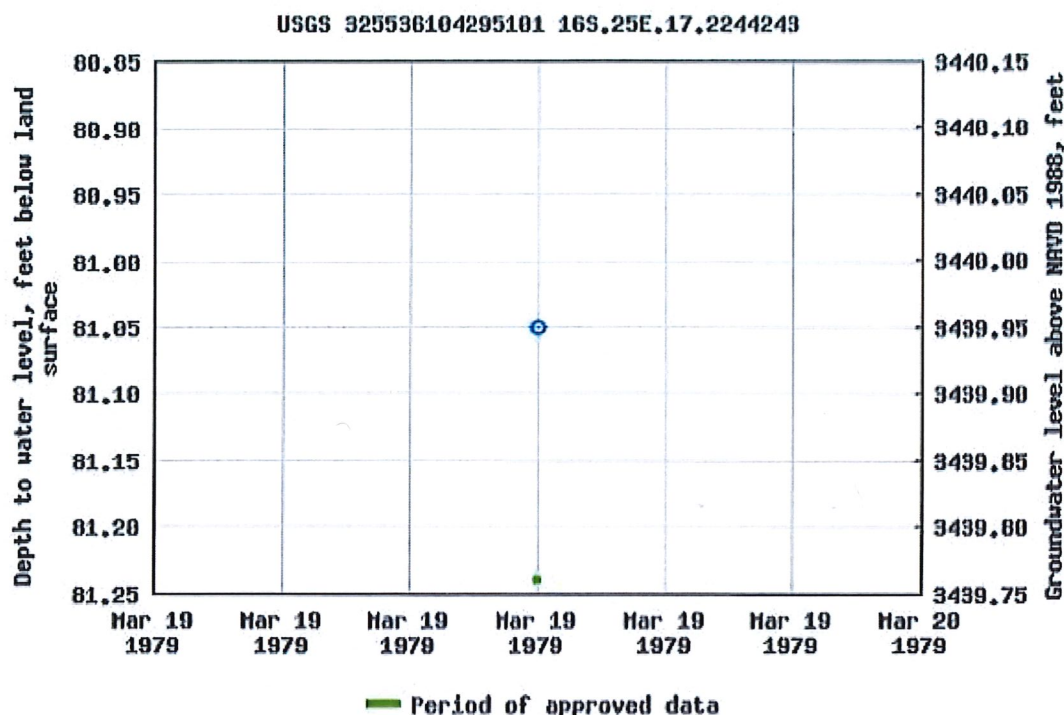
## USGS 325536104295101 16S.25E.17.2244243

The depth of the well is 150 feet below land surface.

Breaks in the plot represent a gap of at least one year between field measurements.
