RE: Administrative Order number 1RF-6

This letter is in reference to Administrative Order number 1RF-6. We are requesting closure of the treated water pond at this time per 19.15.34.14 CLOSURE AND SITE RECLAMATION REQUIREMENTS FOR RECYCLING CONTAINMENTS. Enclosed you will find the Form C-147, a sampling map, and analysis for a 5-point composite sample.

Confirmatory Schematic
Gaucho Treated Water Pond

North Gaucho Treated Water Pond
Leak Detection Inspection Logs

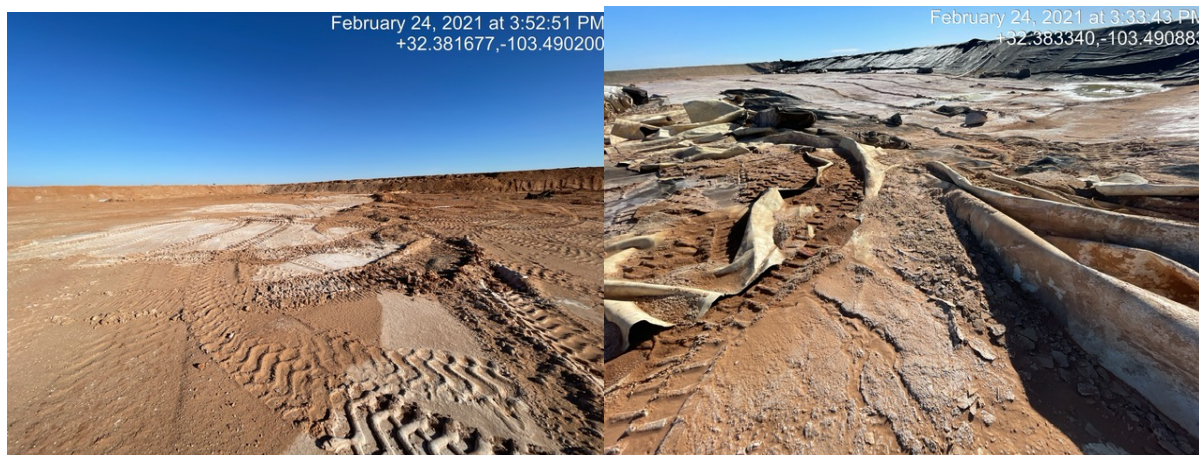
1. Devon must submit all copies of 1RF-6 - North Gaucho Containment and Recycling Facility's leak detection system inspection logs. Operators should include the detailed inspection records for the registration/permit period. Inspection records should include, but are not limited to, notes describing the weekly leak detection system testing and operations, the absence/presence of water in the leak detection system, the last time the containment was cleaned, and any oil product, debris, or foreign material found in the leak detection system and/or containment.
2. Additional delineation samples are required at BH21-07 per 19.15.34.14.C.1.
3. Devon must provide geotag grab samples in the vicinity of the location in the pictures below. Please note that if a release has occurred, Devon must remediate the affected area per 19.15.29. NMAC.

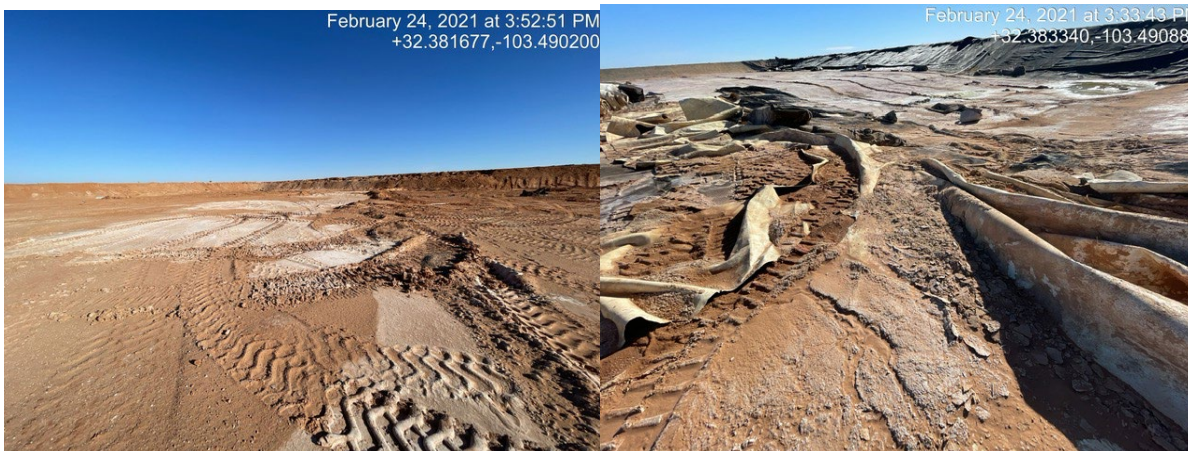
1. Devon must submit all copies of 1RF-6 - North Gaucho Containment and Recycling Facility's leak detection system inspection logs. Operators should include the detailed inspection records for the registration/permit period. Inspection records should include, but are not limited to, notes describing the weekly leak detection system testing and operations, the absence/presence of water in the leak detection system, the last time the containment was cleaned, and any oil product, debris, or foreign material found in the leak detection system and/or containment.
2. Additional delineation samples are required at BH21-07 per 19.15.34.14.C.1.
3. Devon must provide geotag grab samples in the vicinity of the location in the pictures below. Please note that if a release has occurred, Devon must remediate the affected area per 19.15.29. NMAC.

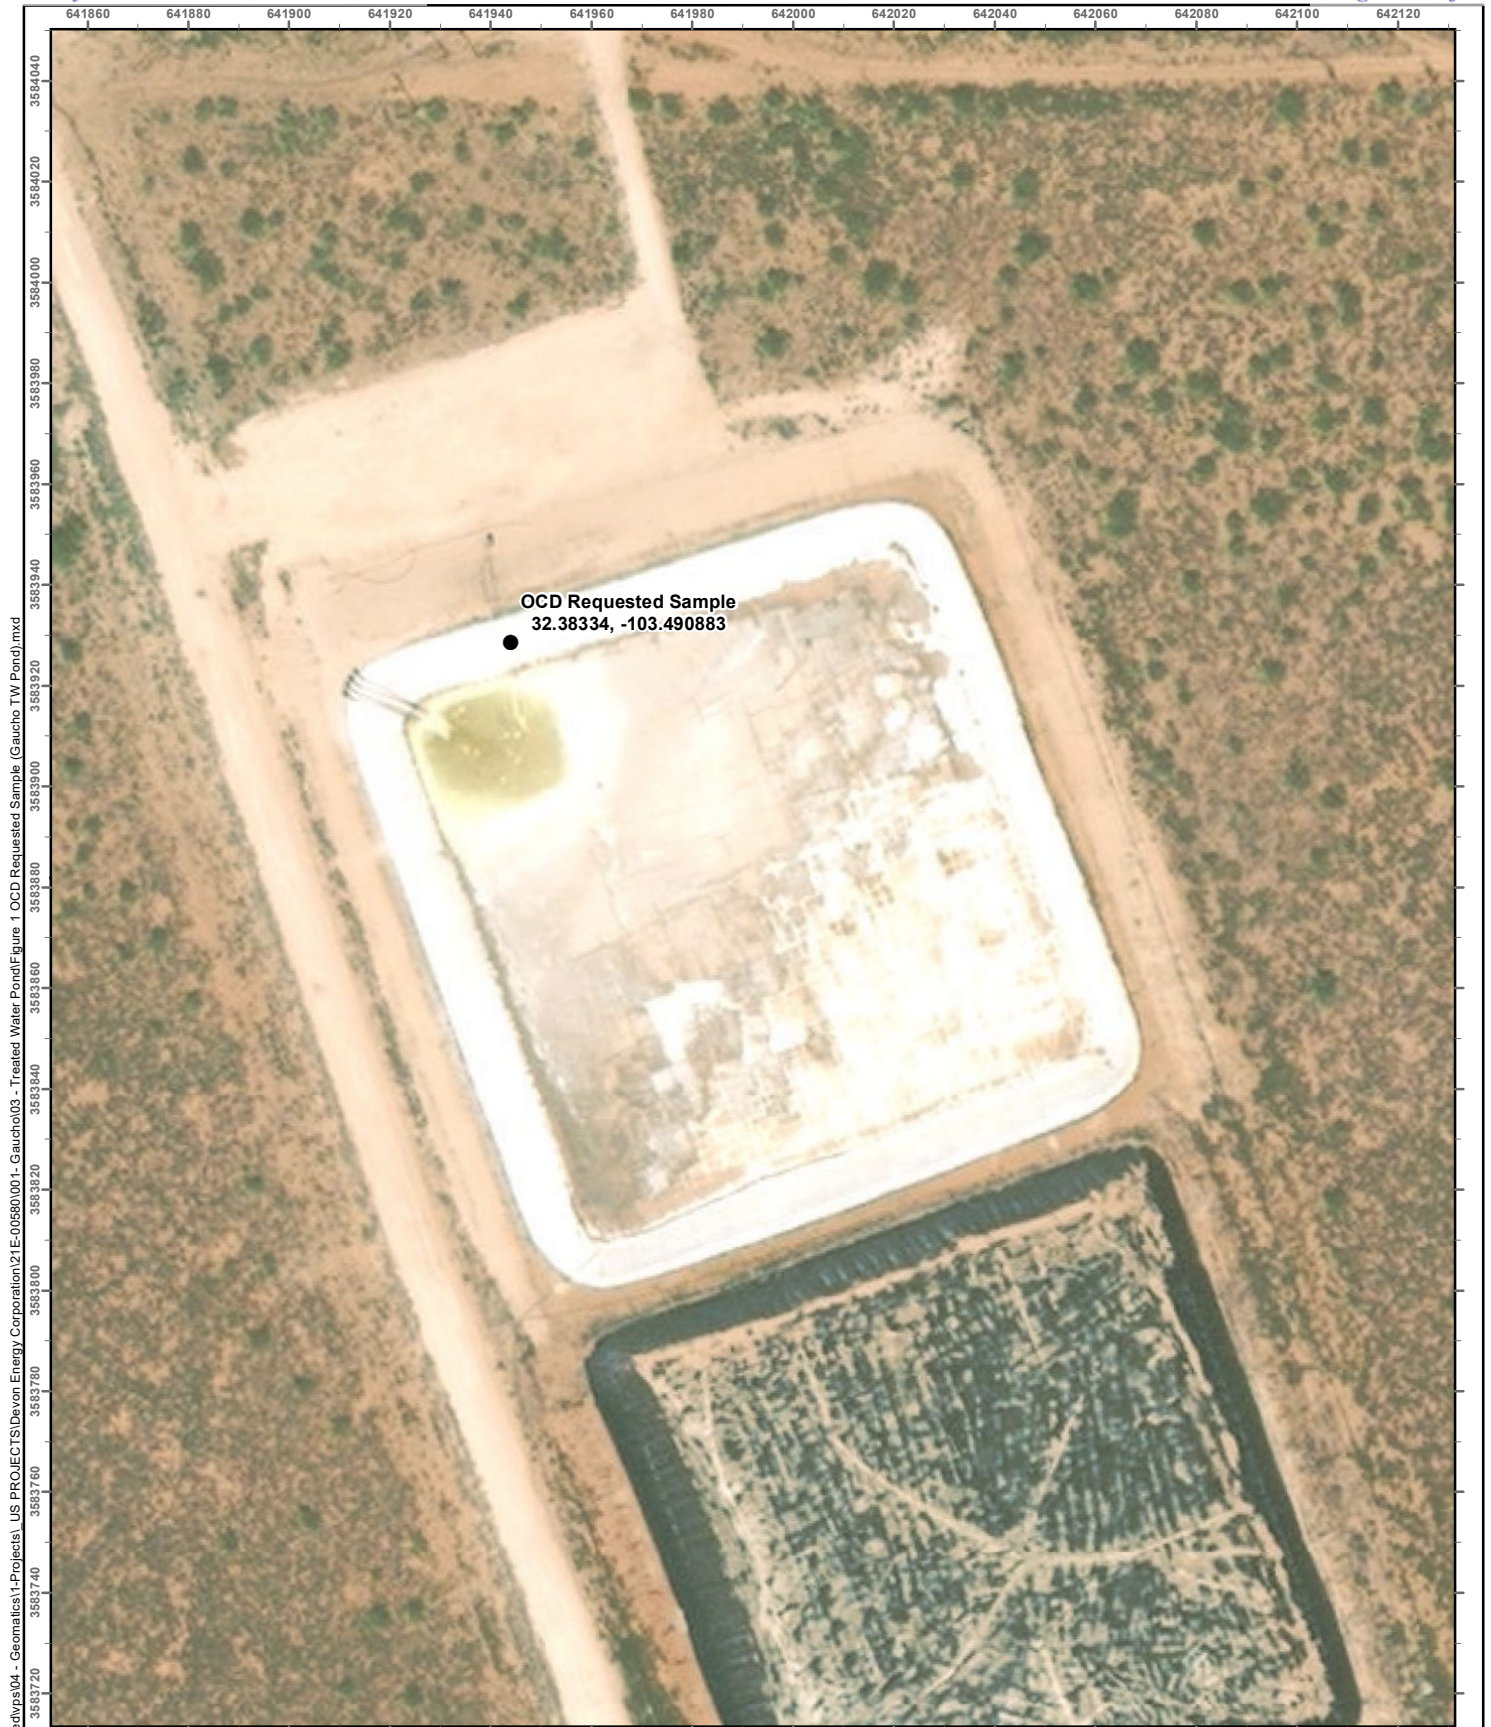
Attachment 4

● OCD Requested Sample
