**GW - 032**

**Borrow Pit  
Interceptor  
Trench**

**RE: Borrow Pit Interceptor Sumps Installation Summary Letter  
Marathon Petroleum Company LP, Gallup Refinery  
(dba Western Refining Southwest LLC)  
EPA ID# NMD000333211**

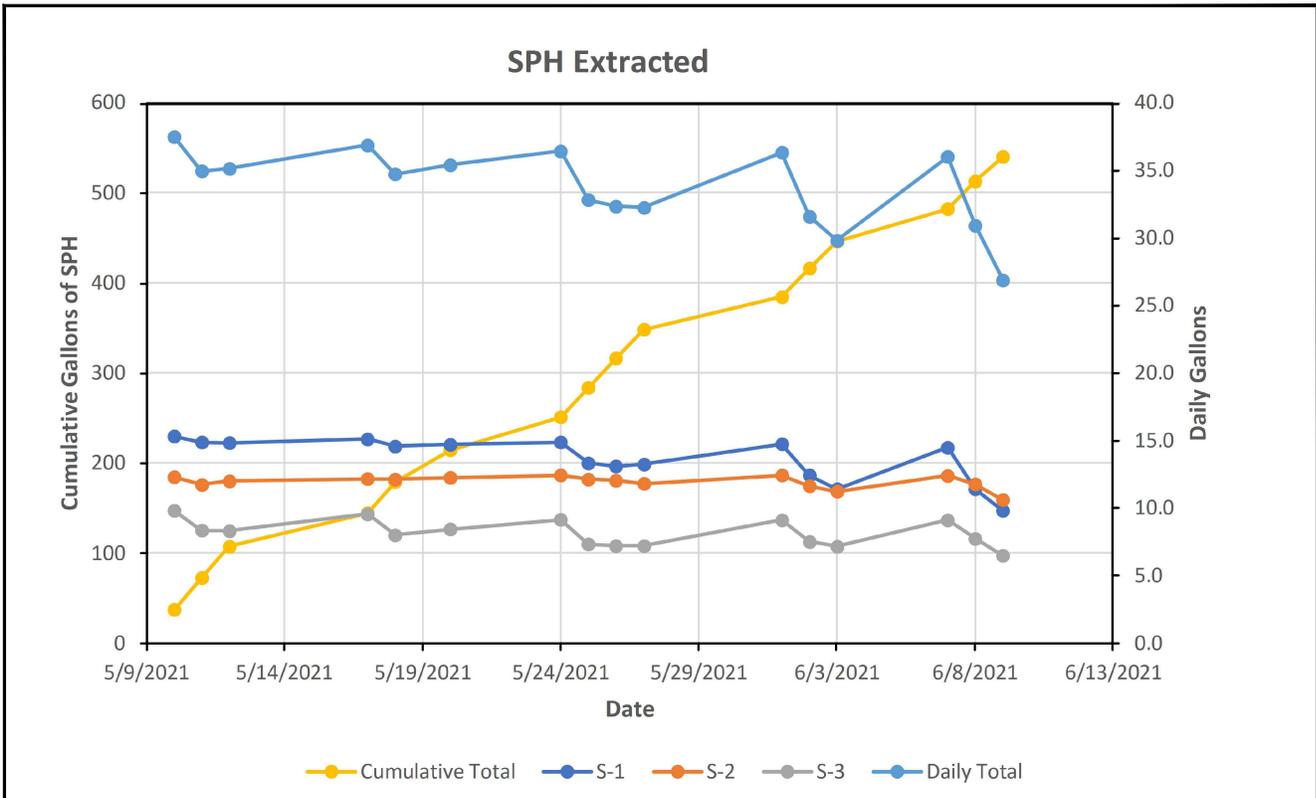
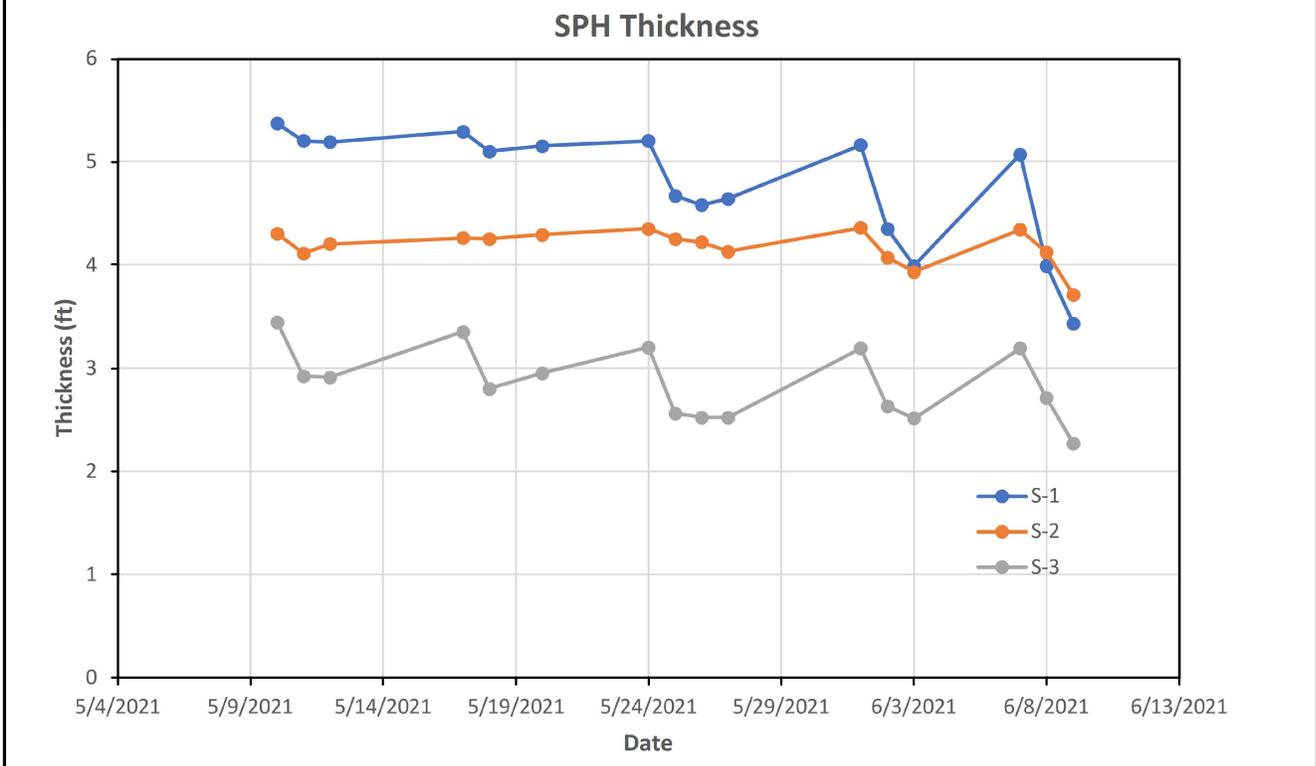
**FIGURE 2**  
**BORROW PIT**  
**INTERIM MEASURE SEPARATE PHASE**  
**HYDROCARBON SUMP DATA**  
**MARATHON PETROLEUM CORP.**  
**GALLUP REFINING DIVISION**  
**GALLUP, NEW MEXICO**

Table 1 summarizes the sump and piezometer gauging data, including depth to water, depth to SPH, and SPH thickness. Sumps S-1, S-2, and S-3 contain measurable SPH. Sumps S-4 and S-5 and piezometers PZ-1 and PZ-2 have been dry and have had no SPH detected since installation. Starting the week of May 10, 2021, total fluids (SPH and groundwater) were removed from the sumps using a vac truck. Evacuation will be continued 3-4 times per week. Approximately 25-35 gallons per visit have been evacuated from these sumps. Figure 2 presents graphs of SPH thickness and SPH recovered versus time. As of the date of this report, approximately 540 gallons of SPH have been recovered. Groundwater and SPH are stored in a frac tank equipped with carbon filters. SPH will be recycled, and groundwater will be treated in the refinery's wastewater treatment plant.

To date, the IM appears to be effective at recovering SPH in the Borrow Pit area. Drawdowns have been observed in the piezometers and sumps. Approximately 540 gallons of SPH have been recovered. Drawdown in piezometers to date is approximately 0.3 ft, and to date SPH has not been observed in the piezometers. SPH appears to be limited to three sumps (S-1, S-2, and S-3). SPH thickness in these sumps has been decreasing, as shown on Table 1 and in Figure 2. Marathon will continue operation of the IM and will evaluate data for effectiveness in a quarterly report for this IM.

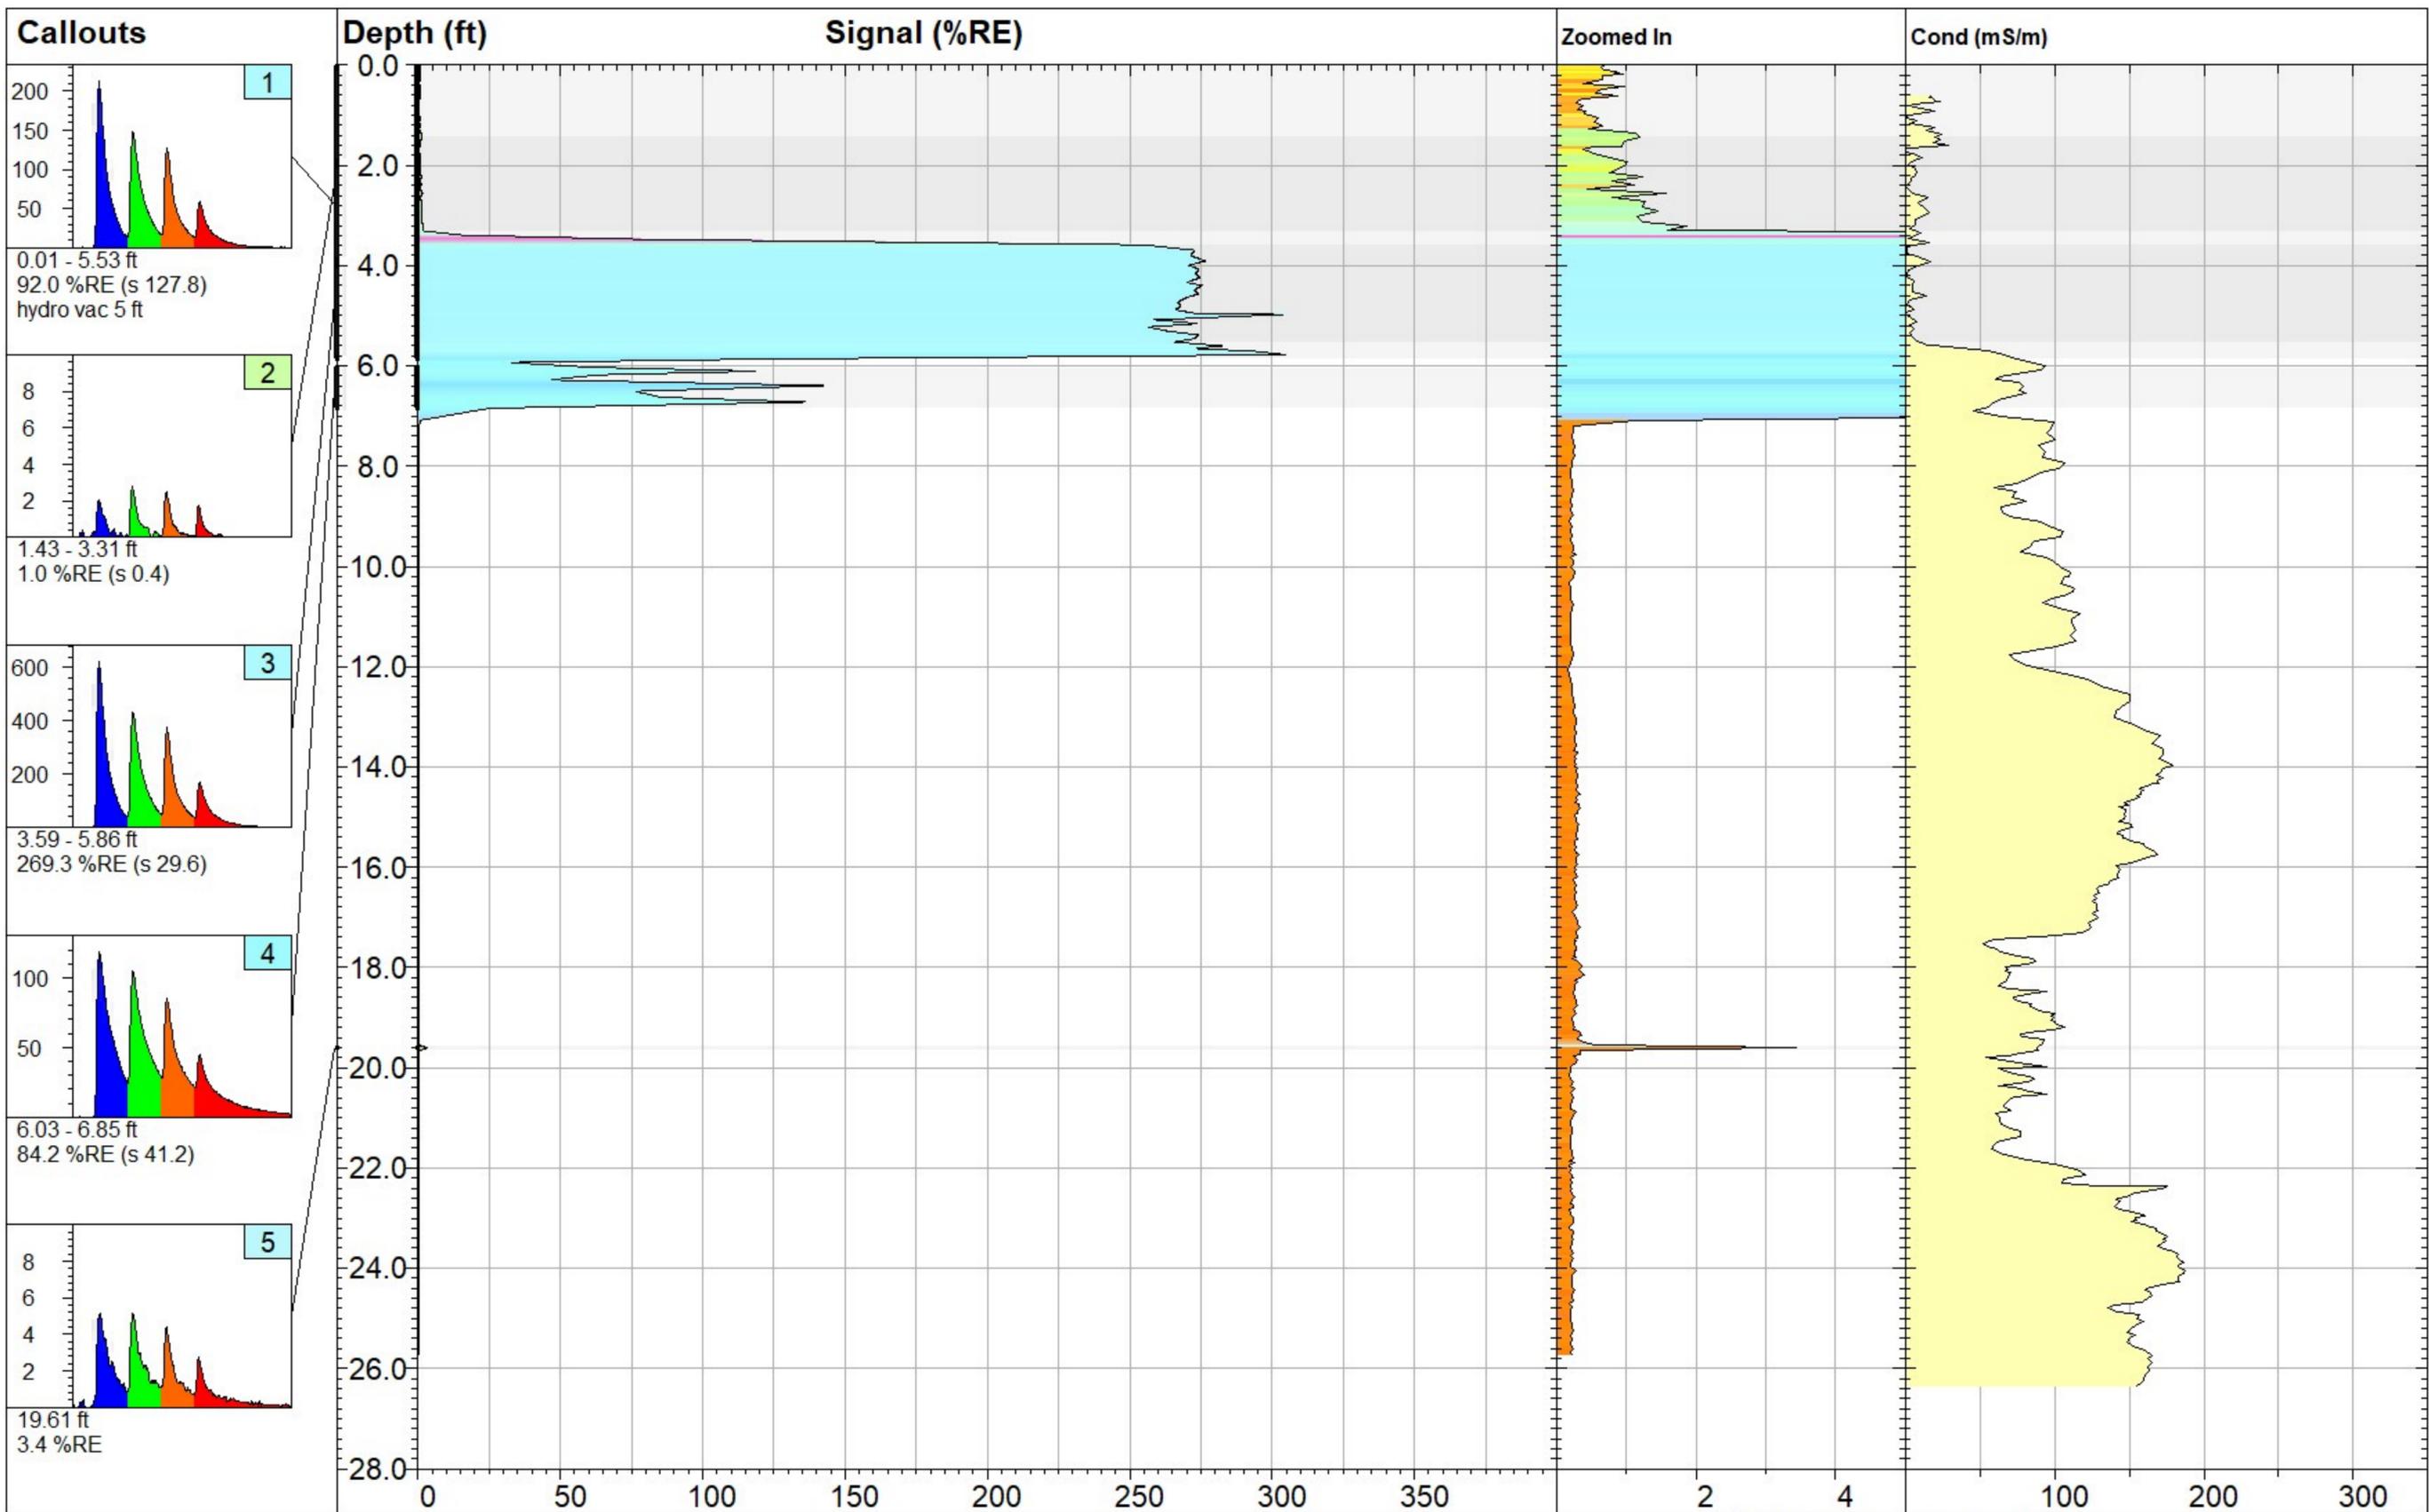
All of the borings showed intermittent silty-sand/clay layers from approximately 2 to 5 ft bgs, with fat clay below approximately 5 ft to a total depth of 8 ft bgs. The upper 2-5 ft bgs zone comprise the primary permeability (silty-sand) for the observed separate-phase hydrocarbon (SPH) and groundwater. Strong gasoline odors were detected in the borings for sumps S-1, S-2, and S-3. Due to prior historical excavation in the Borrow Pit area, the ground surface within the Borrow Pit is lower than the surrounding undisturbed topography. Although wet conditions were observed in the past, the seep area was observed to be dry during drilling activities. Boring logs are presented in Attachment 1. The borings corroborated what was observed in the field during the nearby laser-induced fluorescence (LIF) investigation borings MKTF-72 and MKTF-74, which included conductivity logs (see Attachment 1).

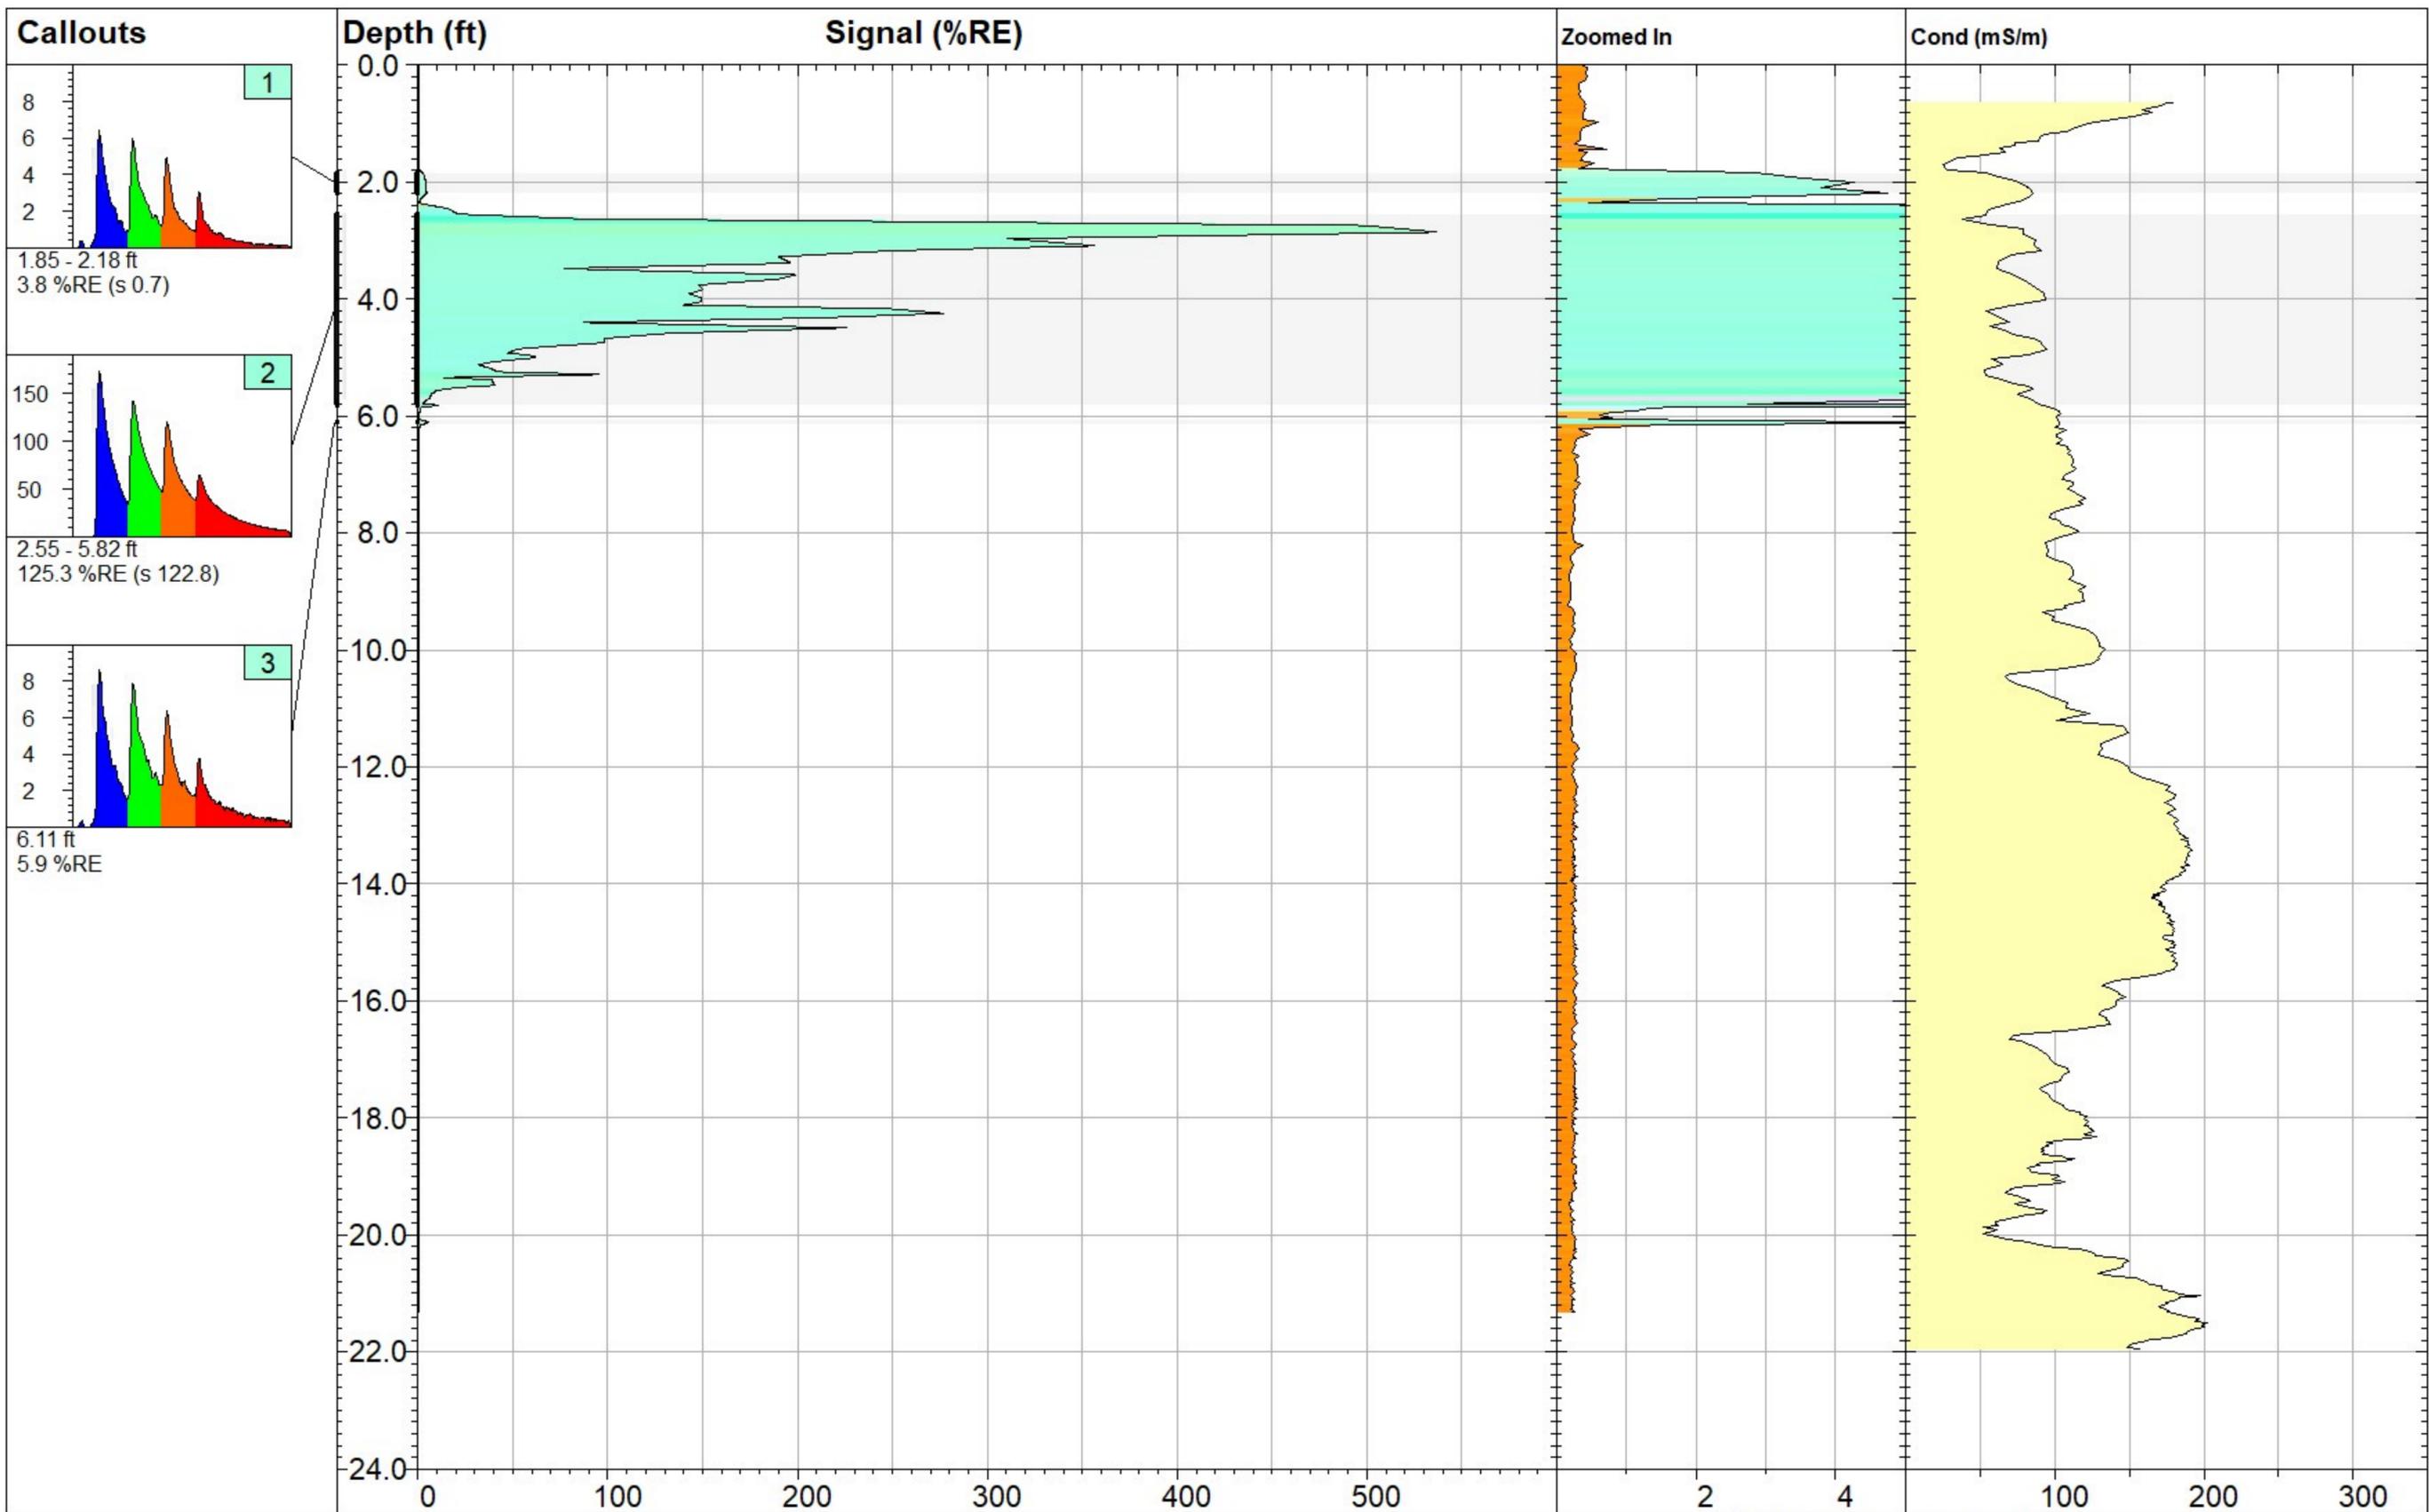
**MKTF-LIF-74**

Max Signal:  
537.6 %RE @ 2.86 ft

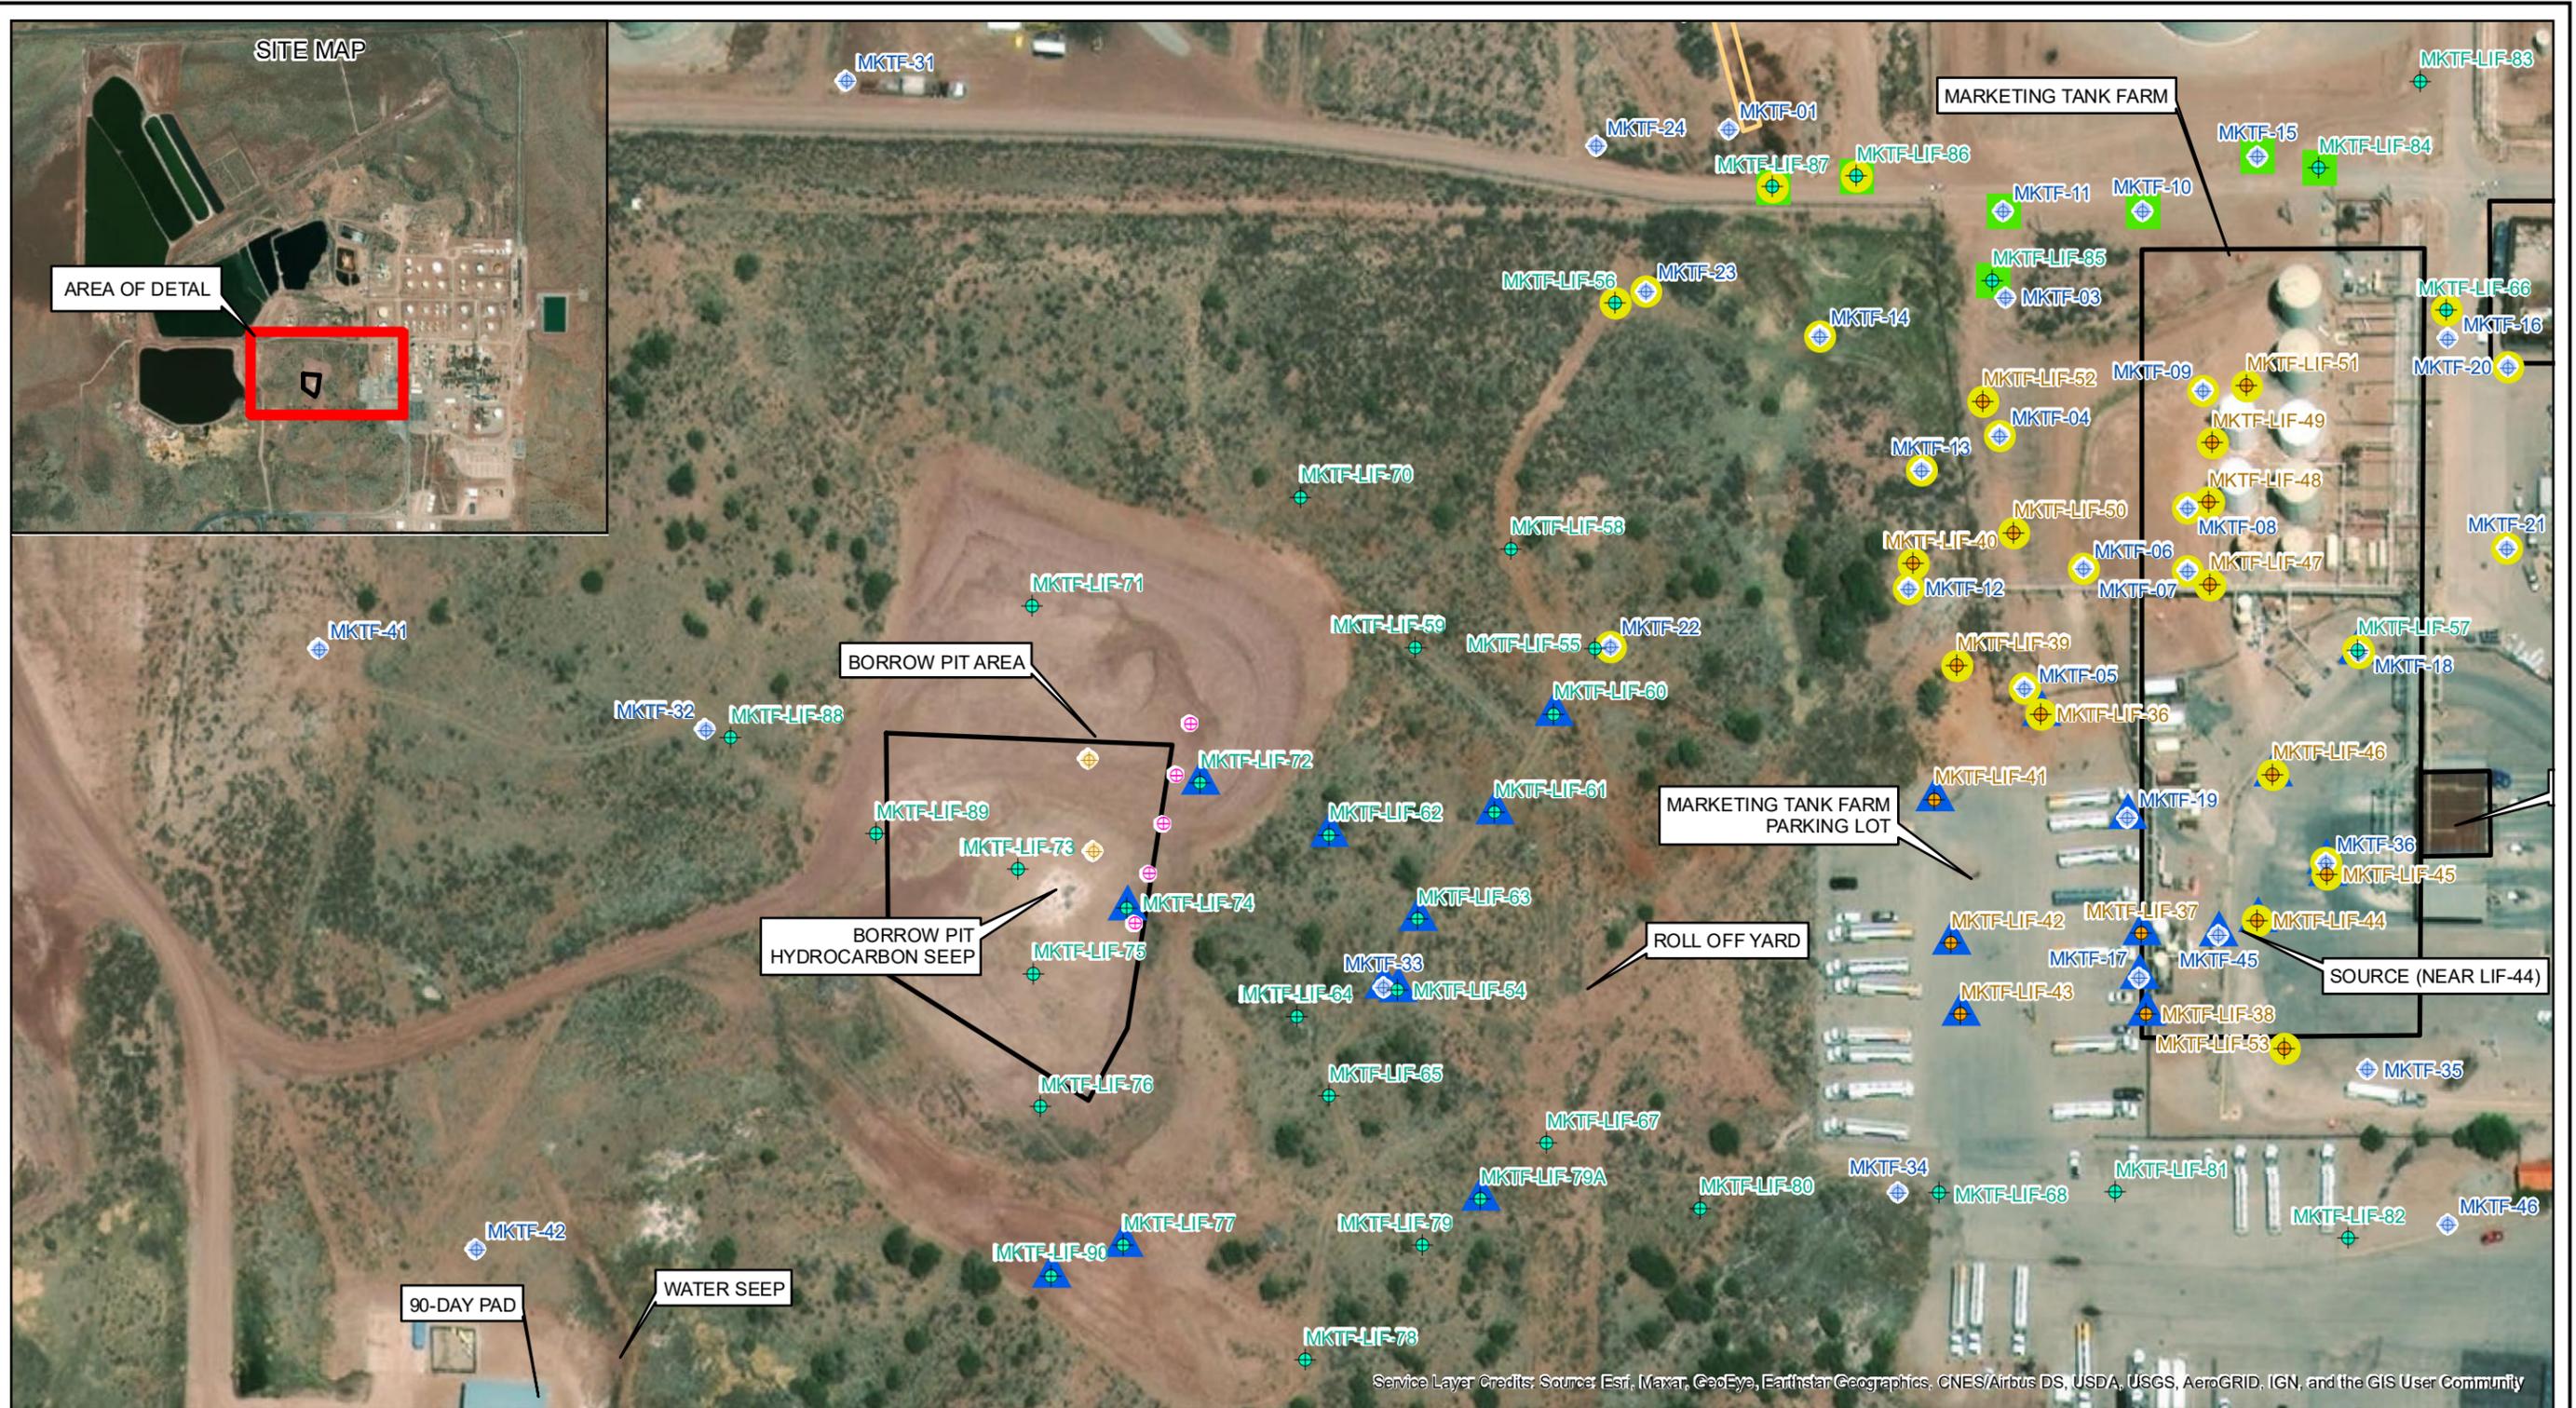
Figure 1 – Borrow Pit Interceptor Sumps Location

Groundwater and separate-phase hydrocarbon (SPH) were first observed on the surface of the Borrow Pit area in 2020. Following a conversation with New Mexico Environment Department (NMED) (March 16, 2021), a plan was developed to intercept the groundwater and SPH. During the week of April 12, 2021, five recovery sumps and two piezometers were installed to intercept fluids within the Borrow Pit area. The location of the sumps and piezometers is shown on Figure 1.

The five sumps (S-1 through S-5) were spaced approximately 40 feet (ft) apart and arranged in a line, as shown on Figure 1. A truck-mounted drill rig using 10.25-inch (in) inner-diameter (14-in flight outside-diameter) hollow-stem auger was used to access the site and advance the borings to 8 ft below ground surface (bgs). The sumps were constructed with 4-in diameter polyvinyl chloride (PVC) casing and 0.010-in slot PVC screen installed from 2 to 8 ft bgs, with a 10/20 sand filter pack installed around the well screen. Due to the unavailability of 6-inch PVC (due to supply chain issues), 4-inch PVC was used. The piezometers were constructed with 2-in diameter PVC casing and 0.010-in slot PVC screen from 2 to 8 ft bgs, with a 10/20 sand filter pack installed around the well screen.
