Please see below for a link for an update to the Sundance Services West, Inc. (SSWI) hydrogen sulfide monitoring plan (H2S Plan) and a completion report for the relining of two of the evaporation ponds at the site. The pond relining was done out of an abundance of caution after the patching of a number of holes in the primary liner. Please let me know if you have any questions or comments. Thanks

June 8, 2021

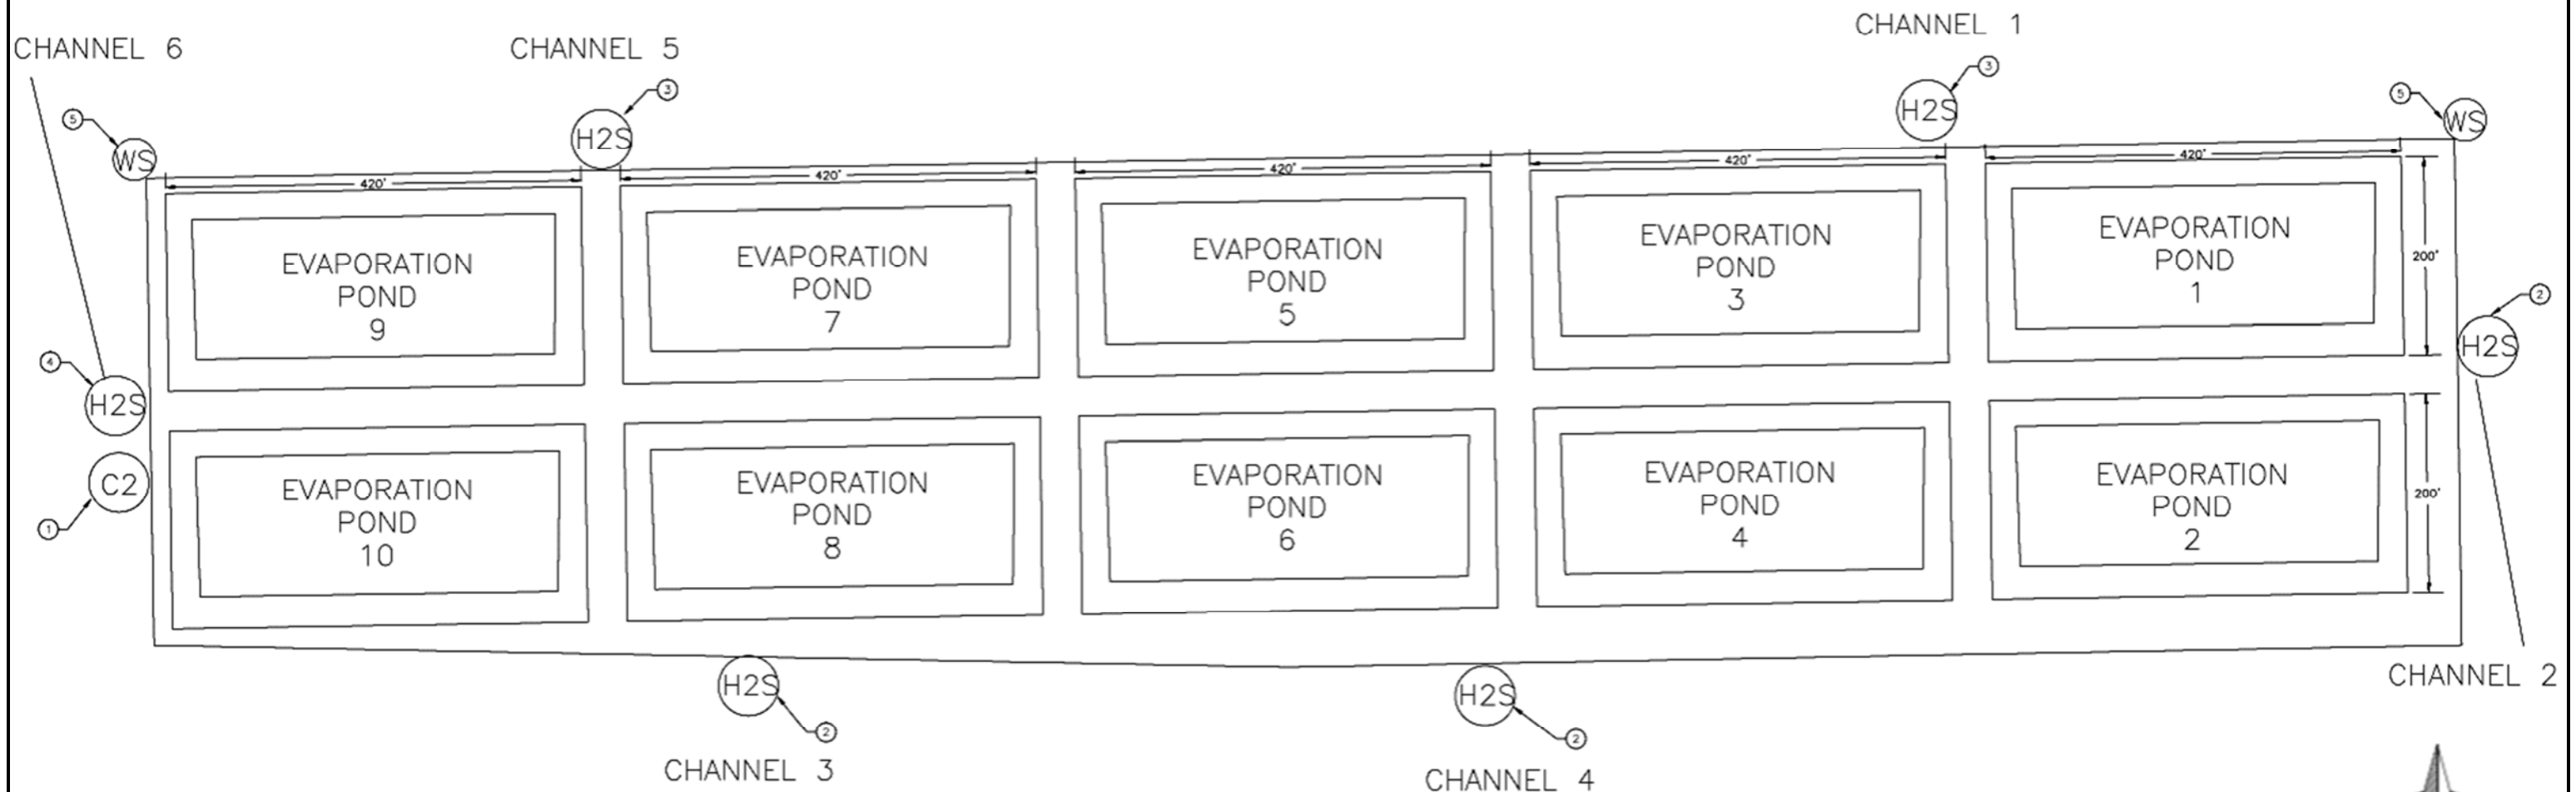
## KEY NOTES:

- ① GDS MODEL C2–TX WIRELESS CONTROLLER WITH OMNIDIRECTIONAL ANTENNA, 100 dB PIEZO BUZZER, AND RED STROBE. MOUNTED ON A POLE IN THE GROUND.
- ② GDS MODEL GASMAX/TX BATTERY POWERED WIRELESS GAS MONITOR W/ OMNIDIRECTIONAL ANTENNA MOUNTED ON WEIGHTED SENSOR STAND WITH MOUNTING PLATE.
- ③ GDS MODEL GASMAX/TX BATTERY POWERED WIRELESS GAS MONITOR W/ OMNIDIRECTIONAL ANTENNA MOUNTED ON THE EXISTING CHAIN LINK FENCE.
- ④ BFT–44 H<sub>2</sub>S SENSOR CONNECTED TO A GDS MODEL GM/TXDC WIRELESS TRANSMITTER MOUNTED ON THE ELECTRICAL RACK.
- ⑤ 18" X 60" WIND SOCK WITH SOLAR POWERED LIGHT.

Evaporation ponds are monitored for the presence of H<sub>2</sub>S by recording at continuous monitors maintained along the outside perimeter of the pond area as shown on **Figure II.3.3**. These monitors can be observed remotely via the internet and measurements are recorded every 5 minutes on a data logging system. Wind socks are placed at the East and West ends of the Northern fence (shown in **Figure II.3.3**), which will be visible from all principle working areas at all times. Wind speeds and direction will also be monitored and recorded regularly when feasible.

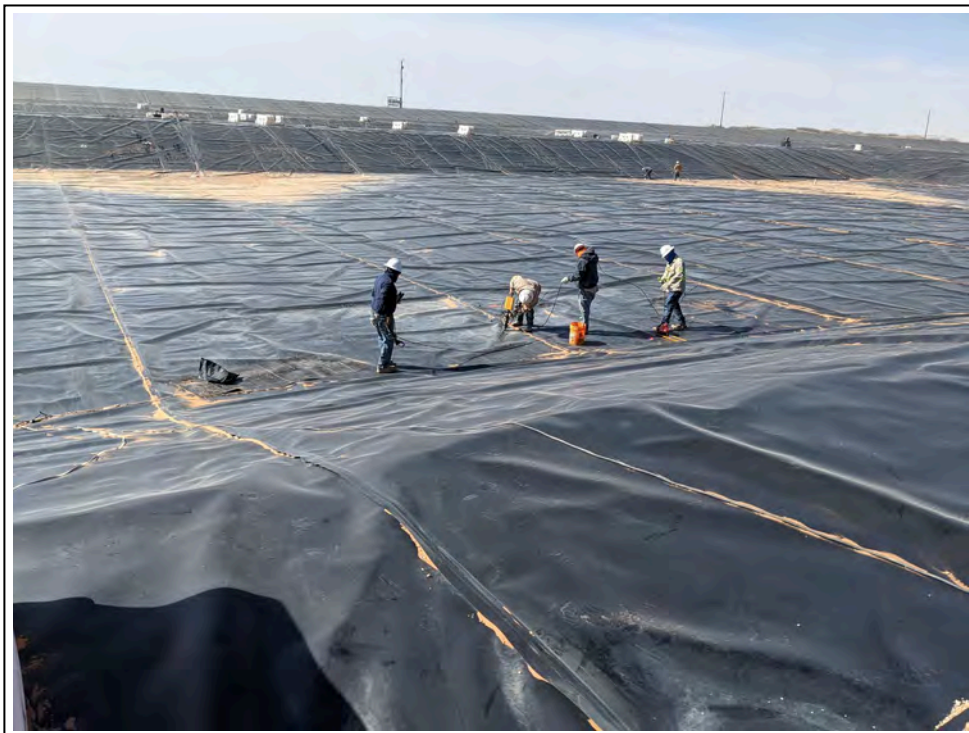
3. 3/31/2021: Crew repairing existing liner in Pond 5; vacuum test was performed on each repair bead and patch (view to southwest)

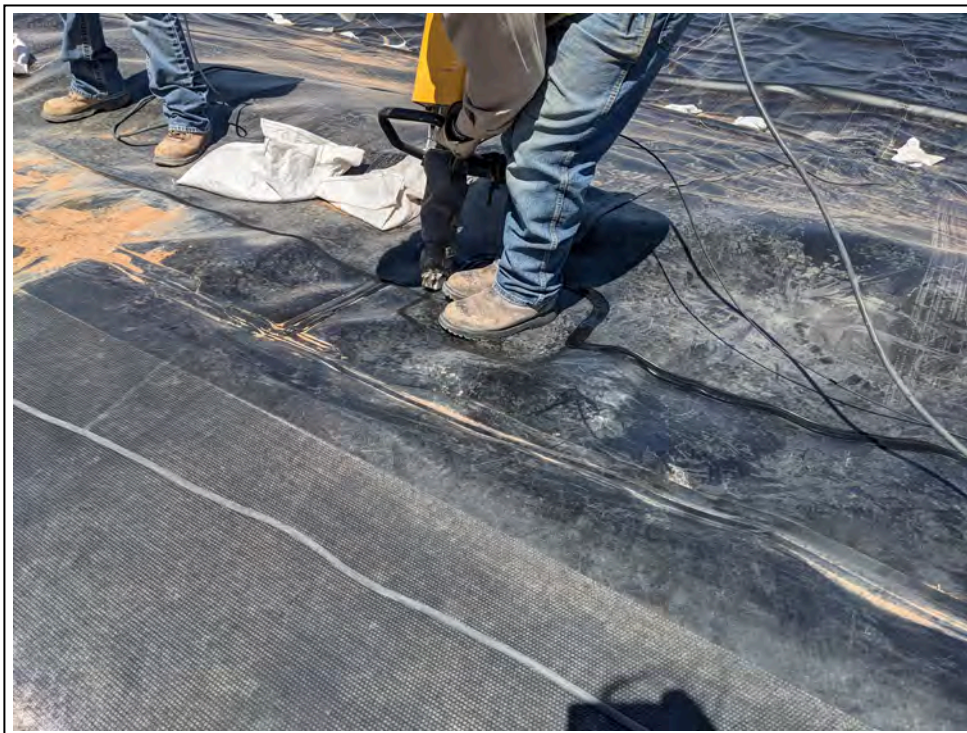
7. 4/1/2021: Top seams extrusion welded; T-seams patched

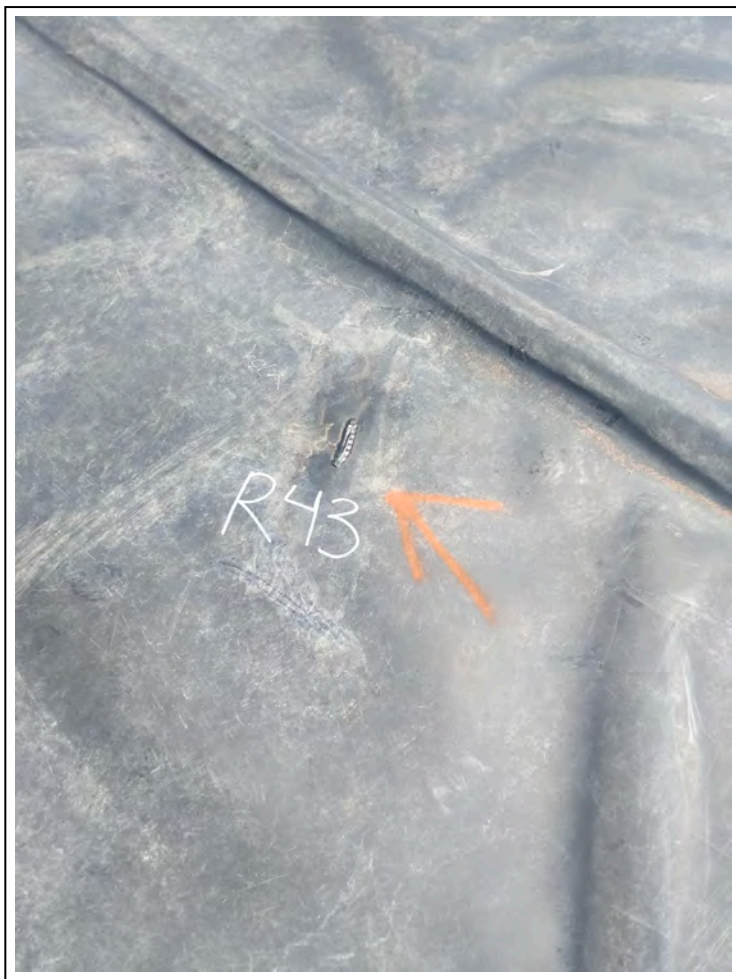
9. 4/1/2021: Pond 5 existing liner repair (bead)

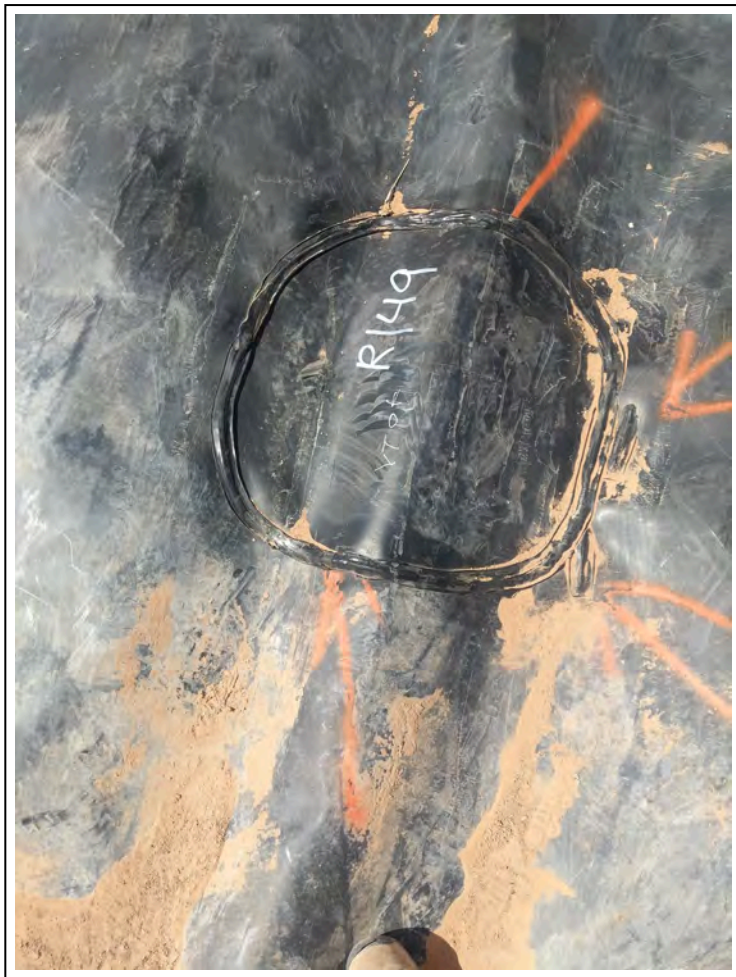
11. 4/1/2021: Pond 6 existing liner repair (patch)

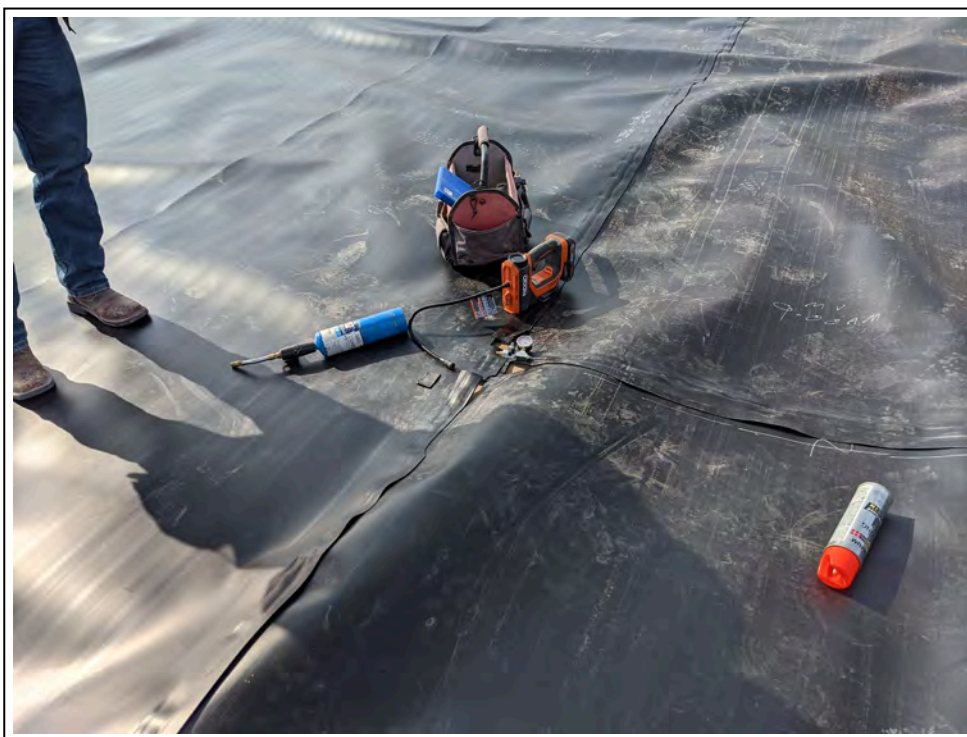
14. 4/2/2021: Seam pressure testing

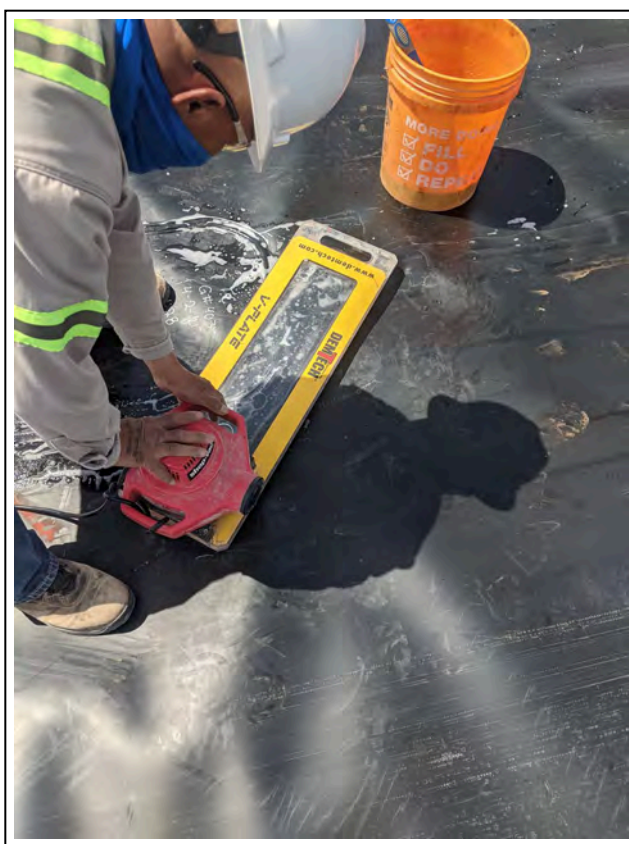
16. 4/2/2021: Vacuum test at DT repair location

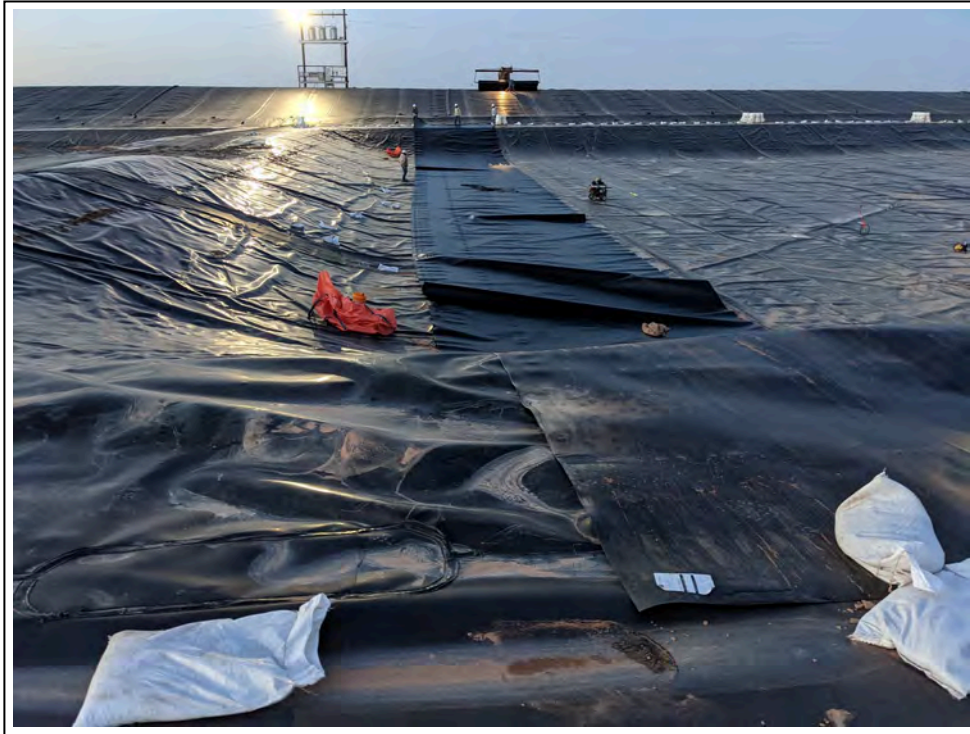
21. 4/7/2021: P-1 of Pond 6 (South Pond) placed (view to south)

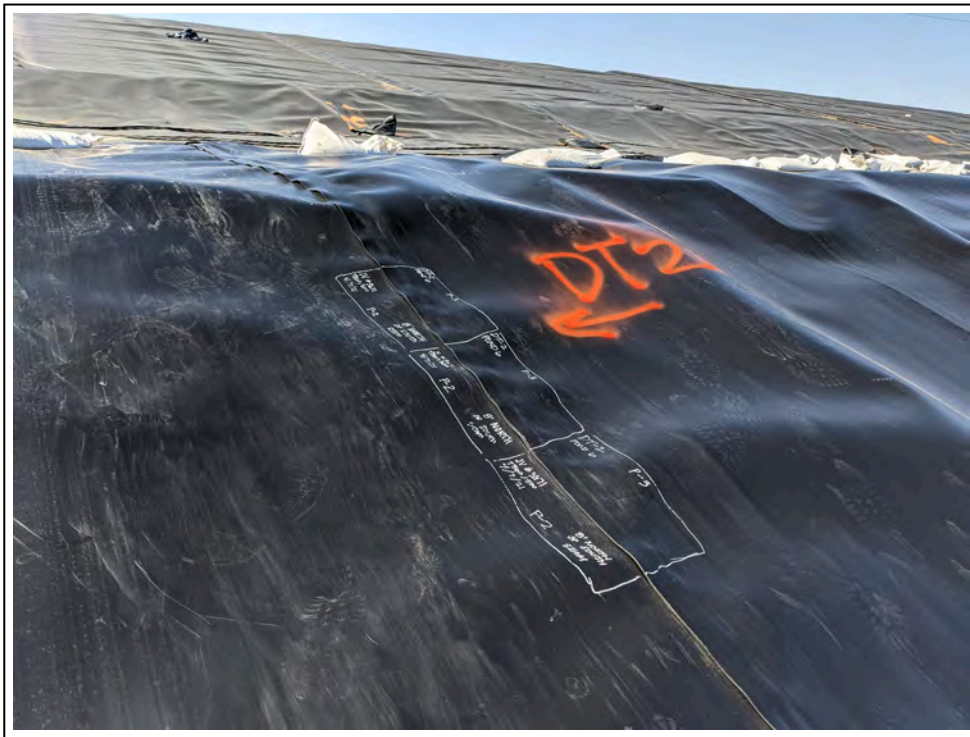
22. 4/7/2021: DT-2 of Pond 6, located on seam P-3/P-2 (view to south)

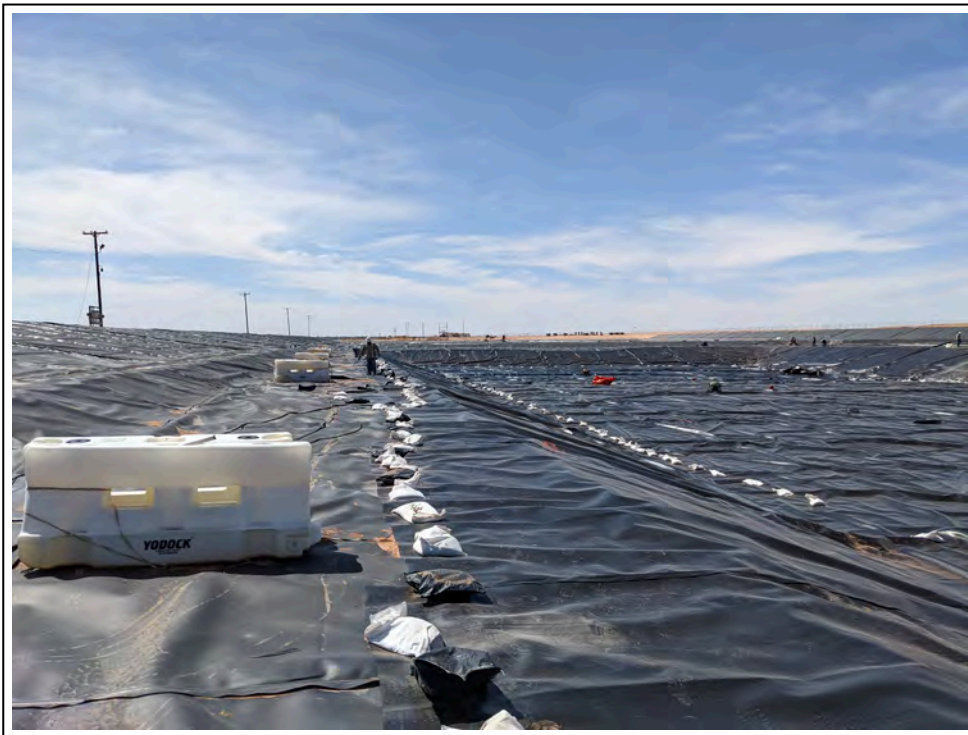
24. 4/8/2021: All panels of Pond 6 placed (view to west)

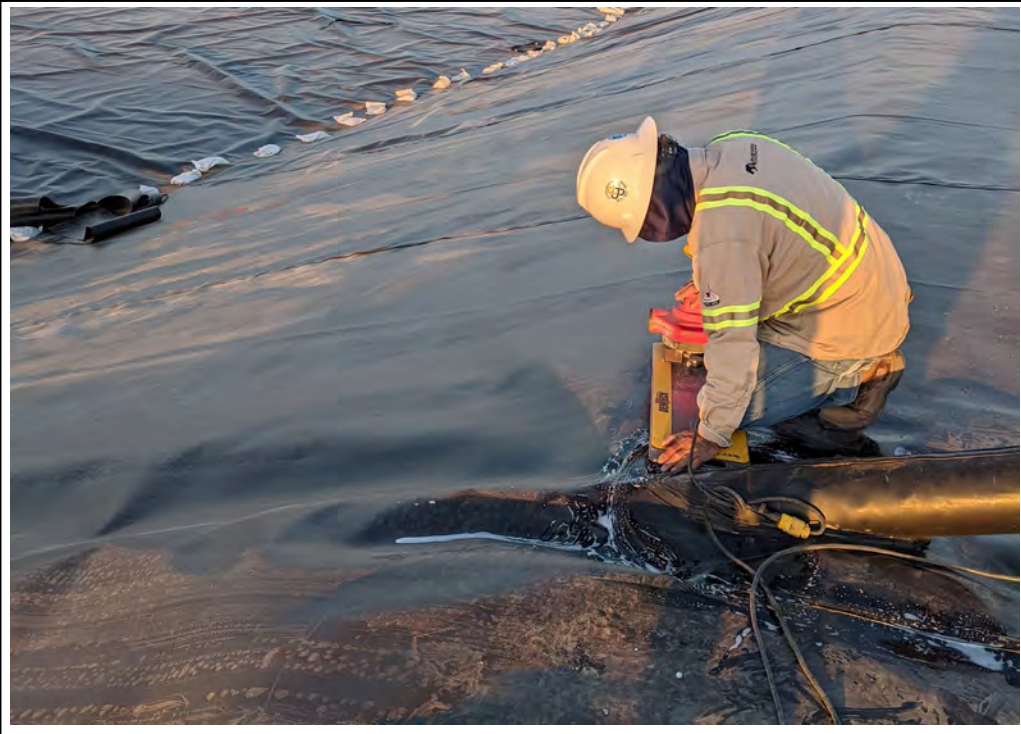
25. 4/9/2021: Vacuum test along northeast extrusion weld seam (view to west)
