Re: Centennial Resource Development, Inc.
Merchant South Containment and Recycle Facility

C-147 Registration Package for Merchant South Containment and Recycle Facility

Section 26, Township 22-S, Range 34-E, Lea County

CENTENNIAL RESOURCE DEVELOPMENT, INC. MERCHANT SOUTH REUSE PIT CONSTRUCTION PLAN LEA COUNTY, TEXAS

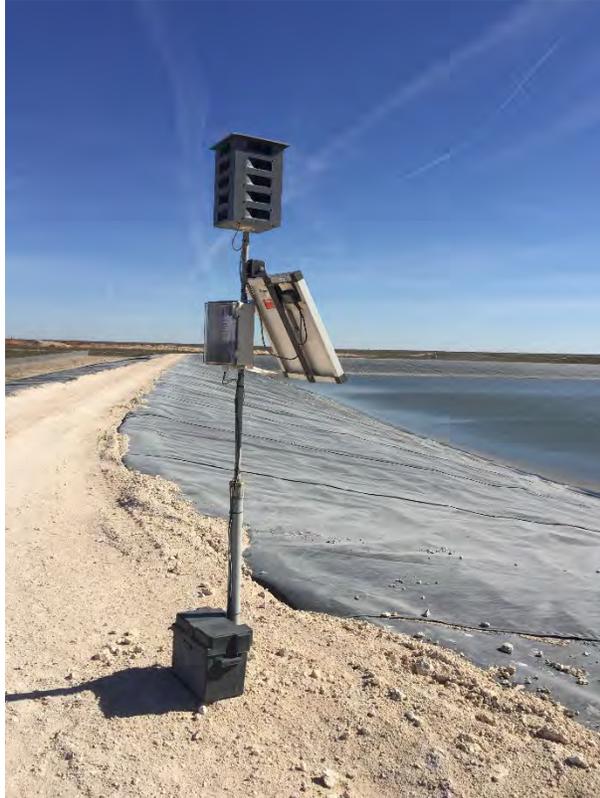
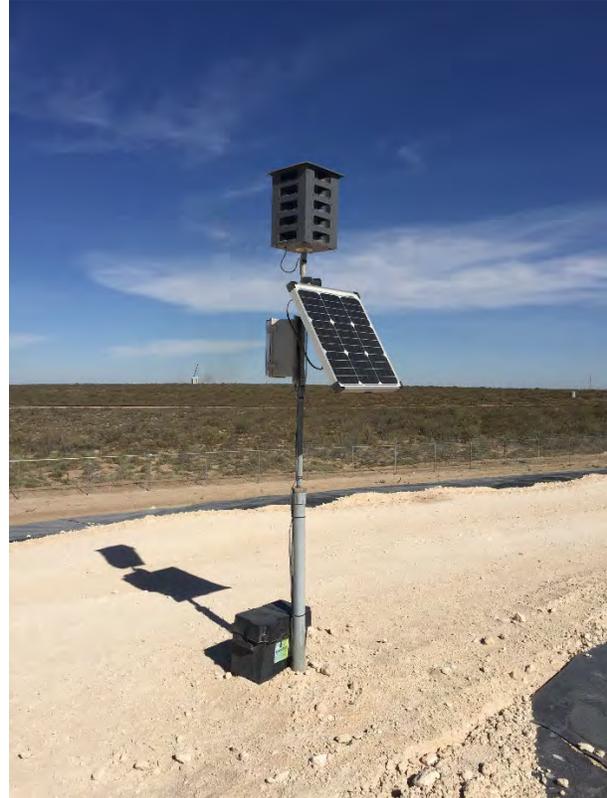
- The effective range of the Mega Blaster Pro is 30 acres, in a circular coverage pattern around the 20-speaker tower with a radius of about 666 feet. The 20-speaker tower features 5 speakers pointing in each direction to create the even dispersal

This is the typical configuration Centennial proposes to utilize at the Merchant Water Recycling Facility and Containment Pit.

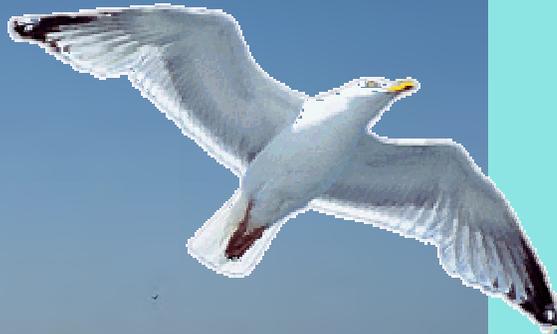
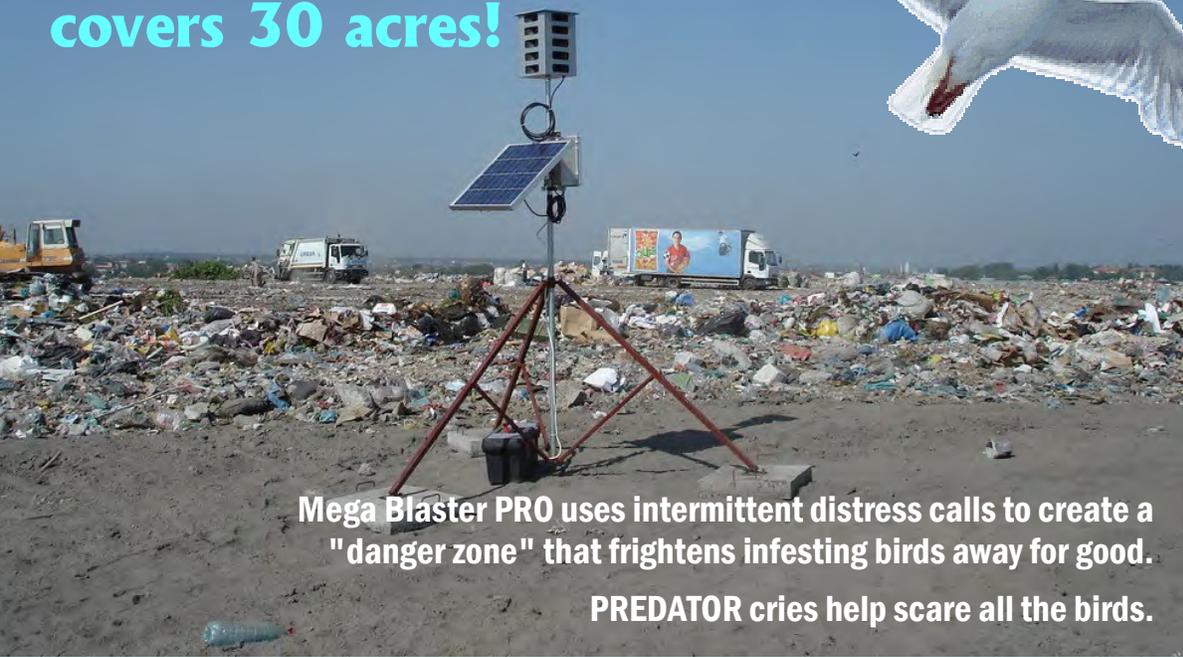
Mega Blaster PRO sonic bird repeller covers 30 acres!

Mega Blaster PRO uses intermittent distress calls to create a "danger zone" that frightens infesting birds away for good. PREDATOR cries help scare all the birds.

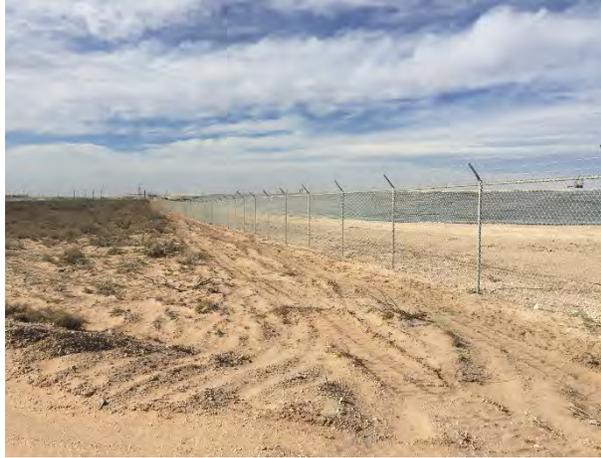
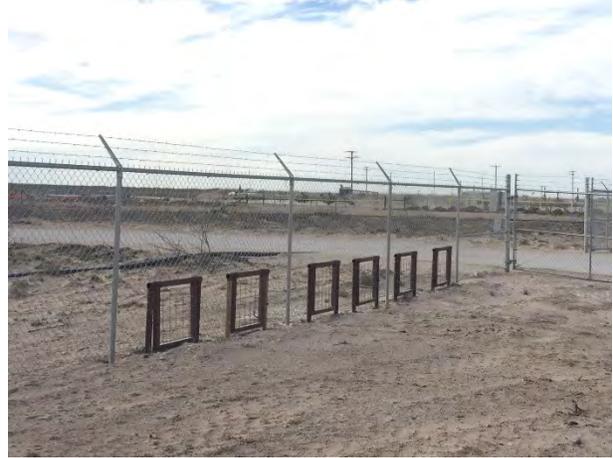
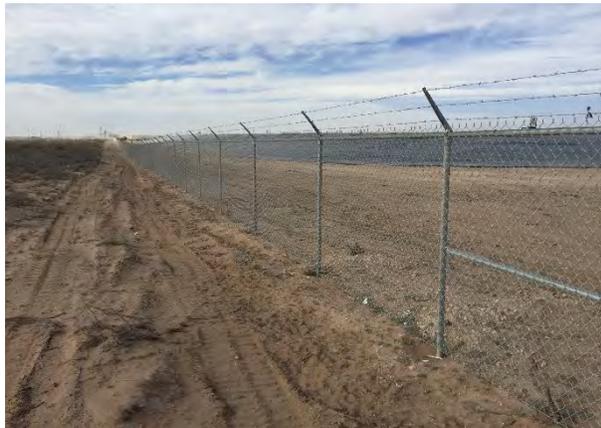
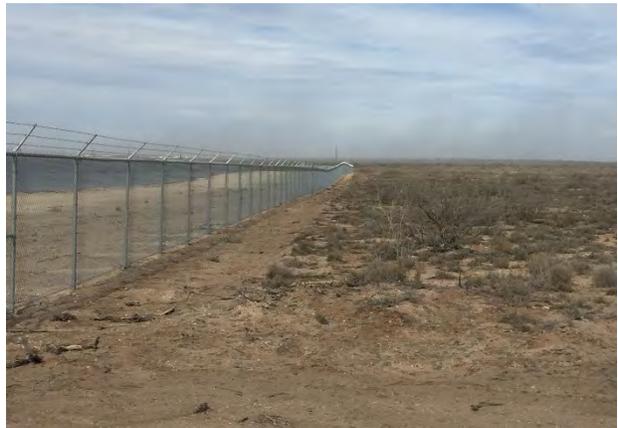
This is the typical configuration Centennial proposes to utilize at the Merchant South Containment and Recycle Facility.
