**4th Quarter 2019
Progress Report
Milestone 3**

**Reference: Fourth Quarter 2019 Progress Report
Sundance Services, Inc. Facility Closure**

Jet-Out Closure Report

**Sundance Services Inc.
NMOCD Surface Waste Management
Facility Permit No.: NM-01-003**

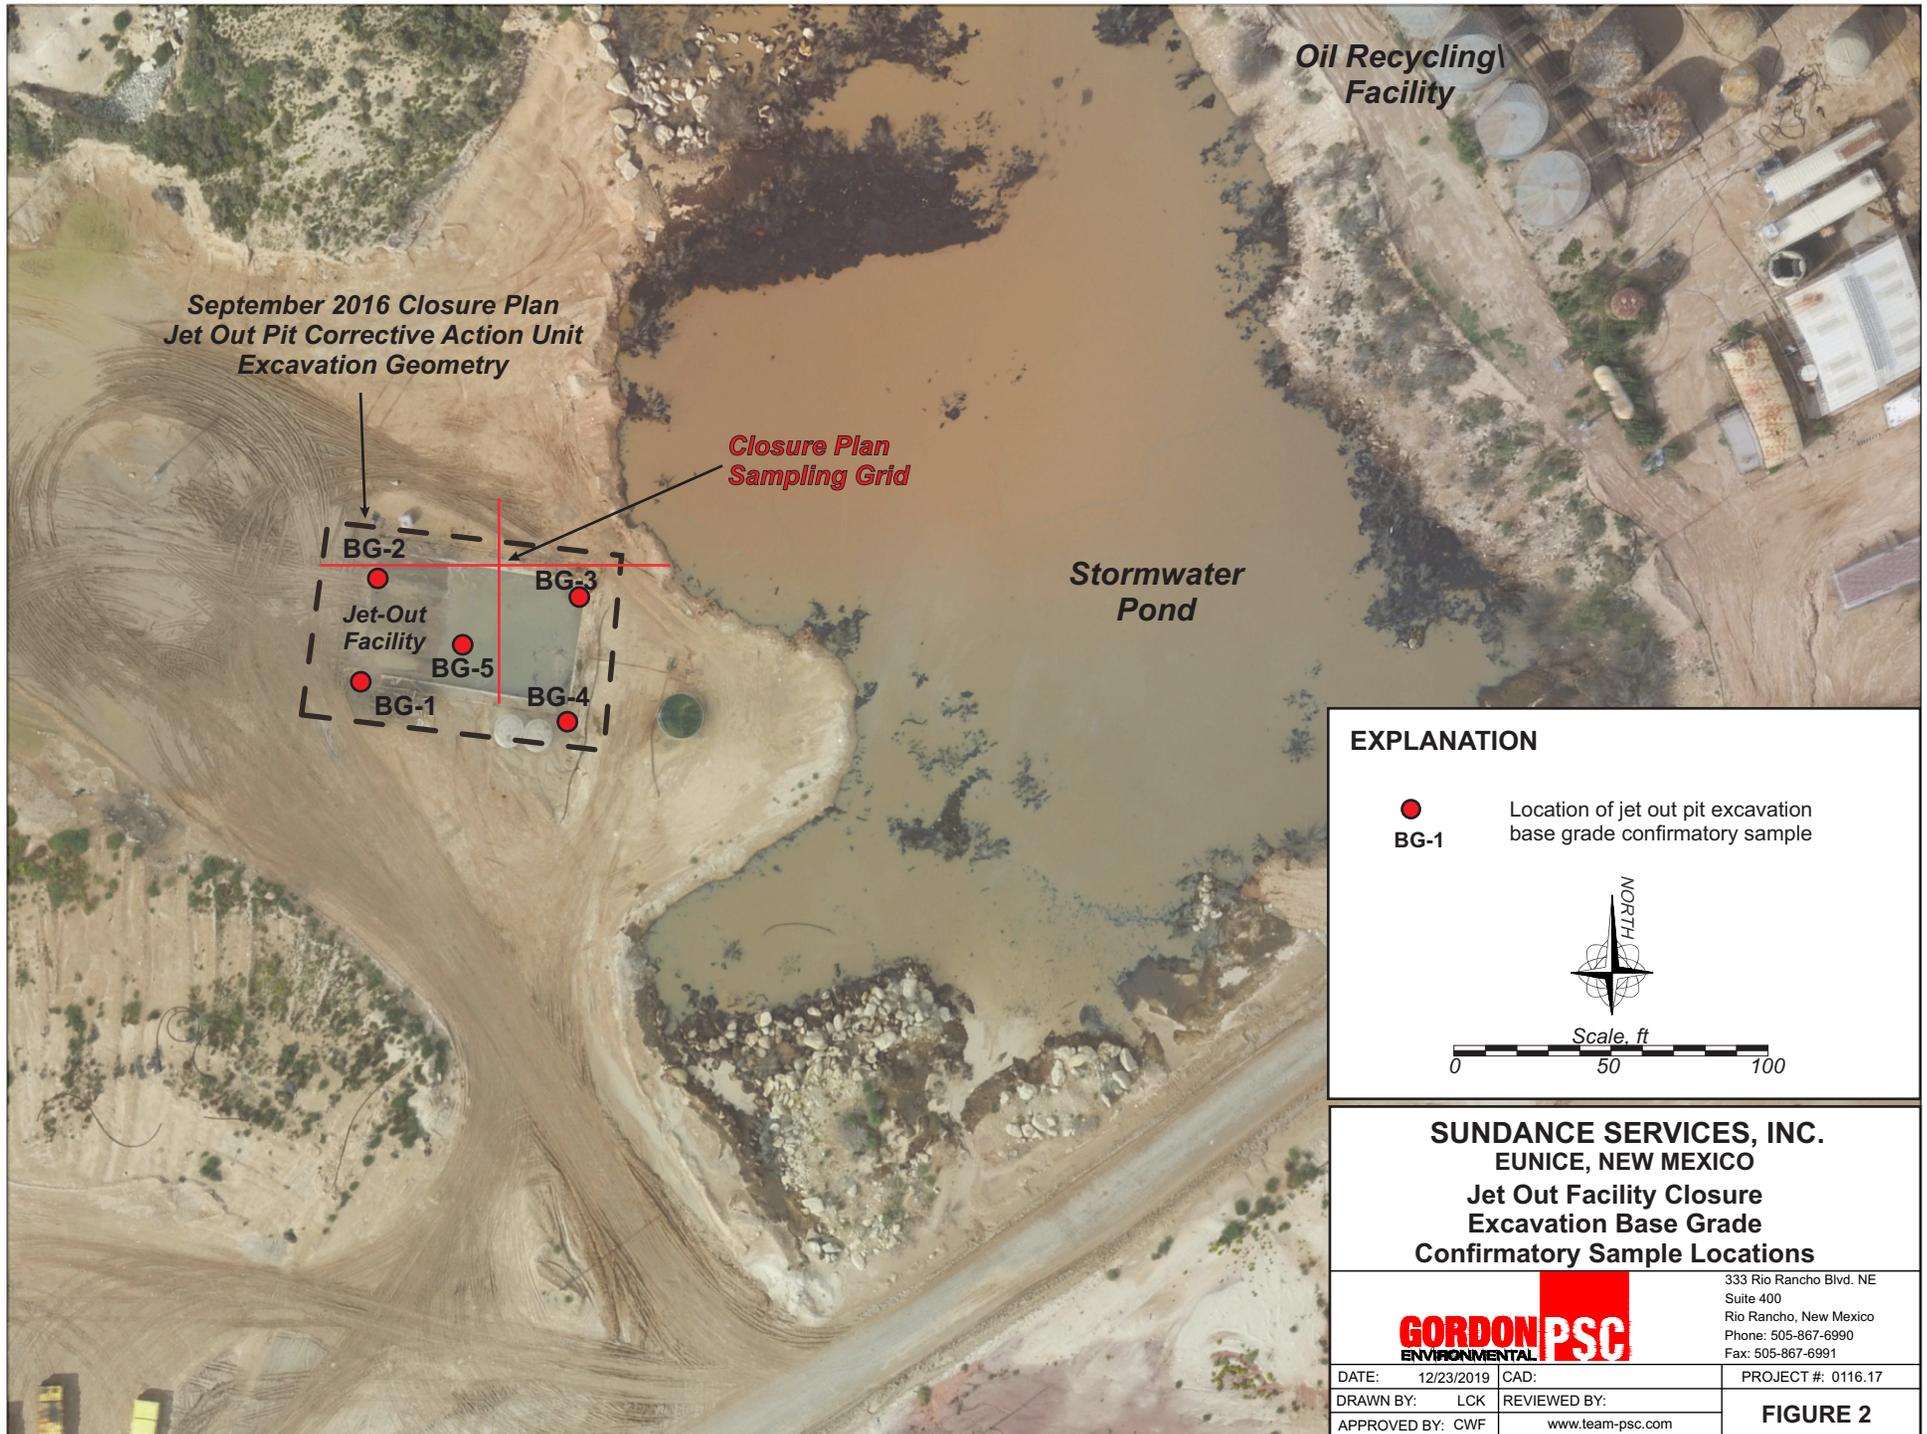
Upon completion of the excavation, 5 base grade confirmation soil samples were collected near the corners and in the approximate center of the excavation. Approximate locations of the base grade samples were determined with a handheld GPS receiver and noted. The soil samples were transmitted to Cardinal Laboratory in Hobbs for analysis of constituents set forth in NMOCD Release Remediation Criteria, 19.15.29.12, Table 1 NMAC, 7/24/2018, including:

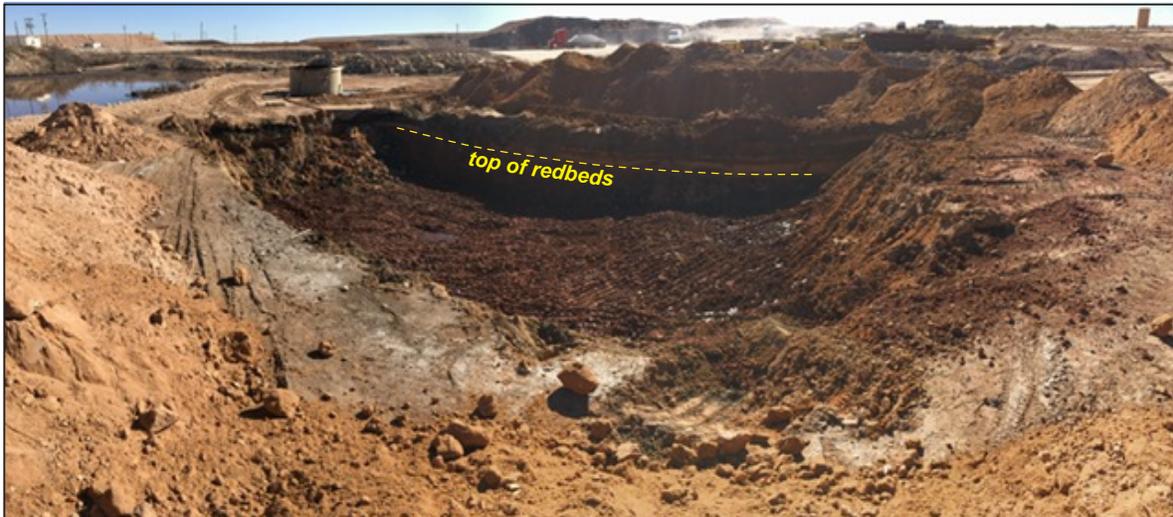
Photo 1.--View from the northwest corner of the completed excavation looking southeast.

JOP demolition and site excavation were completed on December 16, 2018. Concrete floor, walls and infrastructure were demolished and removed prior to site excavation. The excavation was advanced laterally approximately 10 feet beyond the margins of the jet out pit and vertically through 3-5 feet of overburden and an additional 4-5 feet into redbeds throughout the excavated area. Approximate geometry of the final excavation was determined using a handheld GPS receiver and was noted.

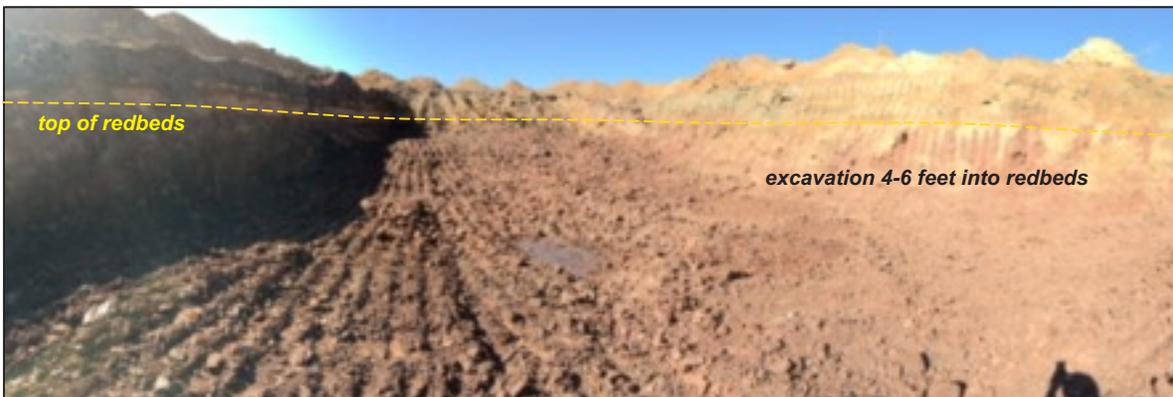
Photo 2.--View from the floor of the southeast corner of the excavation looking northwest.

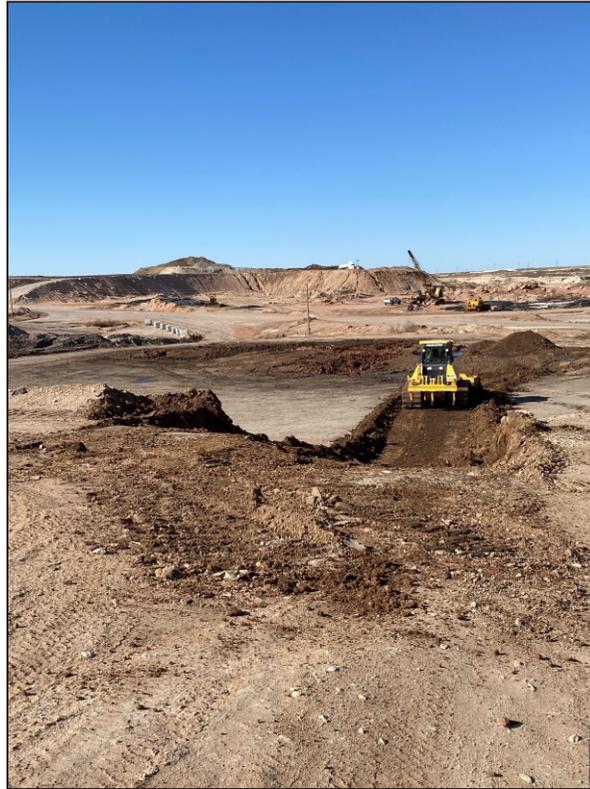
Photo 3.--View to southeast, initial stripping after JOP concrete demolition and removal.

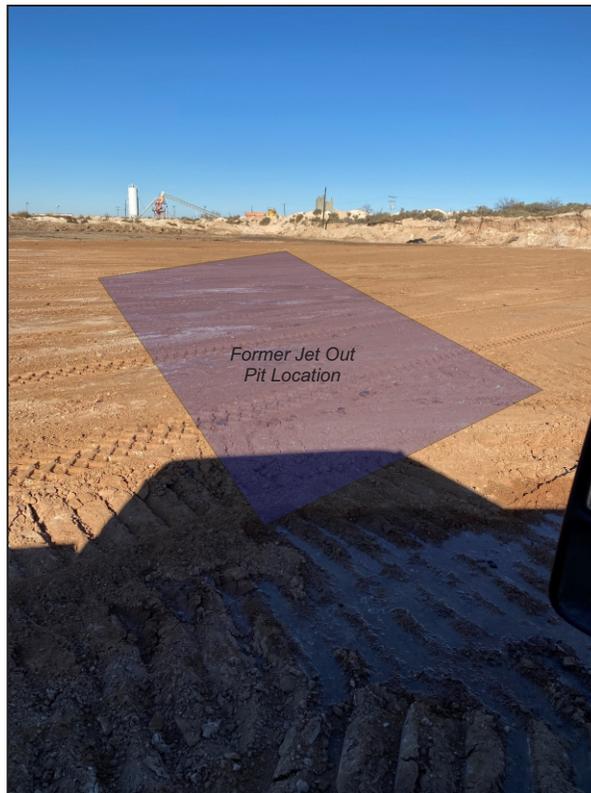
Photo 4.--View to northwest, after placing clean backfill and site restoration.
