# BW - 37

# ANNUAL REPORT

# 2020 Annual Class III Well Report Llano Disposal, LLC BW-37 API – 30-25-26370

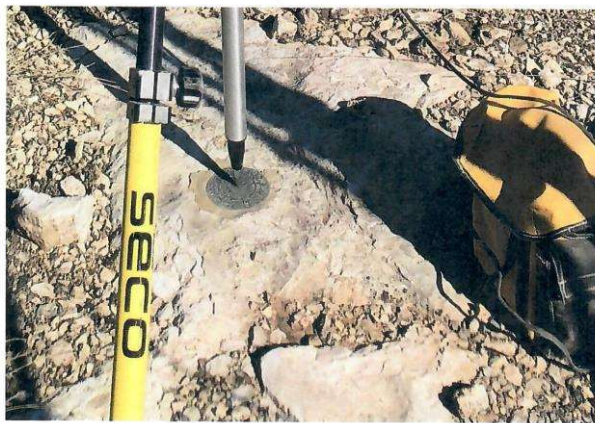
### X95 – DQ0312

NGS Control Point DQ0312 is a brass U.S. Coast & Geodetic Survey Benchmark set in concrete. It is stamped with an X and with the year it was set as shown below, followed by the NGS datasheet:

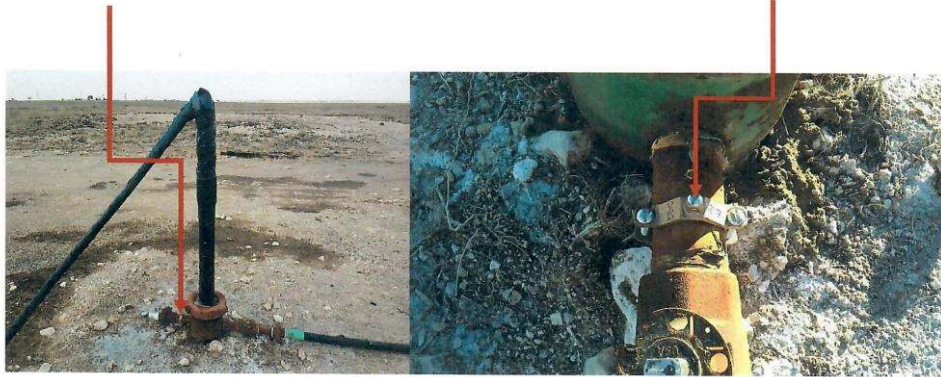
**Llano Disposal LLC'S State 4 BSW #1 (BW037)**

The existing wellhead was measured on the top screw of a brass clamp; leaving the wellhead on a horizontal plane.

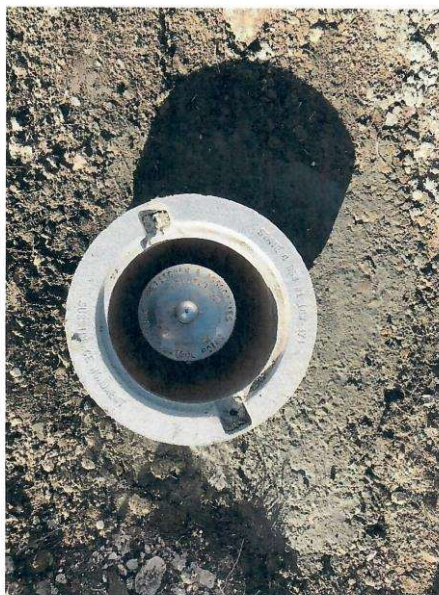
**Subsidence Monument 2**

A Berntsen three quarter inch Aluminum Top Security Sleeve Monument was set. It consists of a rod driven till refusal into a pre drilled three-foot deep hole with a twelve inch diameter. The sleeved rod is encased in six-inch PVC filled with sand, then topped with a Datum Point and an Aluminum Floating Datum Cap. It is then capped with an Access Cover that must be removed with a flathead screw driver or similar tool. The Monument is pictured below:

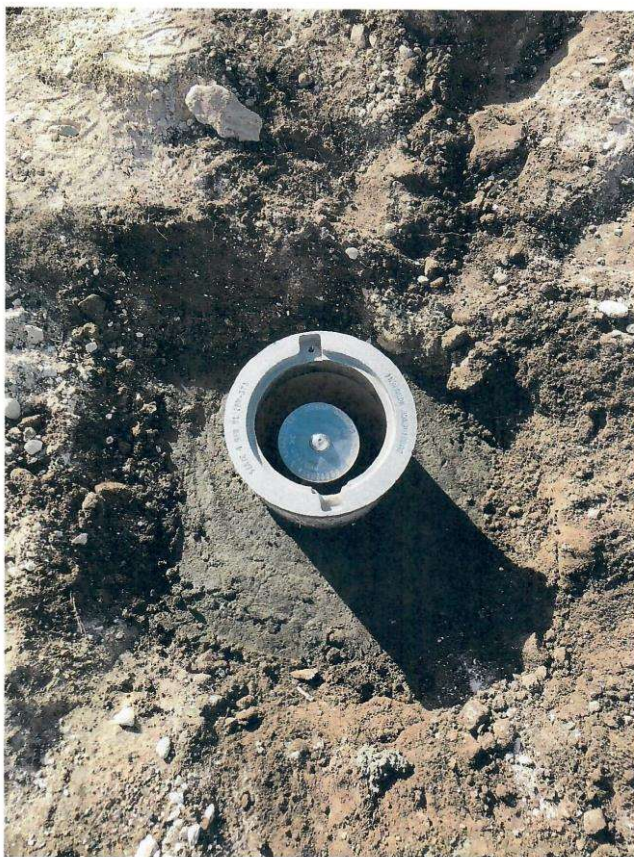
**Subsidence Monument 3**

A Berntsen three quarter inch Aluminum Top Security Sleeve Monument was set. It consists of a rod driven till refusal into a pre drilled three-foot deep hole with a twelve inch diameter. The sleeved rod is encased in six-inch PVC filled with sand, then topped with a Datum Point and an Aluminum Floating Datum Cap. It is then capped with an Access Cover that must be removed with a flathead screw driver or similar tool. The Monument is pictured below

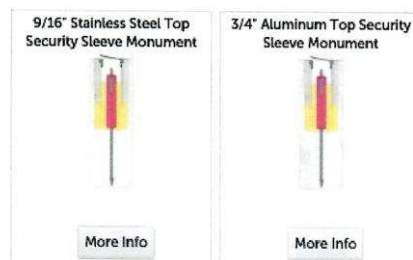
### Top Security Sleeve Rod Monuments

Berntsen's exclusive Top Security™ Sleeve 3-Dimensional Rod Monument System is specifically designed for high-precision geodetic and GPS surveys. Its patented design helps protect against excessive movements in the control monument. The Berntsen extendible rods, when driven to refusal, provide excellent vertical stability. The unique Y-shaped design of the Top Security Sleeve adds the second and third dimension to provide the most stable 3-D survey monument available.

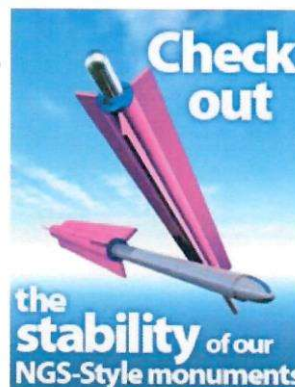
Eliminate most common and unexpected shifts in stability by eliminating most of the direct transfer of shifts in movement from ground level or surface movement. Here's how: Rod markers (driven to refusal) have good vertical stability but can be disturbed by the natural phenomenon known as frost heave. Rod markers, installed with a greased-filled PVC pipe surrounding the upper three or four feet (900 or 1200 mm) (or more) of rod, are known to be effective in combating movement caused by frost heave but offer little protection against possible horizontal movement of surrounding earth (another major cause of differences in readings on rod markers). For the first time, Berntsen's Top Security Sleeve™ with the horizontal stability of the original Berntsen Top Security™ finned rod marker system, this is now available in a commercially available survey monument.

It's even extendible! 3' (914mm) lengths of Top Security Sleeves can also be connected together by Berntsen's exclusive End Cap

Alignment Bushings and a little PVC Cement. When used in combination(s), nearly any even-foot length over six feet long (1.83m) of support for the rod marker is possible. That's innovative and flexible design at work for you.
