## WELLSITE INFORMATION

**Facility Name:** WELCH STATE TANK BATTERY 1  
**Survey Date:** April 23, 2026 10:33 AM

WELCH STATE TANK BATTERY 1, Eddy Co., New Mexico  
 POCO Resources LLC  
 U.L. E; 17 28S 28E  
 Latitude: 32.744134 Longitude: -104.197518  
 Facility ID: FCS2610442494

## SUMMARY OF OBSERVATIONS

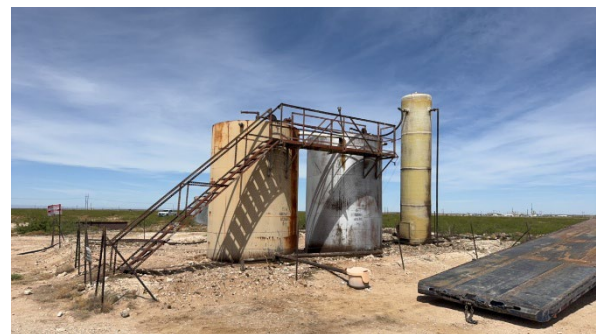
Photograph 1

**Pad:** Caliche well pad with minimal to no vegetation (Photographs 1 through 3)  
**Pit:** No evidence of a pit was observed based on site reconnaissance and review of aerial imagery

- Pad Area** (70,000 sq. ft)
- Collect soil samples to characterize hydrocarbon and chloride impacted soils in accordance with 19.15.17.13 NMAC (TPH and BTEX)
