## Release Notification

Site Name	Rosa Unit 312	Site Type	Well
Date Release Discovered	9/6/2019	API# (if applicable)	30-039-25058

**RE: Signs of recent produced water release through corrosion damage on western production tank, approximately 12ft above base. Standing fluids in containment, based off crusting up berms, estimate release volume greater than 5bbls, current volume in containment less than 1bbl at the Rosa Unit 312 well site. Located in Section 28, Township 31 North, Range 4 West, Rio Arriba, New Mexico.**

**LOGOS Operating, LLC  
Site Pictures  
Rosa Unit 312  
Figure: 1**

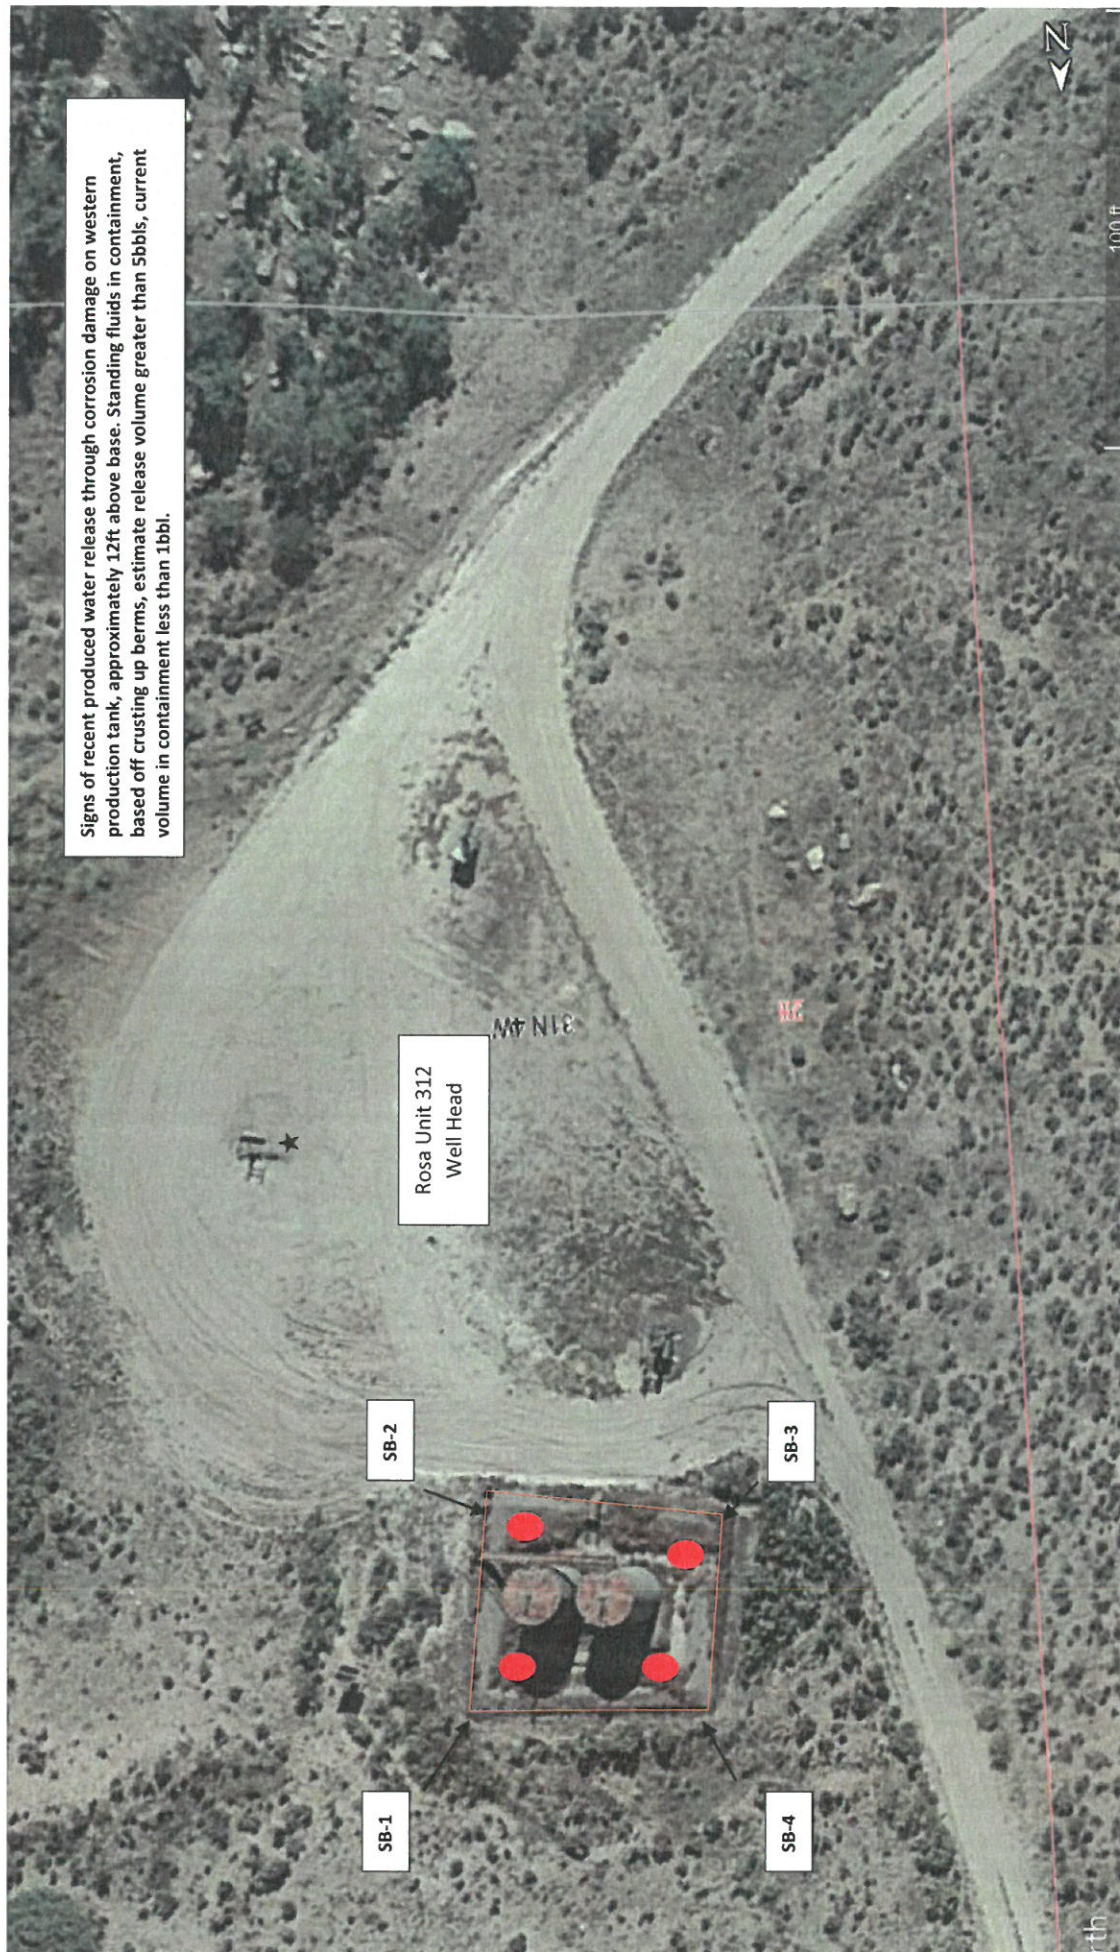
Aerial Site Map  
07/01/2020

Secondary Containment

Soil Boring

Signs of recent produced water release through corrosion damage on western production tank, approximately 12ft above base. Standing fluids in containment, based off crusting up berms, estimate release volume greater than 5bbls, current volume in containment less than 1bbl.

Rosa Unit 312  
Well Head

SB-2

SB-3

SB-1

SB-4

LOGOS arrived at the site on June 24, 2020 to conduct site delineation activities for historical produced water release that occurred at the Rosa Unit 312 well site (30-039-25058). The operator utilized a hand auger four (4) soil borings, SB-1 through SB-4, were advanced into the subsurface within the earthen berm containment. Delineation activities are documented in the enclosed Aerial Site map, and Figure 1 – Site pictures.

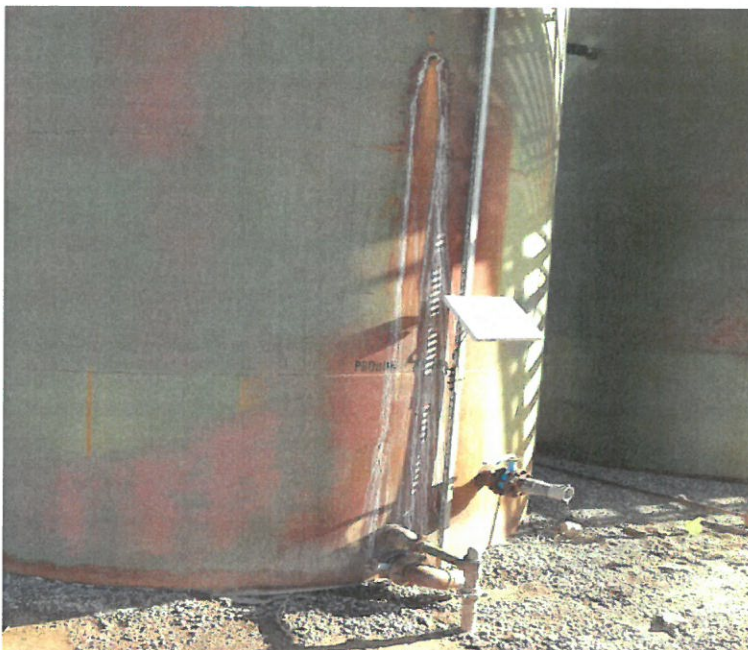
Impacted Area
