Huber Federal #10 CTB Amended Closure Report

**API No. 30-015-44848
Incident #NRH2002849703
Release Date: 12/21/19**

**U/L N, Section 34, Township 19S, Range 25E
Eddy County, New Mexico**

RE: Spur Energy Partners – Amended Closure Report – Huber Federal #10 CTB
Date of Release: 12/21/2019
API No. 30-015-44848
Incident #NRH2002849703
U/L N, Section 34, Township 19S, Range 25E

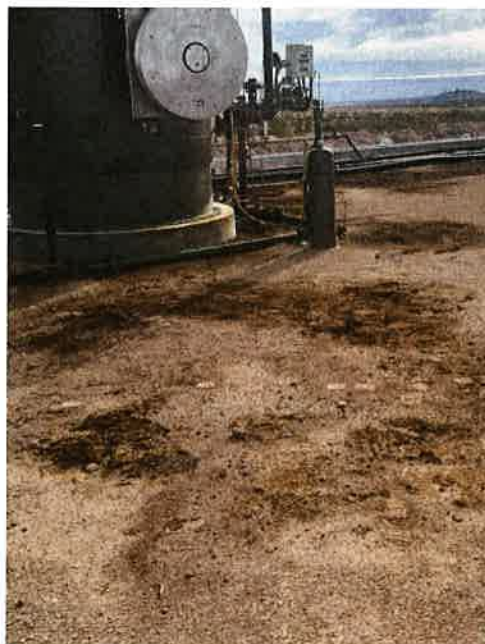
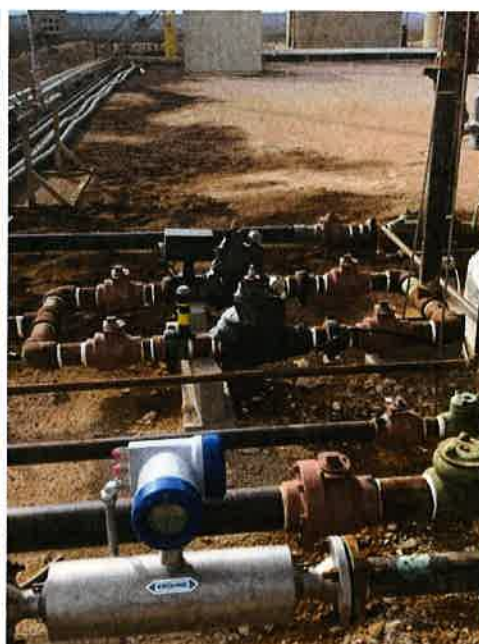
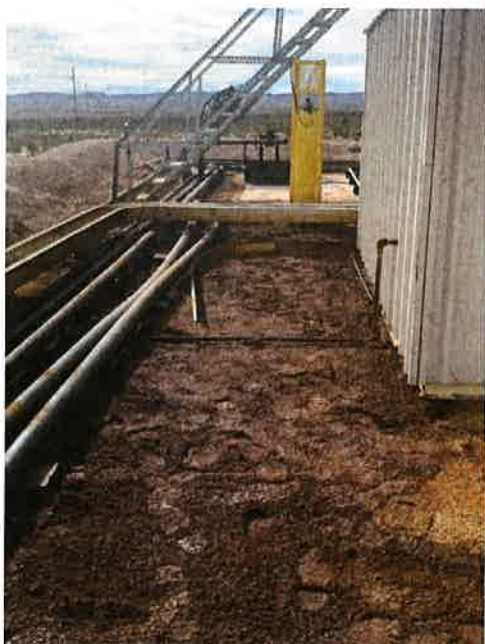
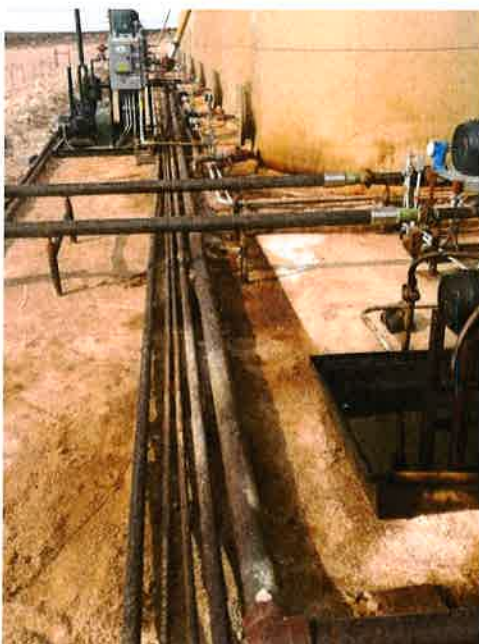
**SPUR ENERGY PARTNERS
HUBER FEDERAL 10 CTB
BEFORE PHOTOS**

Previously Hungry-Horse dispatched a crew to the site on January 13, 2020 to begin excavation of the impacted soil that was on-top of the lined containment. The impacted soil was excavated by use of shovels and hauled outside the containment area where it was stockpiled on plastic for disposal. Once the site was fully excavated, the liner was inspected. During the inspection, on January 15th 2020, multiple perforations were found. A crew was called in, to patch the perforations. 48 cubic yards of impacted gravel and soil was hauled to Lea Landfill for disposal. 38.3 cubic yards of 3/8" pea gravel was hauled in and stockpiled until the liner repair was completed. Once the liner was repaired the containment was backfilled with 3/8" rock. NMOCD/BLM was emailed to witness the liner inspection on or around January 20th, 2020.

THE RECIRCULATING PUMP AT THE FACILITY HAD BLOWN THE MECHANICAL SEAL AND RELEASED OIL INTO THE LINED FACILITY. ESTIMATED AREA IS APPROXIMATELY 85' X 6'.

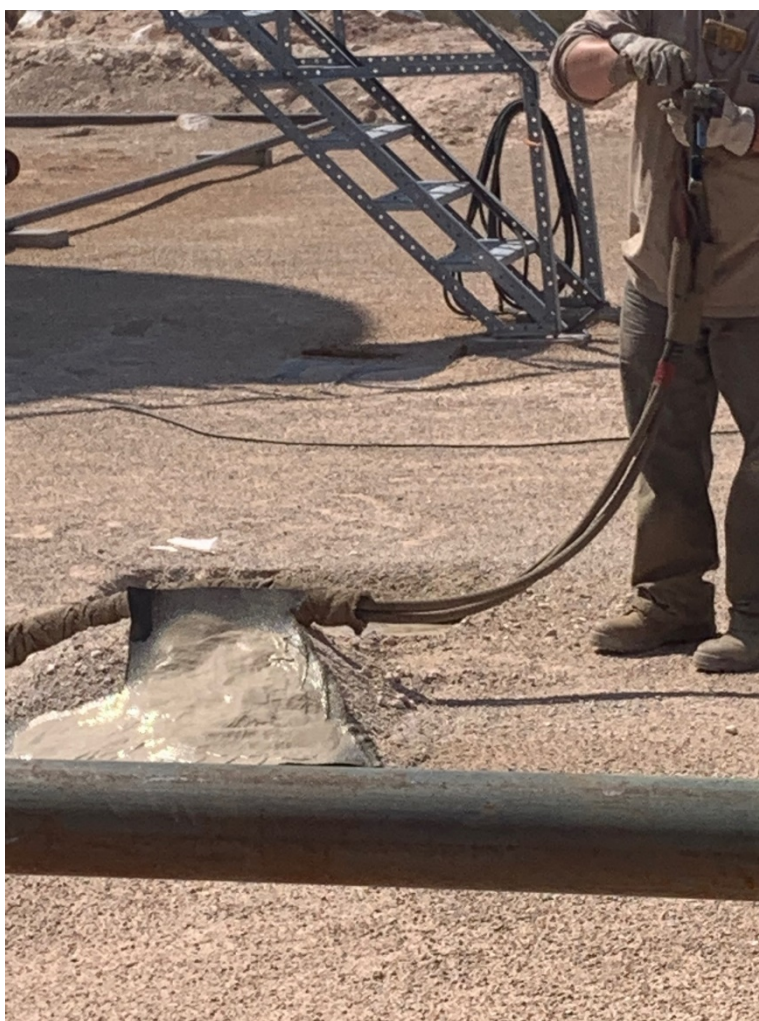
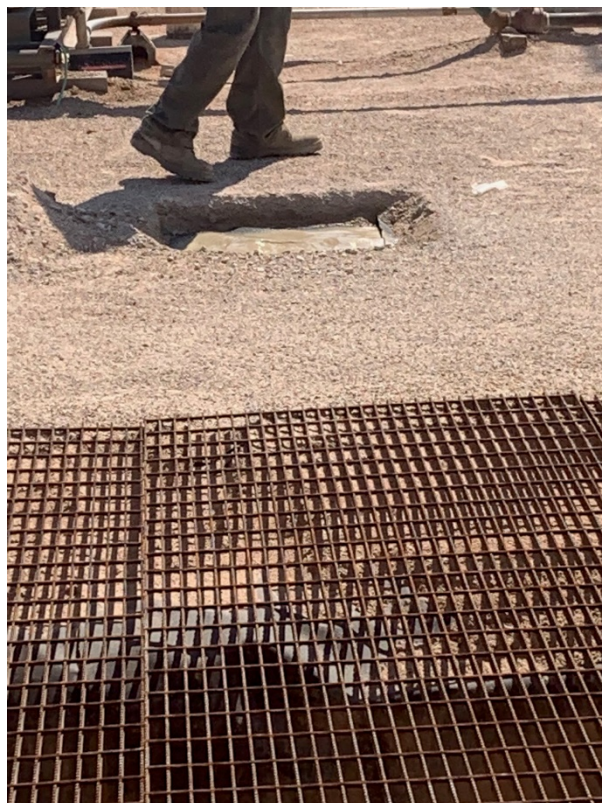
DELINEATION AND LINER PATCHING PHOTOS

On August 25th and 26th, ESS went back out to the Huber Federal 10 CTB to conduct a sampling event under the liner as per the closure denial email received from the OCD on August 14th, 2020. Three separate areas were cut 1' x 1' and delineation was conducted by use of hand auger. Field samples were conducted using the Titration Method to test for chlorides in the soil and a PID Meter was used to test for volatiles found in the soil. The vertical samples were tested in 1' intervals. Bottom hole samples were then jarred and delivered to Envirotech Laboratories for confirmation. A background sample was also taken to determine site background levels.

With the above sampling data, sampling indicated that there was no detection of BTEX, TPH and/or Chloride contamination found under the liner. This data proves that the liner has not been compromised.
